# **FACILITY ASSESSMENTS MUNICIPAL BUILDINGS PHASE I**

**JAFFREY, NEW HAMPSHIRE**

**SEPTEMBER 2008**

**THE H.L. TURNER GROUP Inc.**

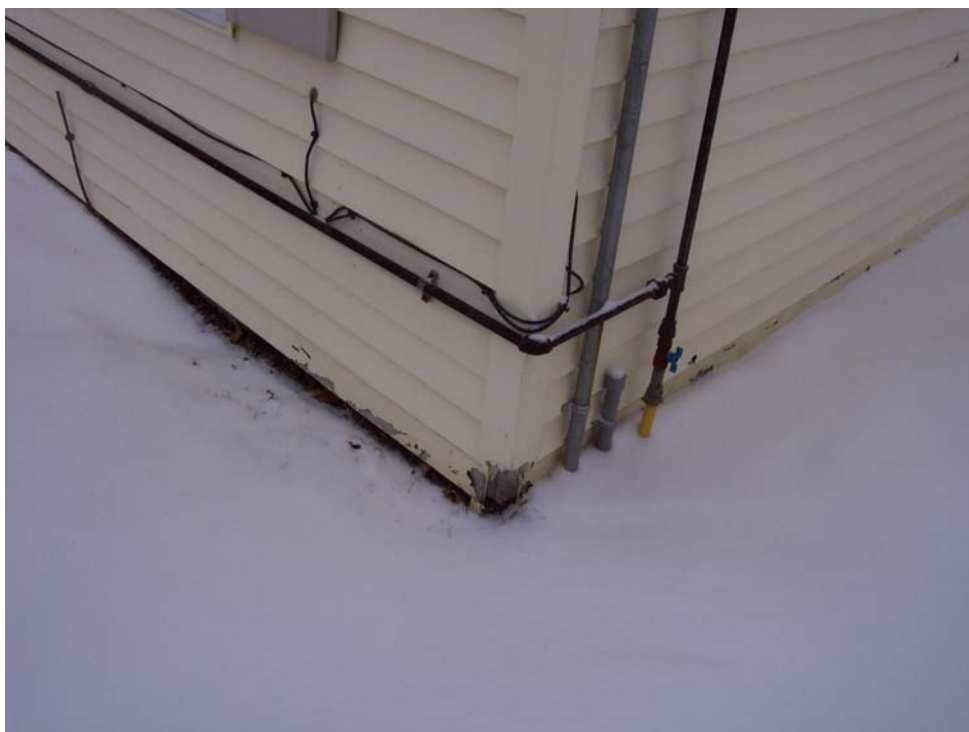
3. There are a few small areas along the south or rear portion of the building where the vinyl siding has been broken or otherwise damaged. These areas should be replaced.

| <b>ARCHITECTURAL</b> | | | <b>\$ Opinion of Cost</b> | | | |
|---|---|---|---|---|---|---|
| Vinyl Siding | Some of the siding along the lower portion of the rear wall is in bad condition. | Re-side the broken and worn sections of siding. | None | \$1,000 | | |

Damaged Vinyl Siding on the East Side of the Building

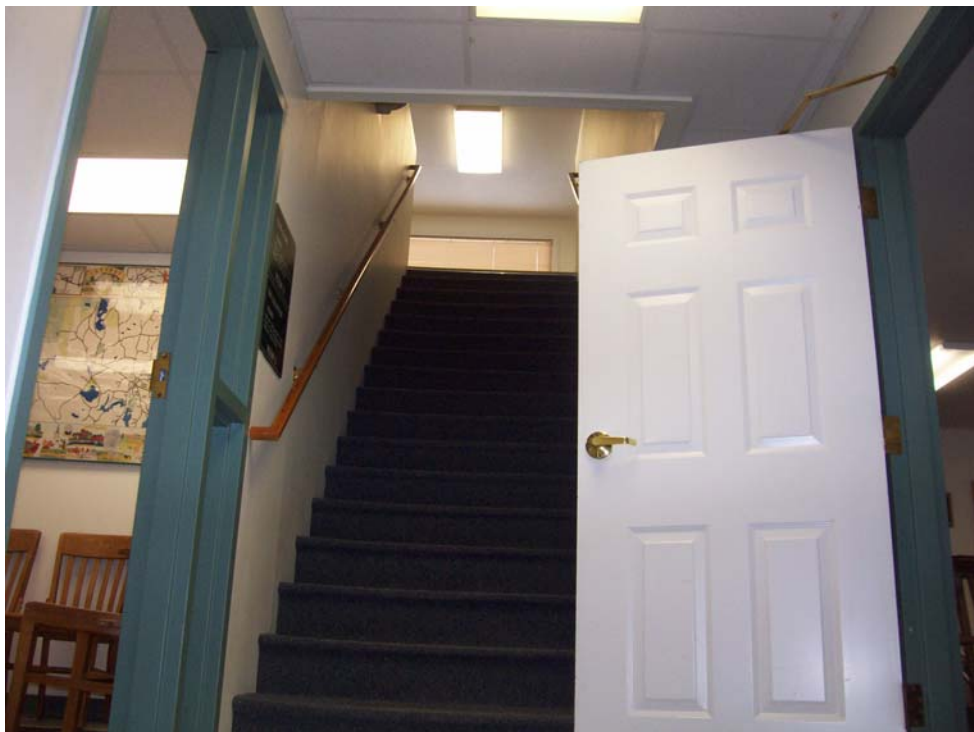
carpeted. The carpeting on the stairs is worn. However, all other carpeted areas are in good condition. Finishes throughout the building are in fair to good condition.

| ARCHITECTURAL | | | \$ Opinion of Cost | | | |
|---|---|---|---|---|---|---|
| Flooring | The carpeting on the stairway is worn. Carpeting is also worn in high traffic areas on second level. | Replace worn carpeting on stairway and in upstairs traffic areas. | 1 to 2 years | \$1,200 | | |

Main Stairway to the Second Floor

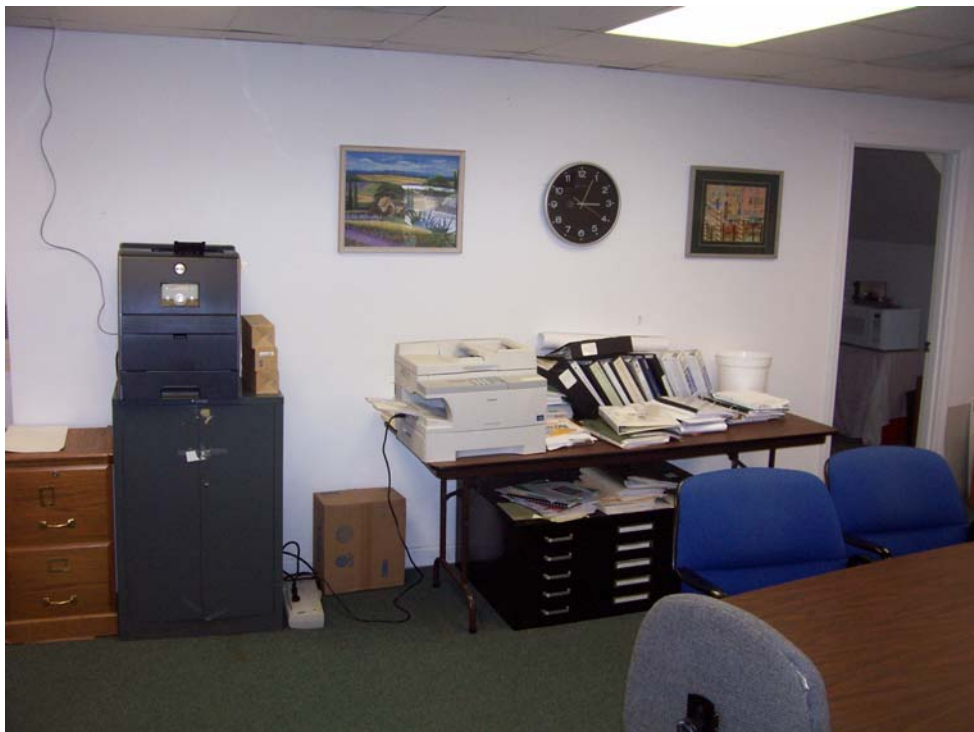
Another structural issue is the knee braces on the columns at the second level along the north side of the building. In several locations, the knee braces had been removed. These were part of the original structural framing system and were intended to reduce the unbraced length of the column, as well as to help reduce the magnitude of the bending in the columns. The original braces should eventually be replaced.

| ARCHITECTURAL | | | \$ Opinion of Cost | | | |
|---|---|---|---|---|---|---|
| Column Knee Braces | At the second floor level, some of the column knee braces had been removed. | Since the knee braces were part of the original design and serve a structural function, they should be replaced. | N/A | \$800 | | |

Second Floor Office and Framing

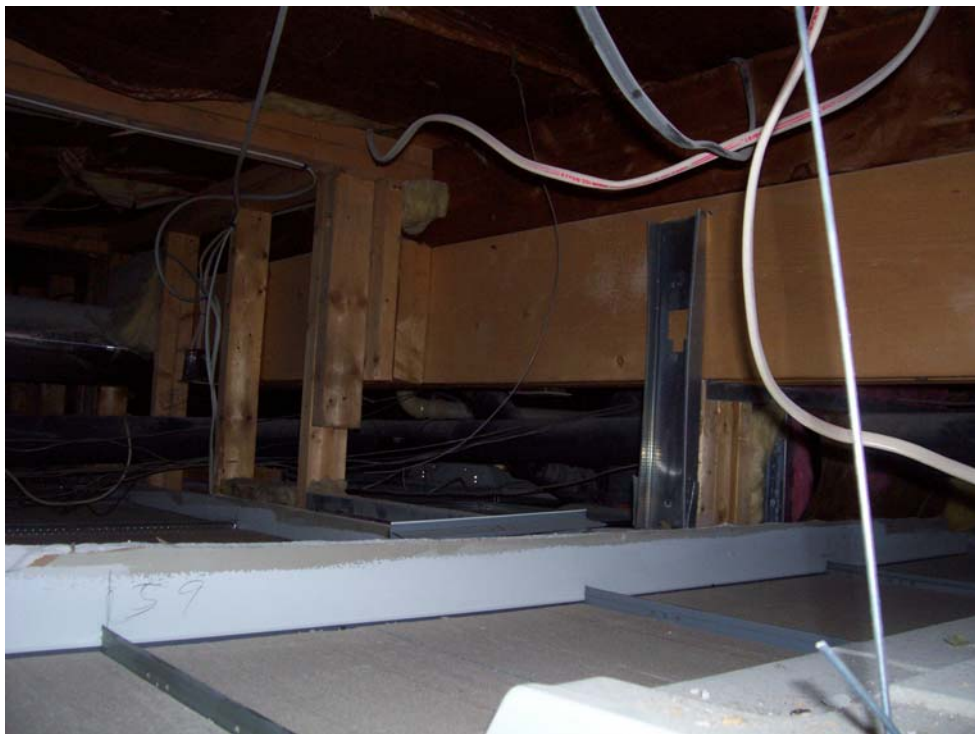
Structurally, the building is in fairly good condition, with the exception of the second floor on the north side of the building in the area of the upstairs meeting room. There is a pronounced sag in the floor near the middle of the building. It is our understanding that the floor was heavily loaded at one time with file cabinets that have since been relocated. However, the sag remains. We investigated the framing below, and found a main carrying beam fabricated from three (3) 2 x 8's in the area of concern. Based on the span, calculations show that the beam is considerably overstressed for normal office loads.

| ARCHITECTURAL | | | \$ Opinion of Cost | | | |
|---|---|---|---|---|---|---|
| Second Floor Structural Issue | Second floor is sagging from overload by filing cabinet storage. The file cabinets have since been removed. An engineering evaluation indicated the present beam to be undersized. | The existing floor must be shored, jacked, and leveled, and the main carrying beam replaced. | N/A | \$8,500 | | |

Second Floor Framing at Sagging Floor

8. The structural issues should be addressed as soon as possible, the sagging floor issue in particular. The existing beam, which consists of a series of three (3) 2 x 8's, is very much overstressed for normal office loads, never mind a row of heavy filing cabinets. The entire beam or beams in this area should be replaced with properly sized members.

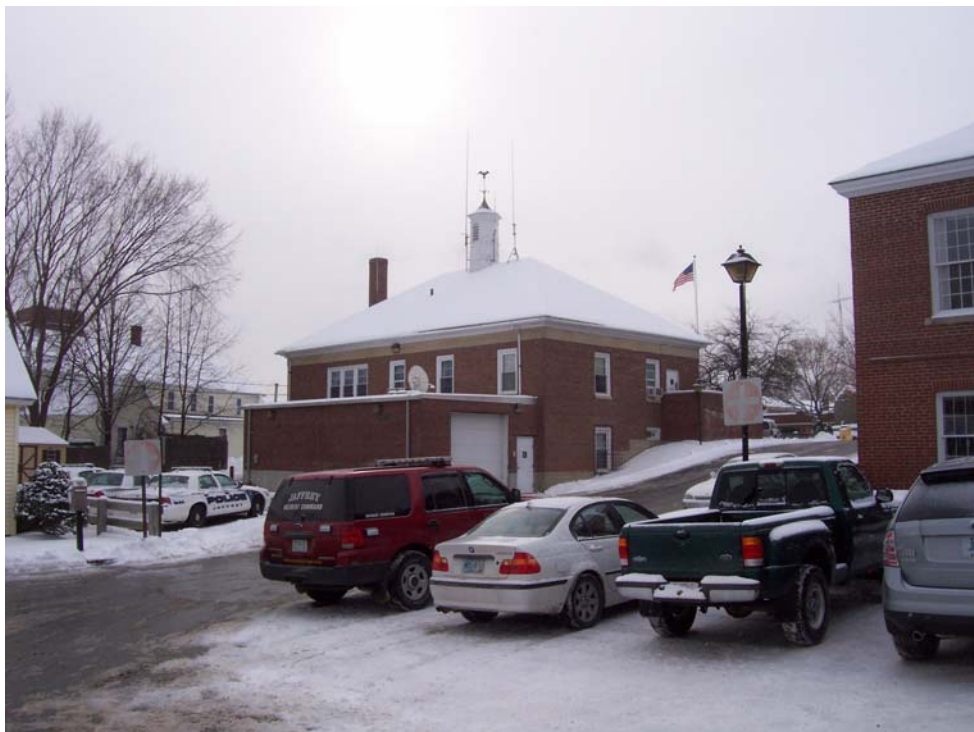
The sally port is in good condition, although we did note that there is a sizable gap between the north side overhead door and the doorframe, or the doorframe and the rough opening. This gap should be closed-up as it could account for appreciable heat loss.

Sally Port on North Side of Building

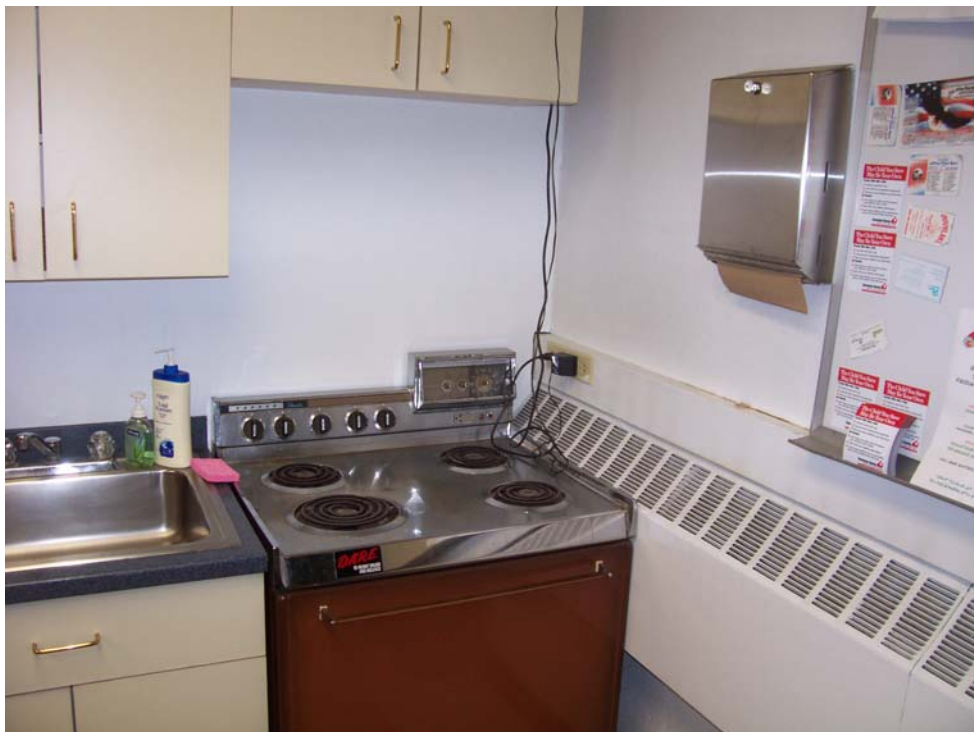
The interior spaces on the first level are predominantly vinyl composition tile or carpeting on the floors with painted gypsum walls and ceilings. All of the spaces in the basement have vinyl tile on the floors, and the walls are painted CMU block. It was noted that the tile flooring in the squad room is badly worn and in need of replacement. This particular floor is subject to heavy use and is a good candidate for rubber flooring, a product that stands up very well to high traffic. The break room consists of a stove, refrigerator, sink, soda machine, and television. Most of the appliances and furniture are outdated, and the entire space could use upgrading. We noted a receptacle just above one of the burners on the stove. The receptacle should be moved, as it is a code violation.

Plug Adjacent to and Wires on the Stove in the Kitchen

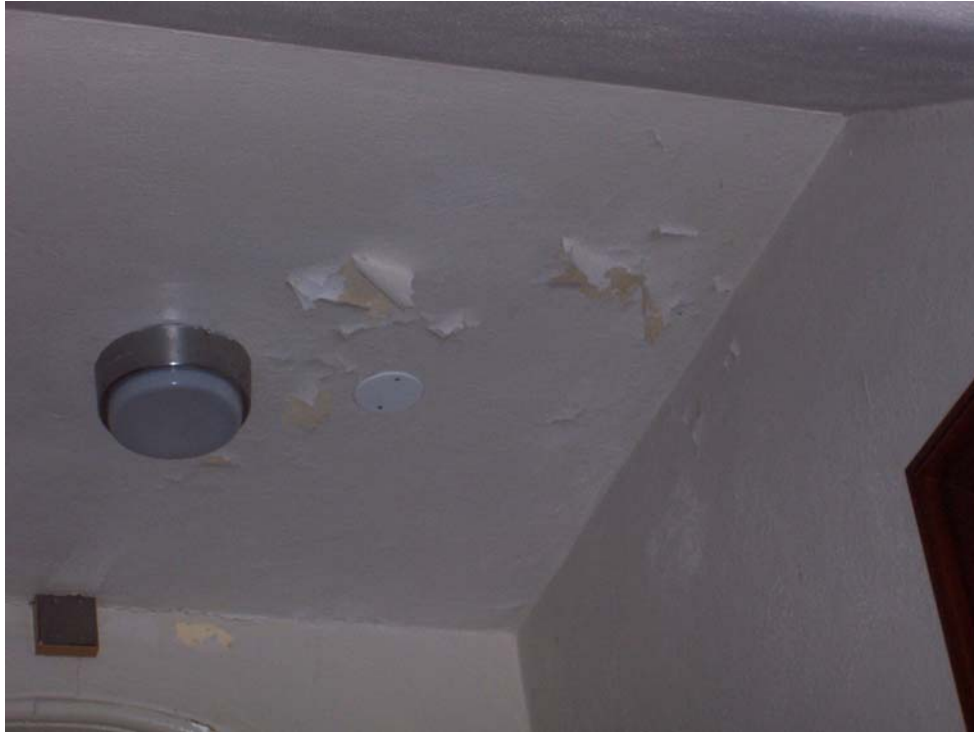
Peeling Paint in the Original Library Second Floor Ceiling

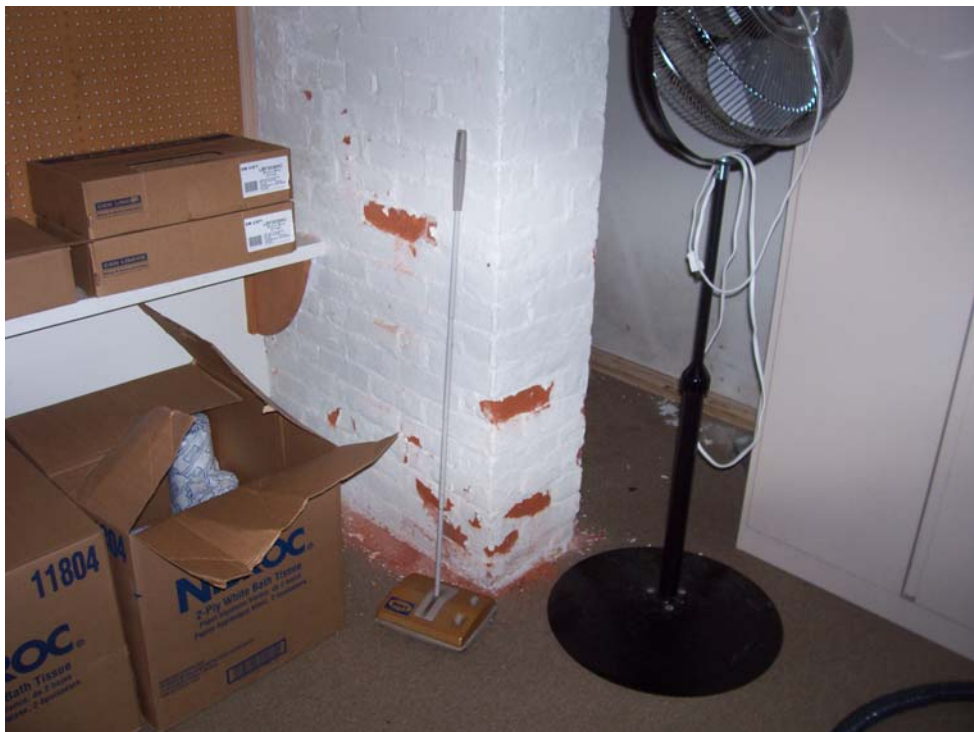
Original Library Basement Brick with Peeling Paint

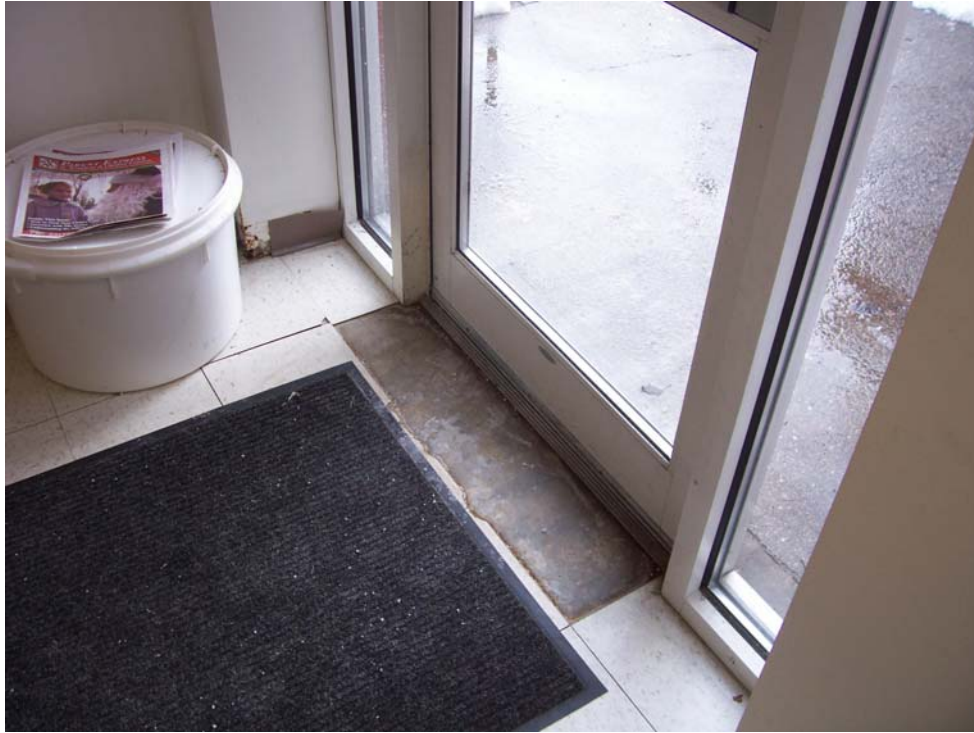
Missing Floor Tiles at Lower Level Entrance – Library Addition

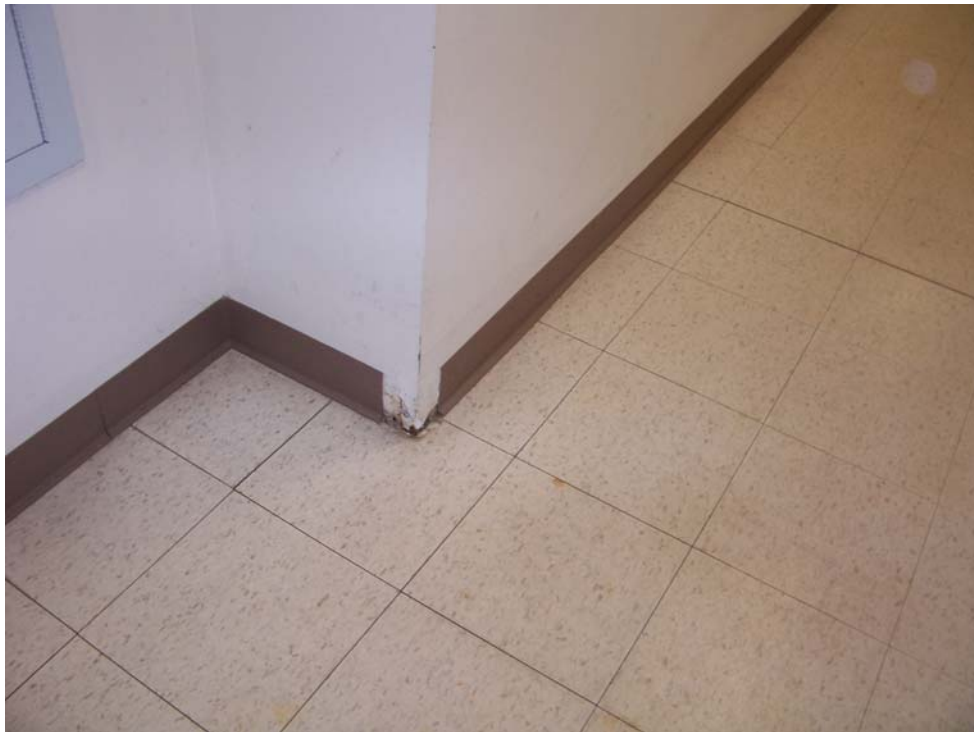
Damaged Drywall near Lower Level Entry Door  
Library Addition
