FACILITY ASSESSMENTS MUNICIPAL BUILDINGS PHASE II

JAFFREY, NEW HAMPSHIRE

JANUARY 2009

THE H.L. TURNER GROUP Inc.

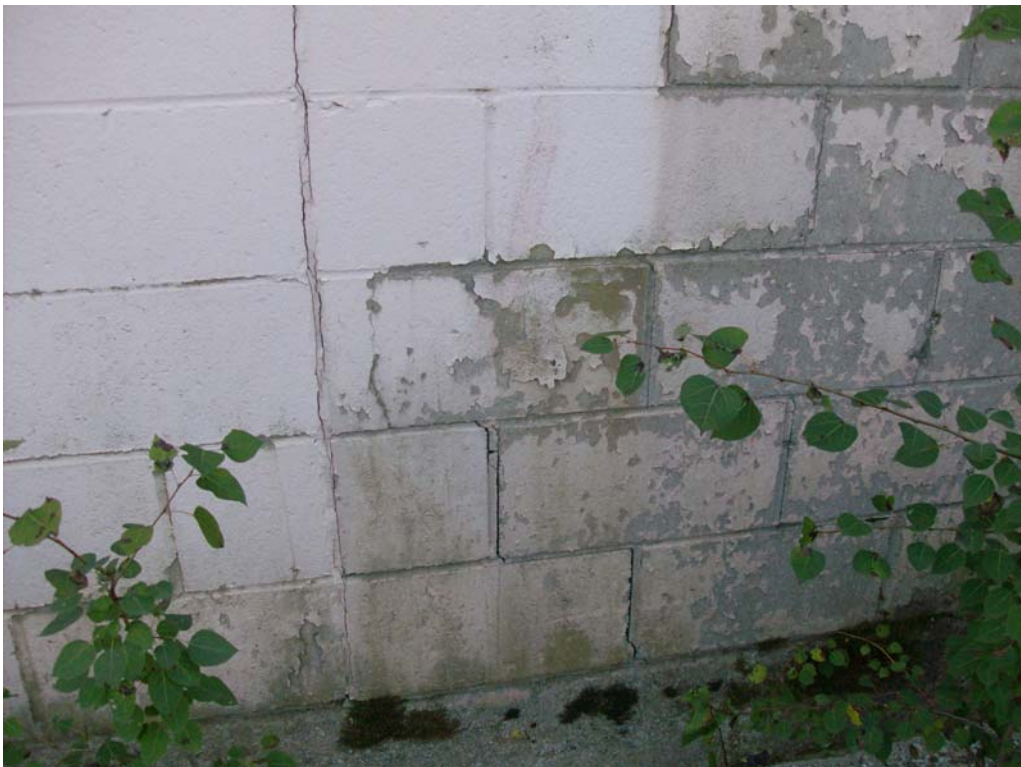
The CMU walls, particularly along the north wall or rear of the building, have some cracking at the mortar joints, and there are large areas where the paint is peeling and flaking off the wall. The lack of a frost wall makes the building very susceptible to movement from frost heaves, which may explain some of the cracks in the masonry walls. Along the lower courses of block, moss has started to grow, indicating a persistence of moisture and an inability of the block to dry out. Despite these issues, most of the block is in generally good condition.

North Wall of Garage – Note Cracking, Peeling Paint, and Moss Growth

5. Re-point the cracks in the CMU block, particularly at the rear of the building. Scrape and paint the CMU block.
6. Add additional insulation over the ceiling of the Administration wing. Improve ventilation by adding a ridge vent.

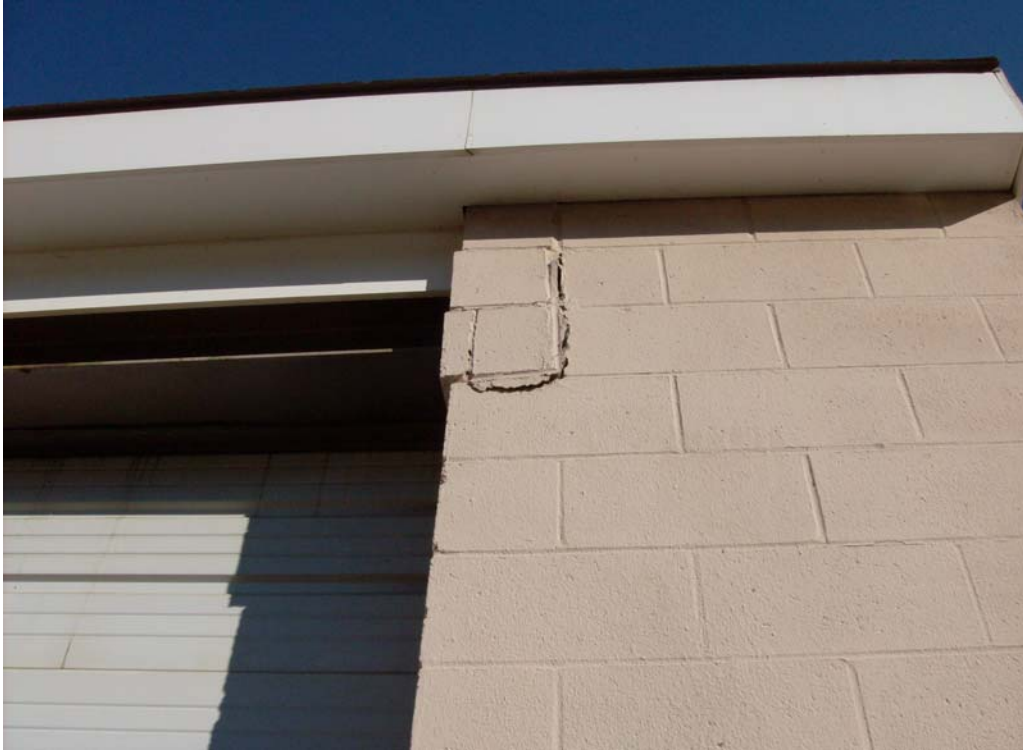
The CMU block at the header of the eastern-most overhead door is cracked and damaged. Repairs are urgently needed in this area, as sections of the block could break loose and fall, possibly causing injury. Reports from DPW personnel indicate the damage was not the result of a vehicle impacting the top of the door opening. We suspect that the damage was the result of differential movement between the CMU and the steel lintel that runs across the top of the door opening. For this type of building construction it is typical for the end of the lintel to be fixed to the CMU block by means of a bearing plate anchored into the grouted core of the block. Movement of the lintel as a result of expansion and/or contraction of the steel could have damaged the block over the years. A similar situation exists at the lintel of the western-most overhead door. Existing cracks in the mortar joints indicate that some movement has already occurred, and if left unattended, this could possibly end up as more significant damage. The lintel connection should be detailed to allow for small movements of the steel relative to the fixed masonry.

Damage at Head of Overhead Door – Southeast Corner of Garage

3. Repair the cracked and broken CMU at the header of overhead door eight at the east end of the main garage. Provide a means for the lintel to move independent of the masonry to prevent future damage.

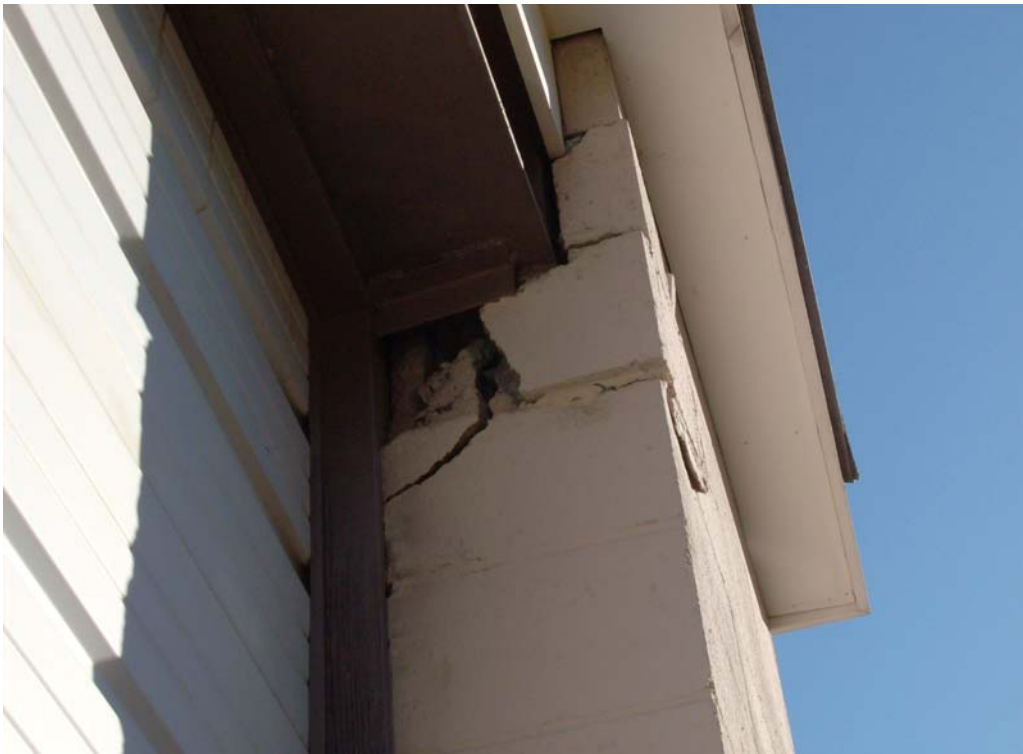
CMU Damage at Overhead Door – Southeast Corner of Garage

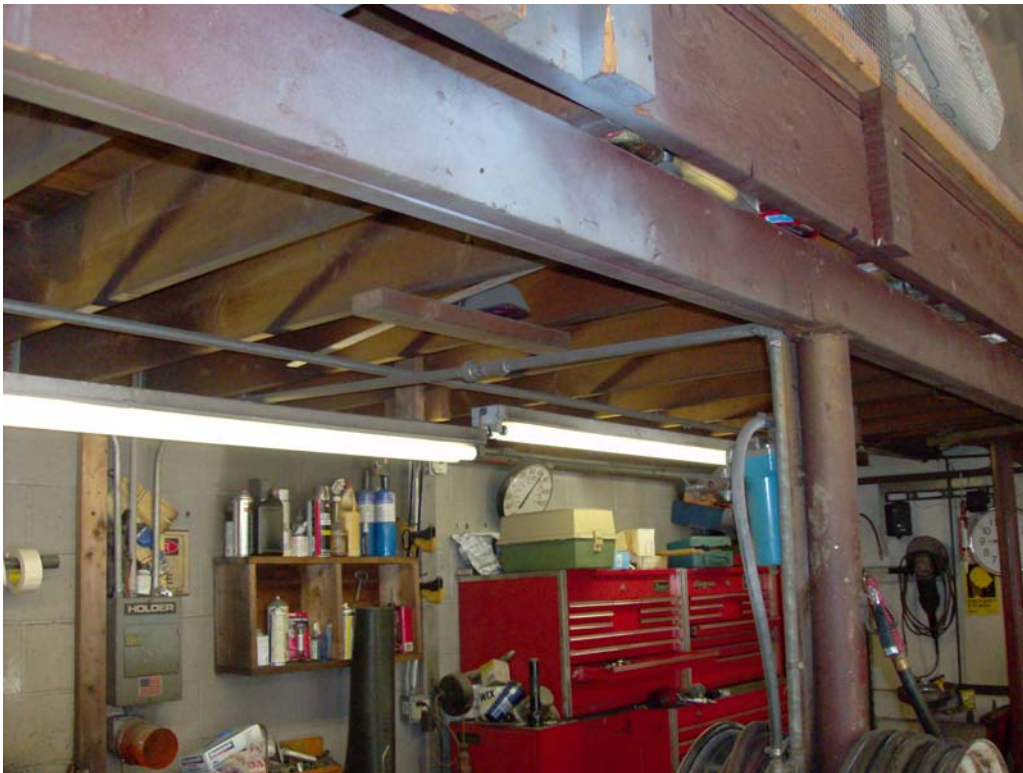
There is a wood-framed mezzanine in the garage along the north wall. It runs nearly the full length of the equipment bays. The framing is somewhat questionable in that the main beam supporting the floor joists is a pair of 2 x 8's that span over 8-feet between columns. Also, the post supporting the eastern-most corner of the mezzanine is not aligned below the support beam and relies on a cantilevered piece of channel off the post to support the mezzanine beam. It is recommended that calculations be performed to determine the safe live load capacity for the mezzanine. Eventually a sign should be posted with the load limit.

Wood Framed Mezzanine Along North Wall of Garage

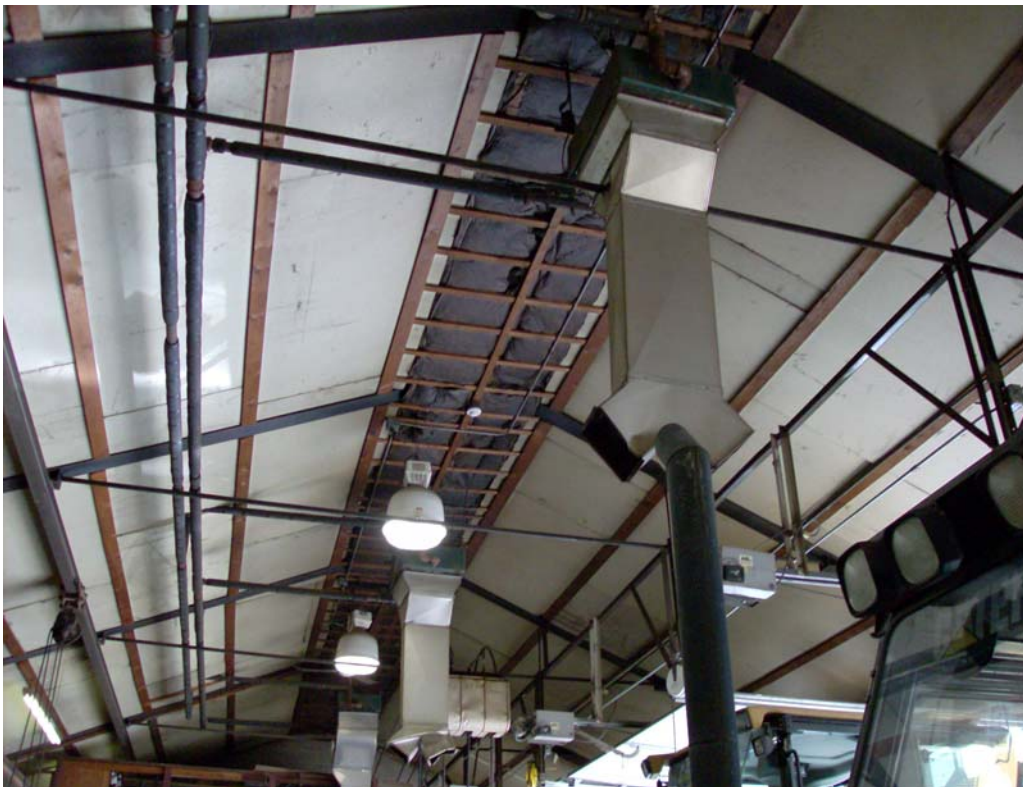
The garage area ceiling is insulated with expanded polystyrene insulation. In some areas the panels have shifted such that the effectiveness of the insulation is negated. At the time of the next garage roof replacement, consideration should be given to adding more insulation at the roof. This could be in the form of polyisocyanurate or polystyrene sheets under the roofing materials, whether it is wood sheathing with asphalt shingles or a standing seam metal roof. The result of adding more insulation to the roof means that there is a possibility that more snow could accumulate on the roof. Of course, before any insulation is added, a study of the structural capacity of the roof support members must be undertaken in order to determine if any of the members become overstressed under the weight of the additional snow load.

Insulated Roof of Equipment Bays

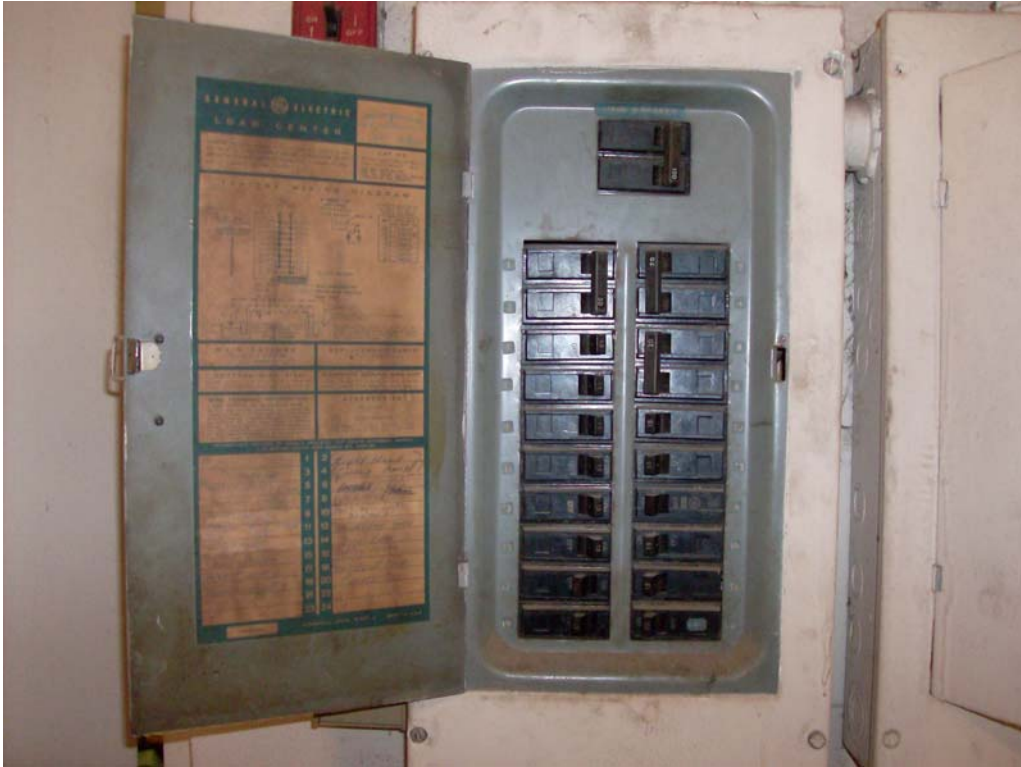
Three-phase power was added just prior to the year 2000. However, many of the original electrical panels are old and outdated and should be replaced. The lighting in the garage is a combination of 8-foot long fluorescent strip lights and a total of four large Mercury Halide lights. The existing lighting appears to be adequate.

Typical Electrical Panel

12. Upgrade or replace the existing fire alarm system to include horns and strobes throughout the building as required by code.
13. Upgrade some of the old electrical panels.

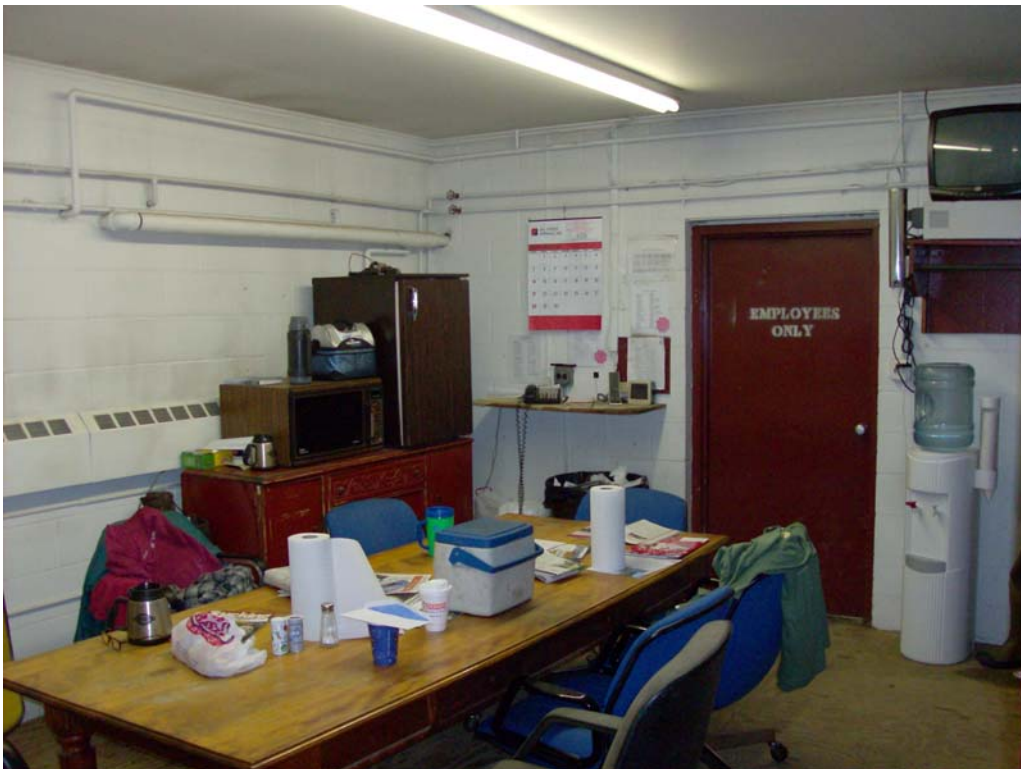
The break room across the hall needs a new floor. The existing plywood floor is worn out. We were informed that the existing concrete floor under the plywood was damaged during a fire back in 1967. Apparently, the room was originally used to store chemicals and the chemicals got onto the floor prior to the fire. Several attempts have been made to restore the floor with little success. Some feel the only alternative is to jackhammer out the floor and replace it. The available crew space does not provide adequate space for meetings and training, or for those personnel who work long hours during snowstorms or emergencies.

Break Room for DPW Workers

9. At a minimum, replace the floor of the break room. Replace the existing lockers with new lockers and re-do the entire room with new finishes, counters, etc.

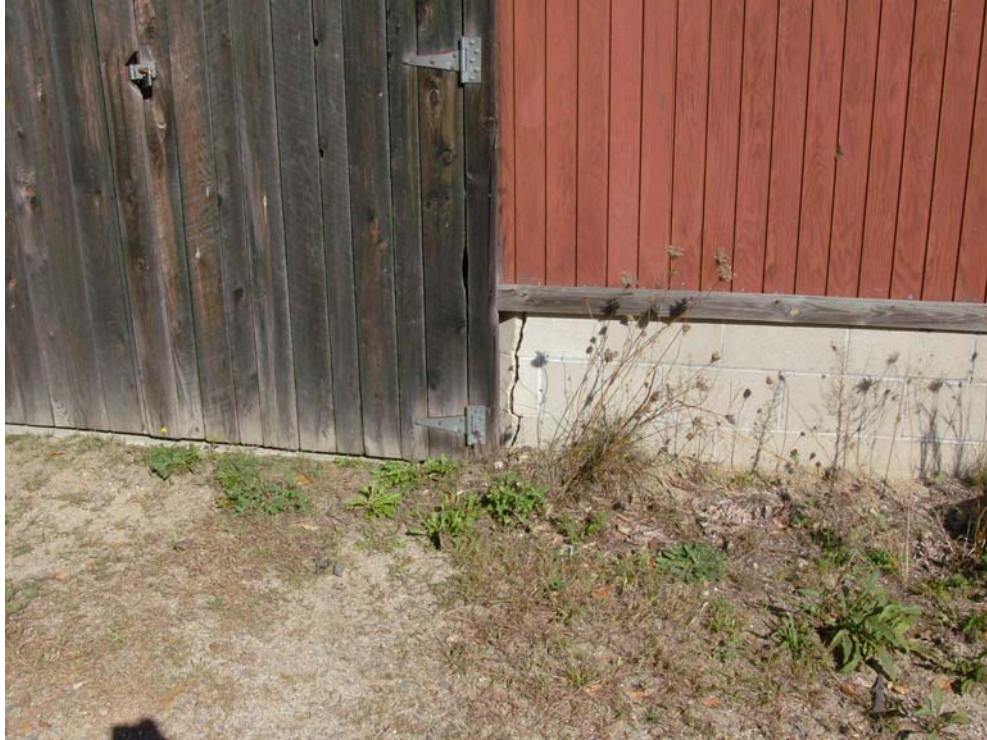
a concrete slab-on-grade. The CMU foundation wall is cracked at a few locations and there is very pronounced cracking in the walls at two of the three doorjambes. Further north is a wood-framed building that appears to be structurally unstable as evidenced by the pronounced lean of the walls. It is not known if this structure is currently being used for storage, but judging by its appearance, it is recommended that it be abandoned or demolished.

Damage to CMU Foundation of Storage Shed

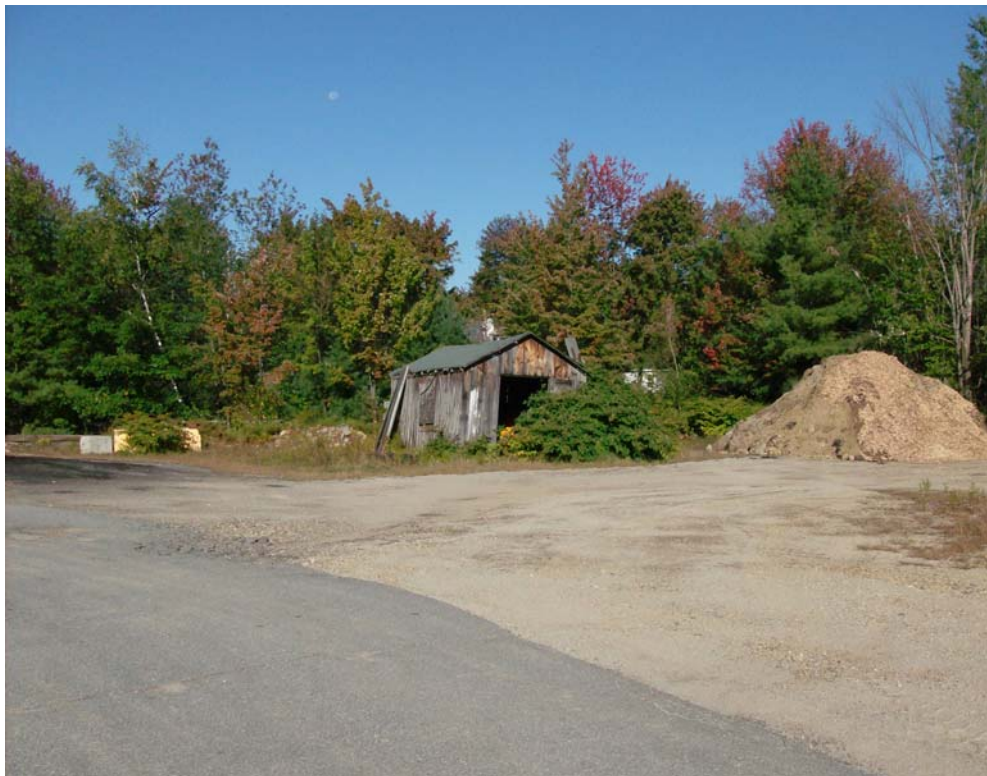
Dilapidated Storage Shed at Northwest Corner of Property

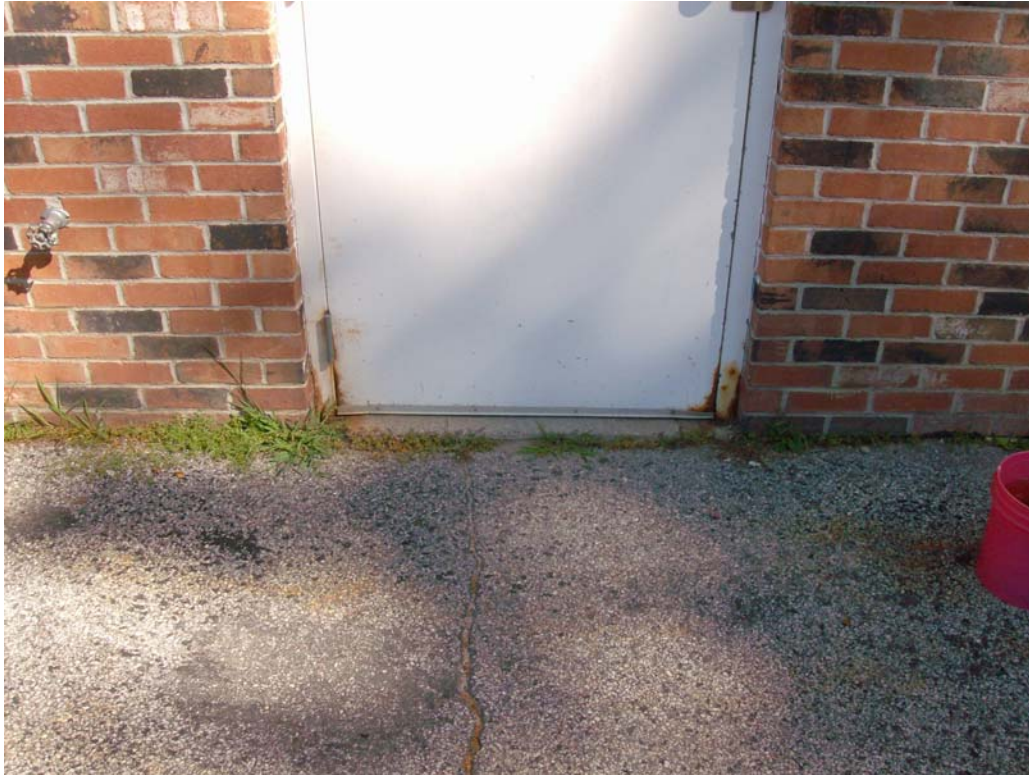
Man Door at Back of Station – Note Rust on Frame and Bottom of Door

1. Install new energy-efficient, double hung windows in the meeting room.
2. In the next 2 to 3 years, replace the steel man door at the rear (south side) of the station.

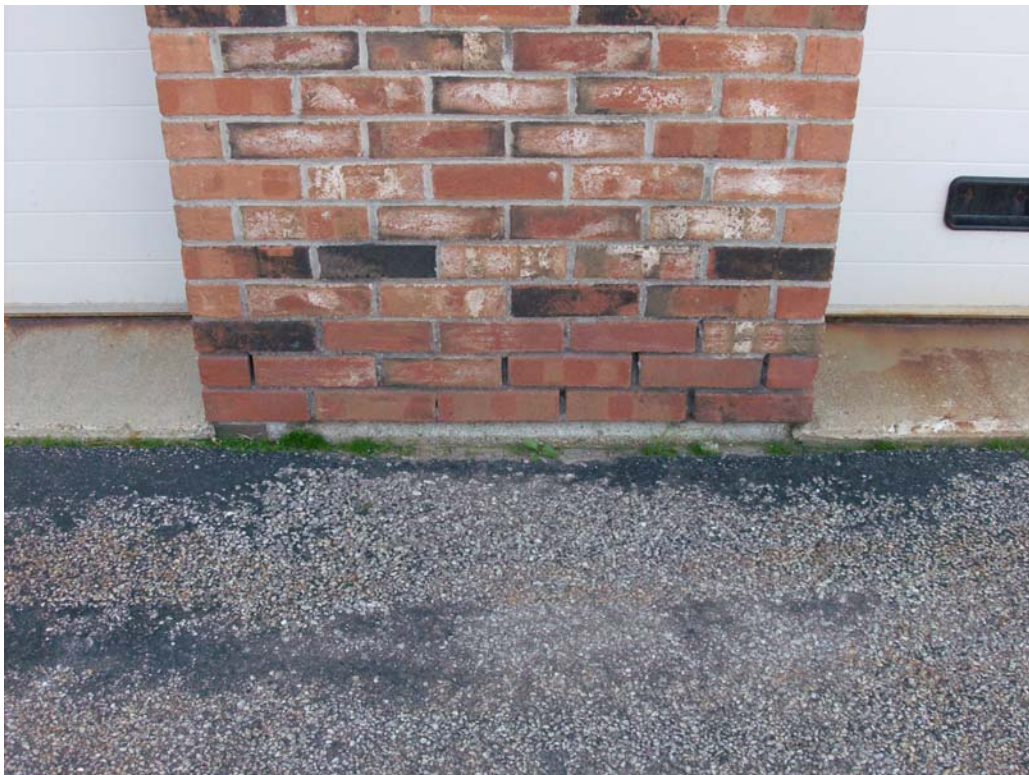
The building is constructed of load bearing concrete masonry block with a full brick veneer all around. The brick is generally in good condition, although we did notice some mortar loss on some joints, particularly on the front of the station at the lower 3 to 4 courses of brick. There are six overhead doors into the apparatus bay which are in good condition having been replaced several years ago. The steel man door at the rear of the building is starting to show signs of rust along the lower edges of the frame and door.

Mortar Loss in Joints at Lower Brick Courses

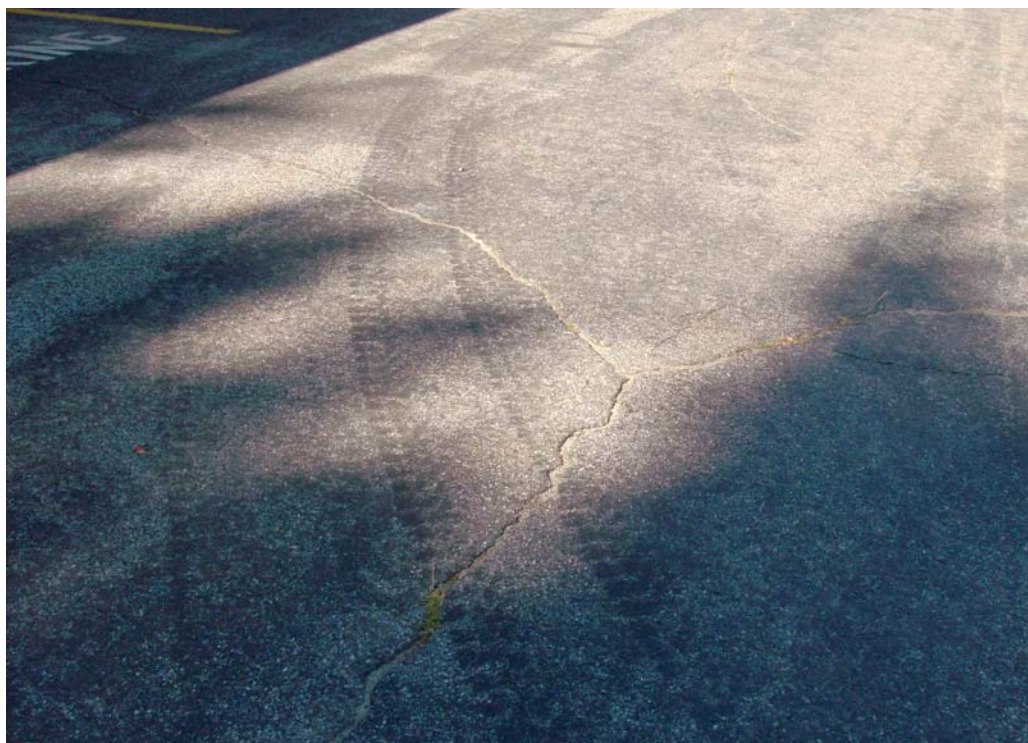
There are large paved areas in the front and rear of the apparatus bays and station. The front area of pavement, which enjoins Turnpike Road, is cracked in numerous locations. As a minimum, the cracks should be filled and the parking lots seal-coated, but the long-term solution calls for re-surfacing the lots. The front entrance is not handicap accessible due to the height of the step at the threshold of the main entrance. A ramp/apron would be required to remedy this situation.

Cracks in Pavement at Front of Station

10. Upgrade the fixtures, replace the flooring, and reconfigure the toilet stall in each of the two bathrooms.
11. Fill cracks and sealcoat the pavement, both in the front and rear of the building. In the next few years, consider the installation of a new pavement surface.

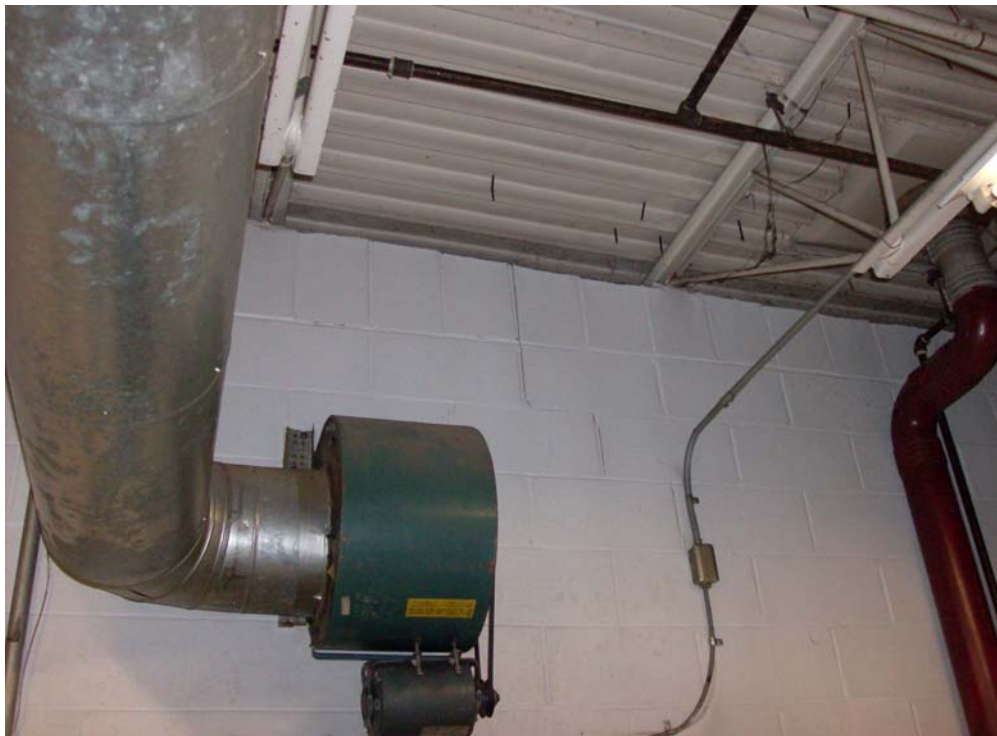
Like the rest of the station, the apparatus bay is in generally good condition. There are a few hairline cracks in the CMU, but nothing that was determined to be structurally serious. Some of the walls are stained with diesel soot, in particular the areas between the overhead doors. Most of the exhaust is handled by the "Plymovent" system, which connects directly to the exhaust pipes of the trucks. Through a series of hoses, fans and vent pipes, the exhaust is directed outside the building. There was evidence of moisture at the base of the walls, particularly near the overhead doors. The overhead doors should be weather-sealed and caulked to help prevent air and moisture infiltration. The lighting in the apparatus bay consists of 8-foot long fluorescent strip lighting with outdated T-12 bulbs. The concrete floor of the apparatus bay is in good condition with few hairline cracks and no spalling. The floor finish is very smooth, and most likely was coated with a product specifically made for sealing concrete floors. As a result, the floor can be very slippery, especially if it becomes wet.

Hairline Cracks in Masonry of Garage

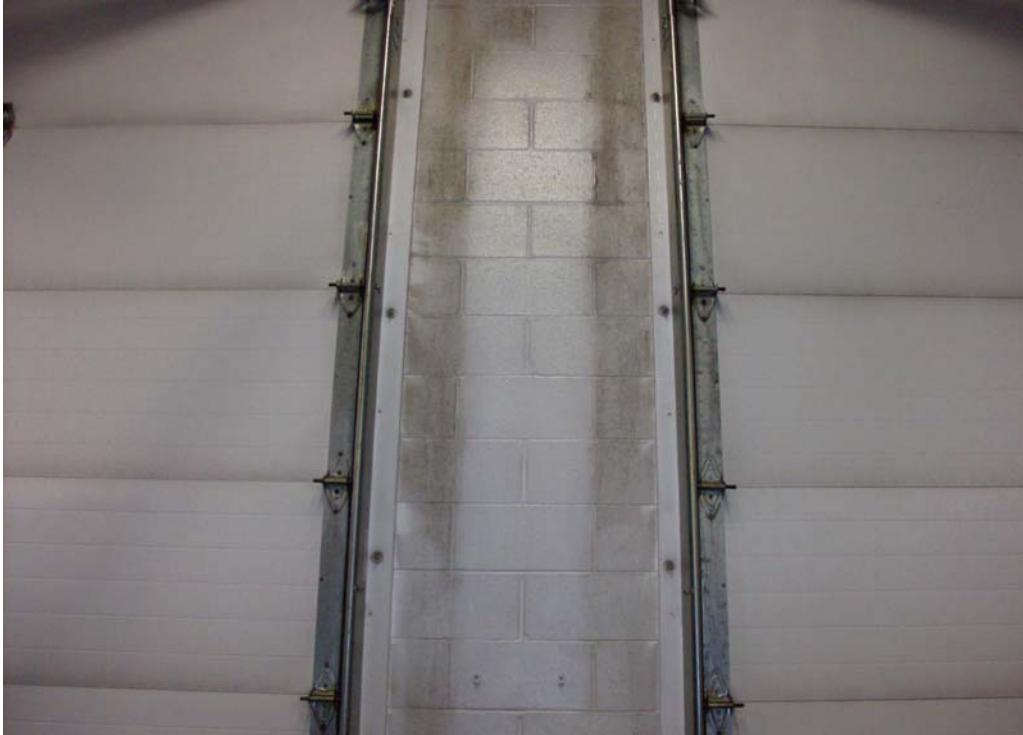
Discoloration on Walls Adjacent to Doors

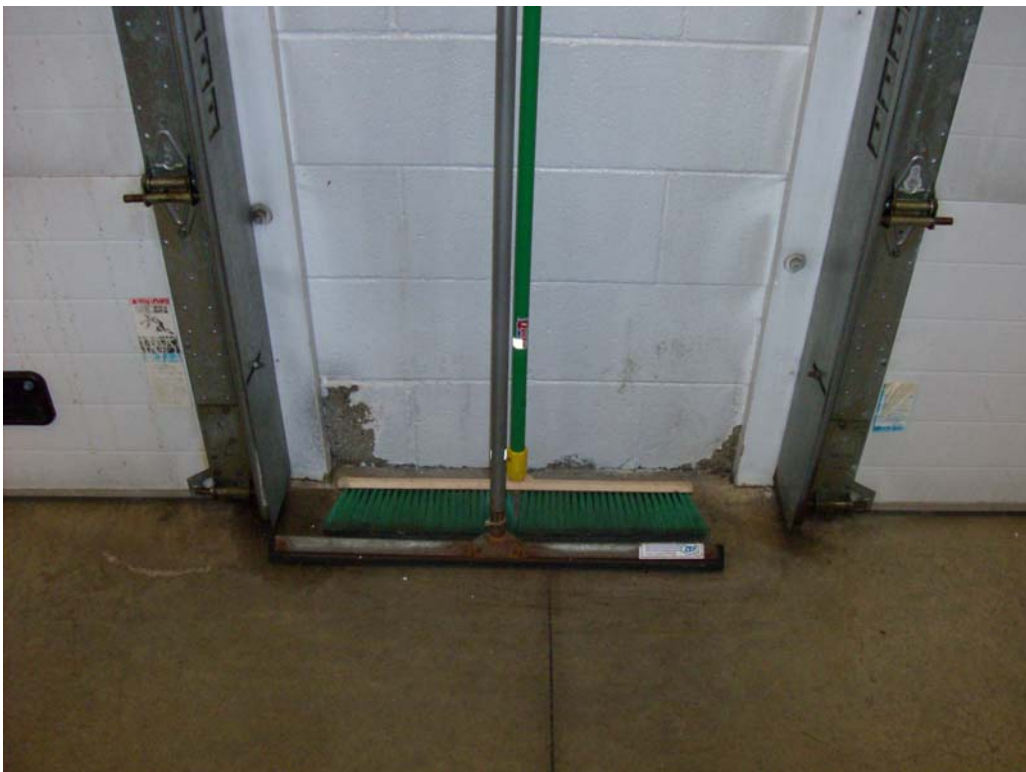
Spalling on Face of Masonry Block

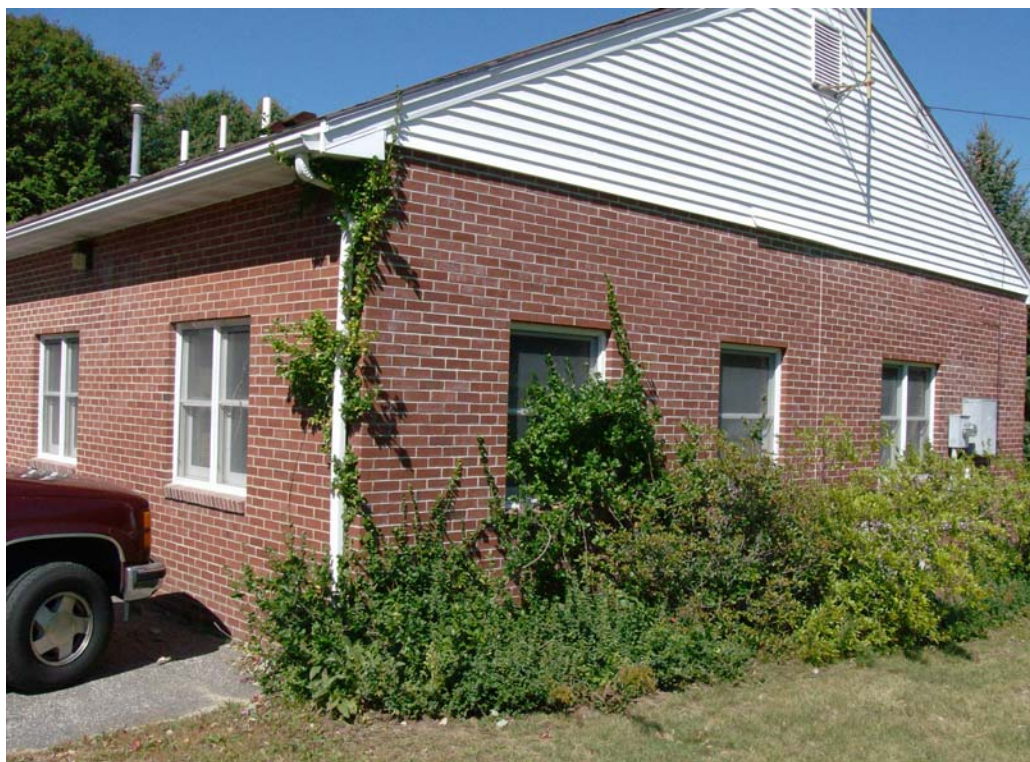
Excessive Vegetation on East Side of Building

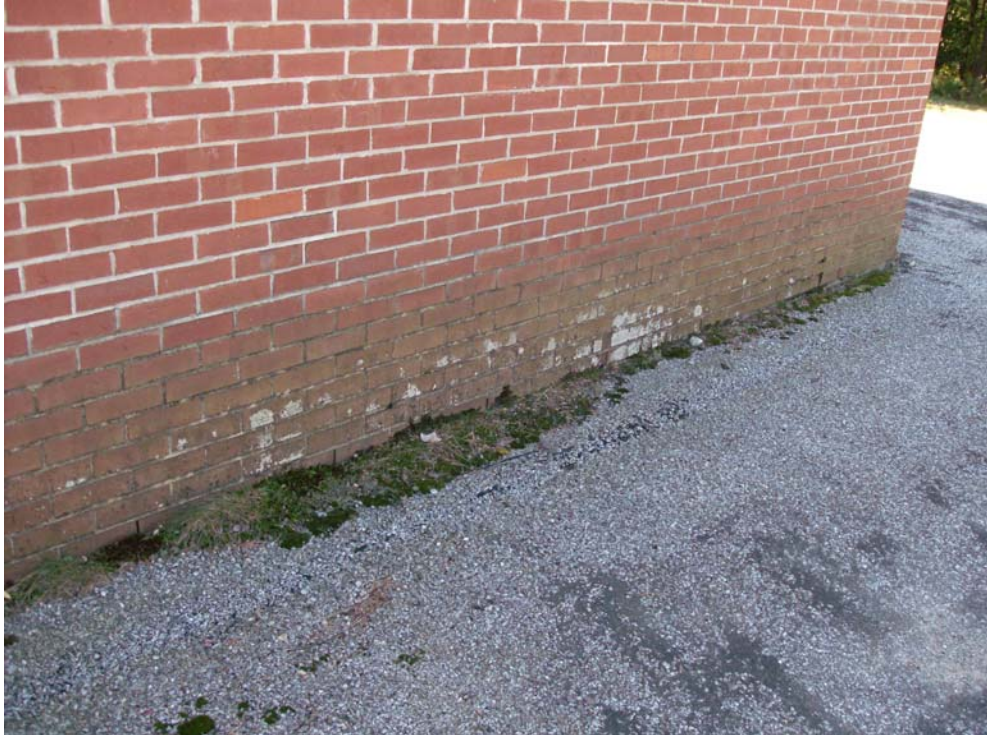
Water Damage and Moss Growth on Northwest Corner

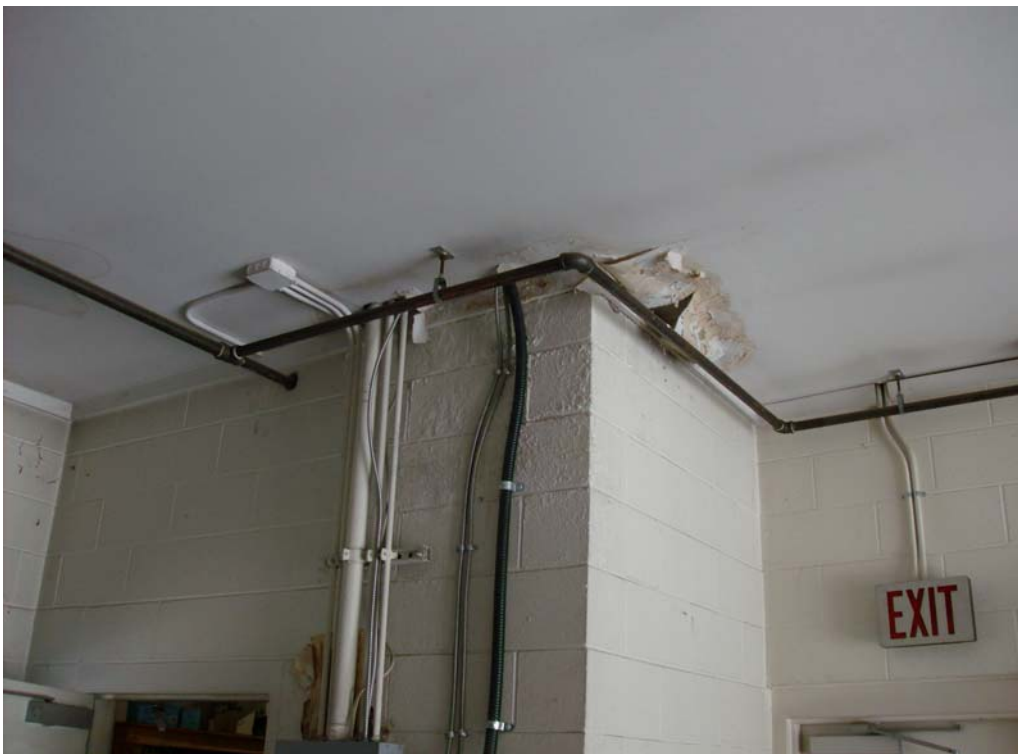
Prior Water Damage Around Chimney in Garage

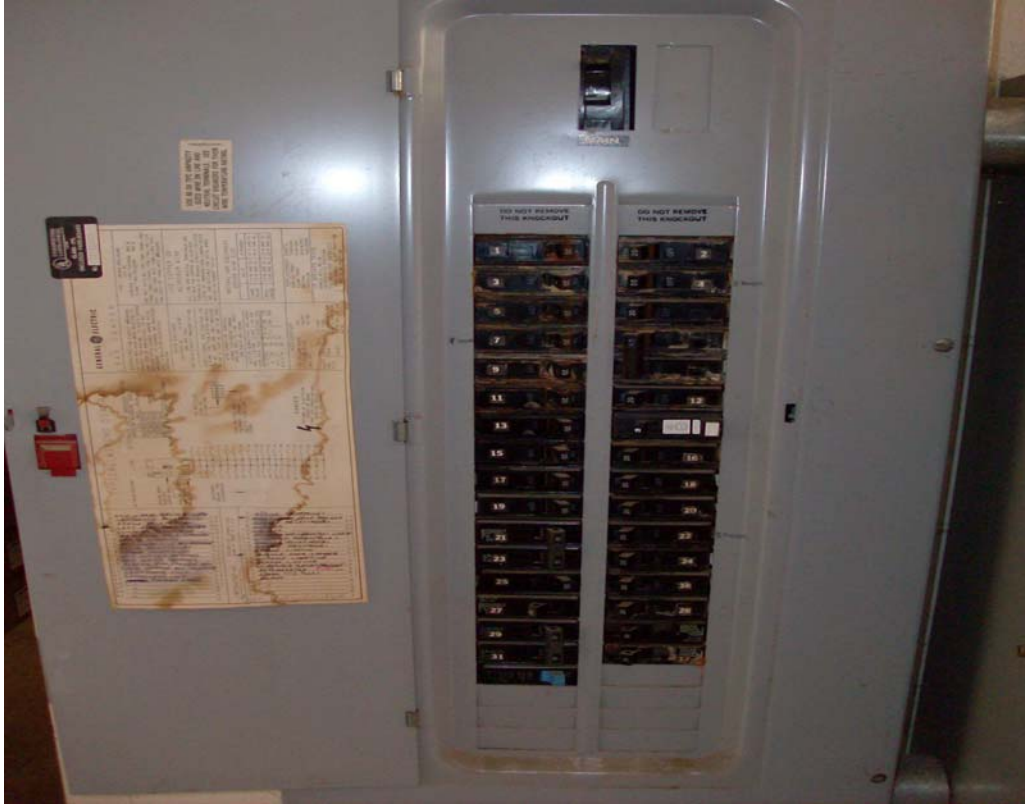
Water Damage in Electrical Panel

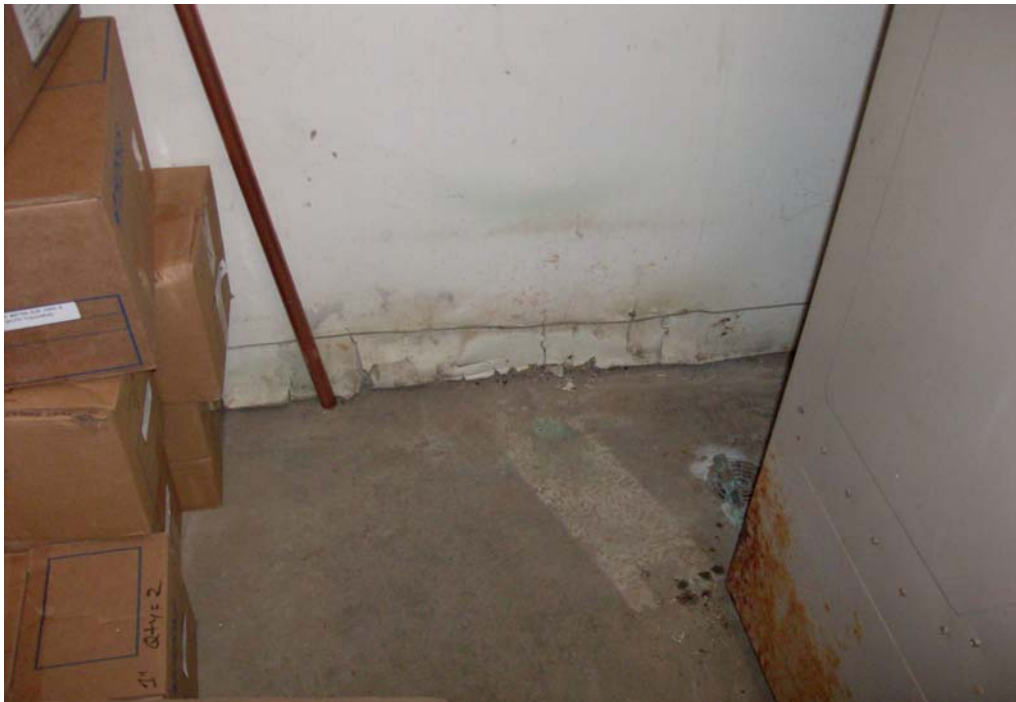
Water Damage Along Wall – May be from Leaking Water Heater

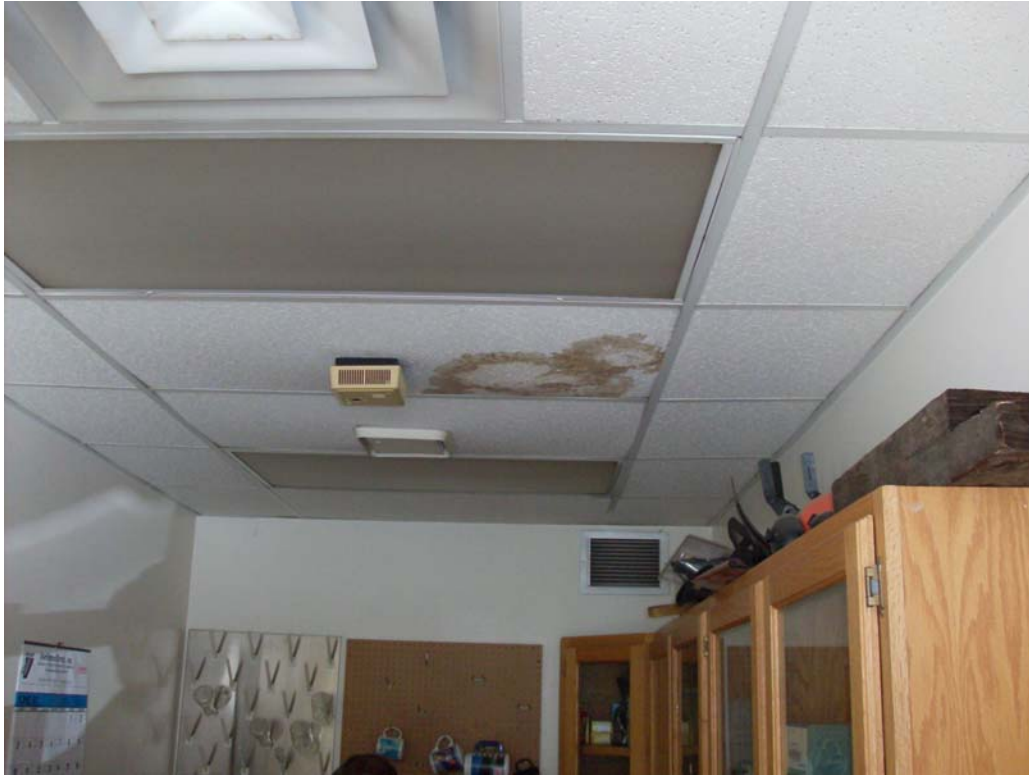
Water Damaged Ceiling Tile in Lab Area

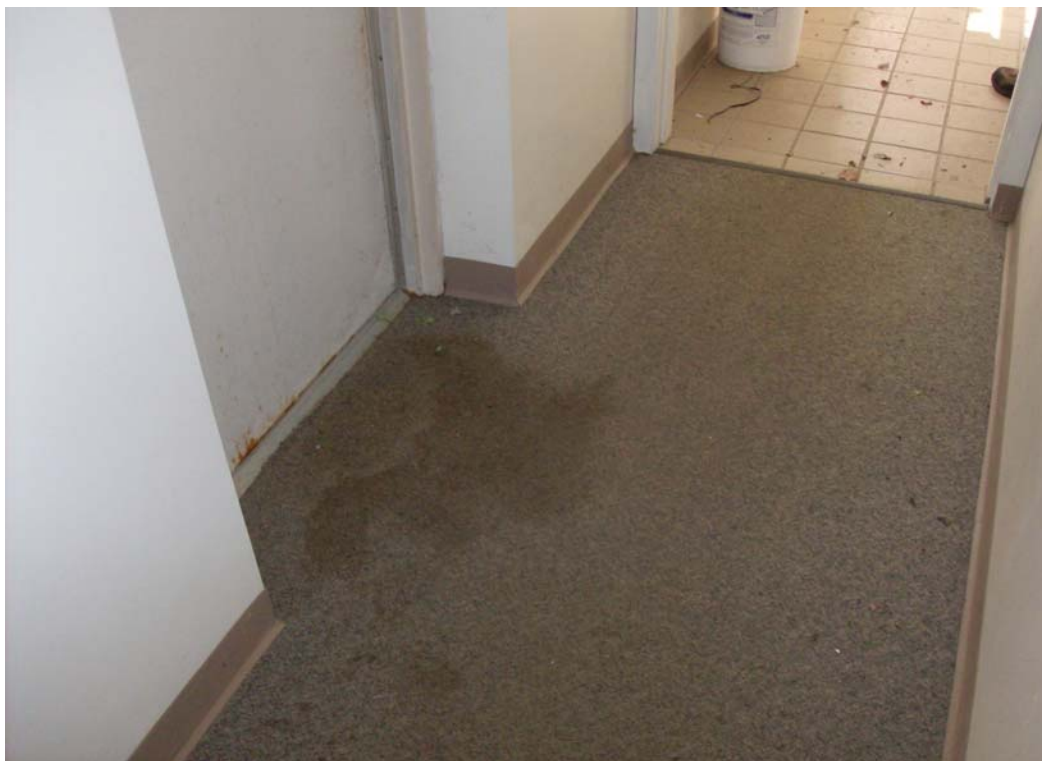
Stained and Water Damaged Carpeting at Rear Entrance

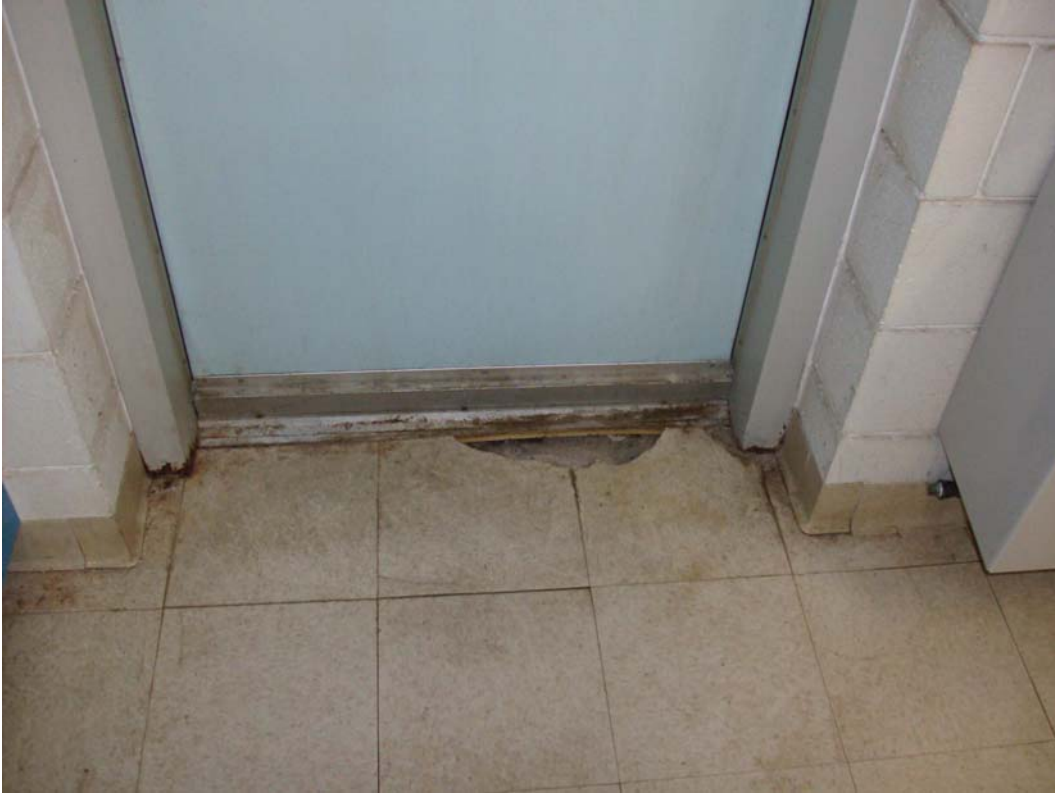
Damaged Tile at Laboratory Door

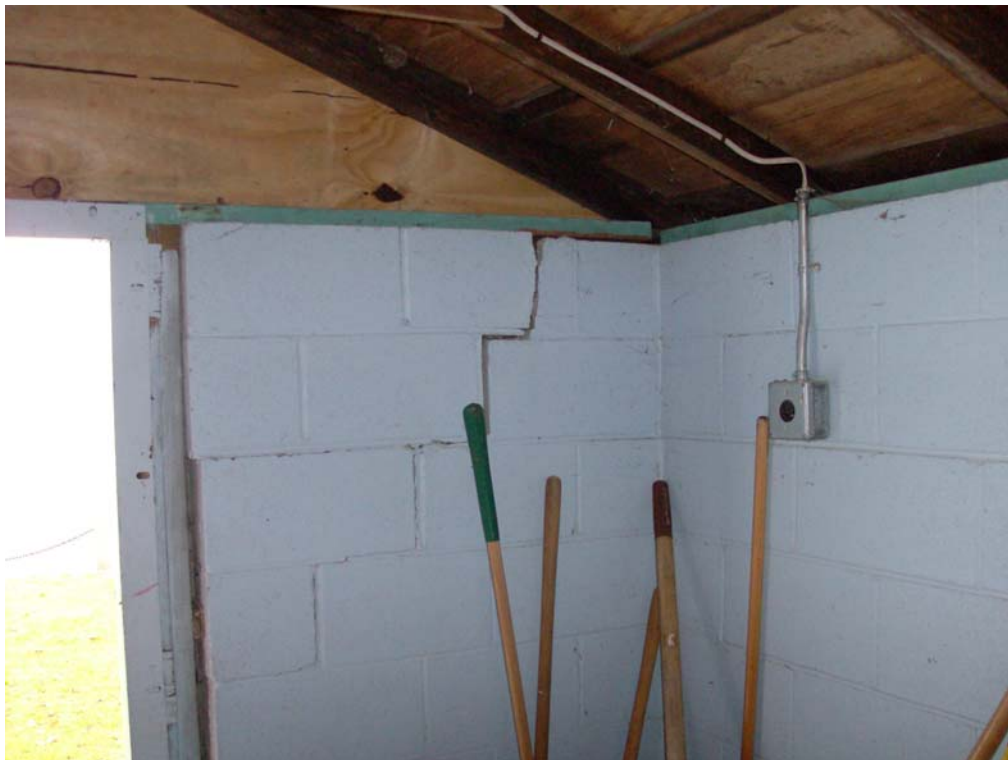
Crack in CMU – South Wall of Changing Room

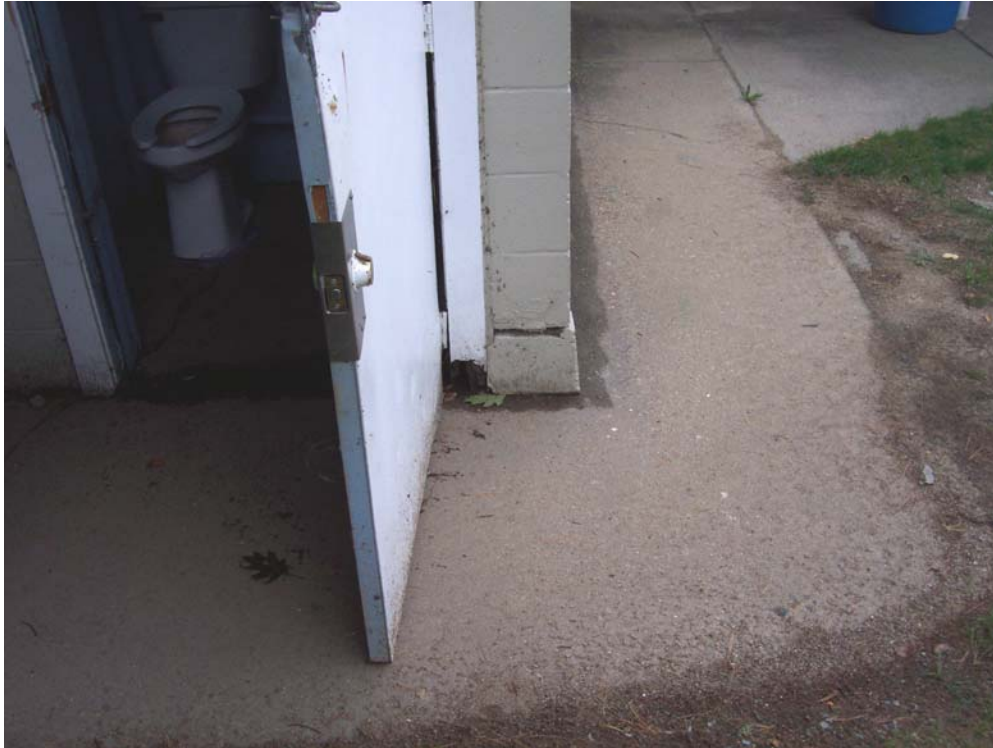
Damaged Door at Bathroom – Rear of Bath House

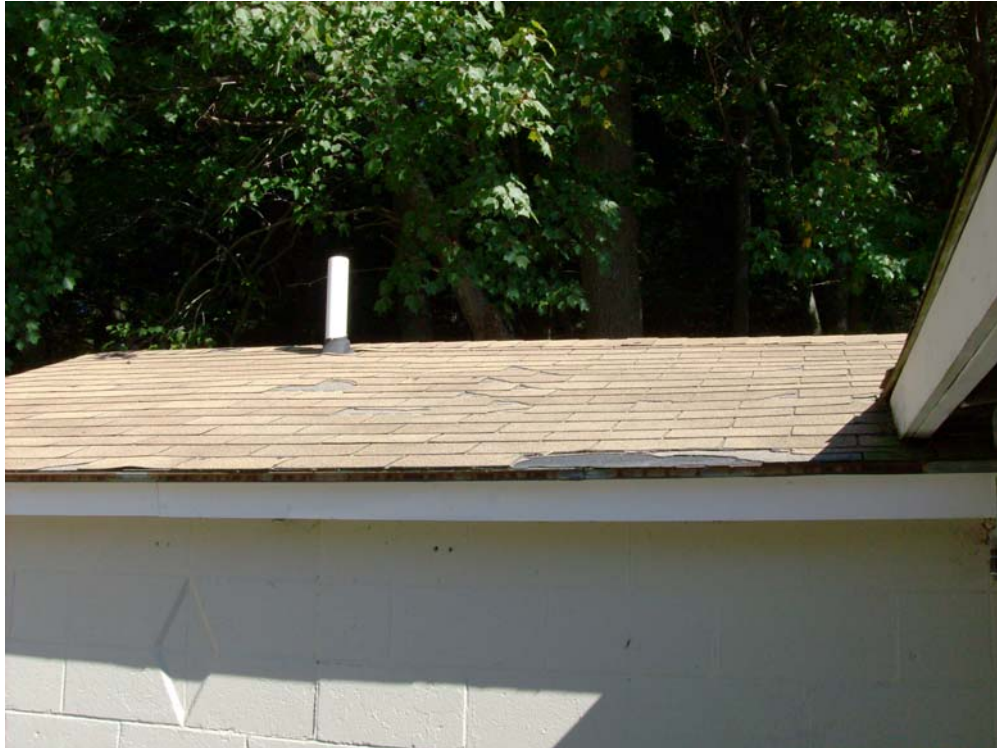
Missing Roof Shingles Over Bath House
