FACILITY ASSESSMENTS MUNICIPAL BUILDINGS PHASE II

JAFFREY, NEW HAMPSHIRE

JANUARY 2009

THE H.L. TURNER GROUP Inc.

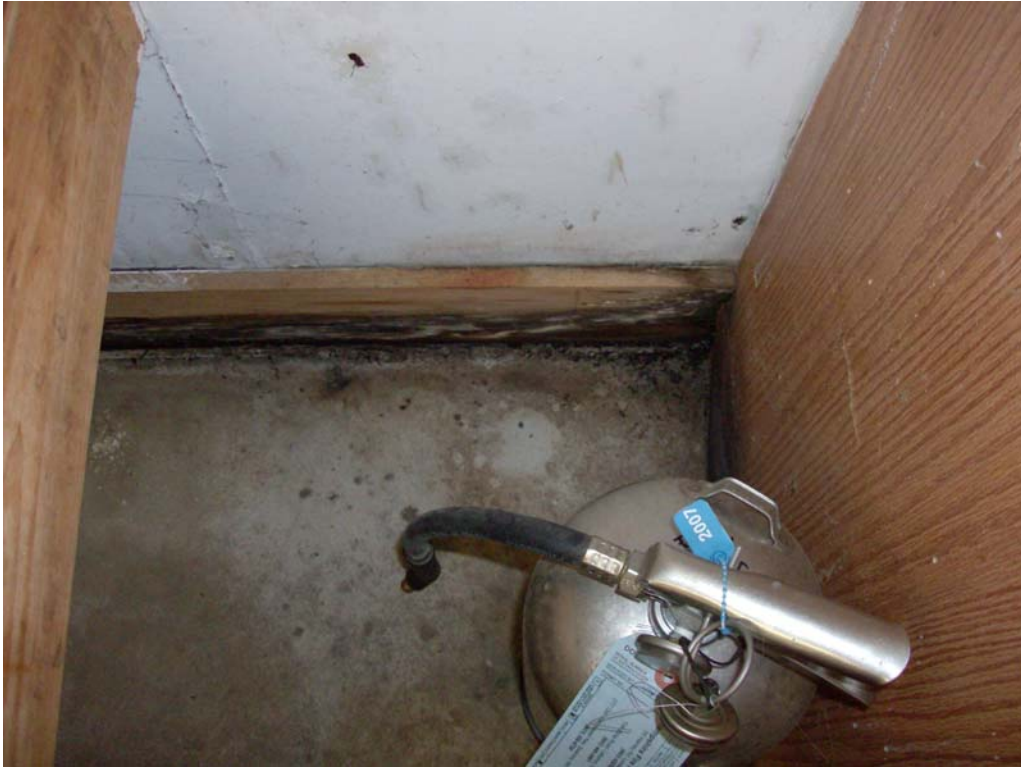
Water Damage and Mold Along Baseboard

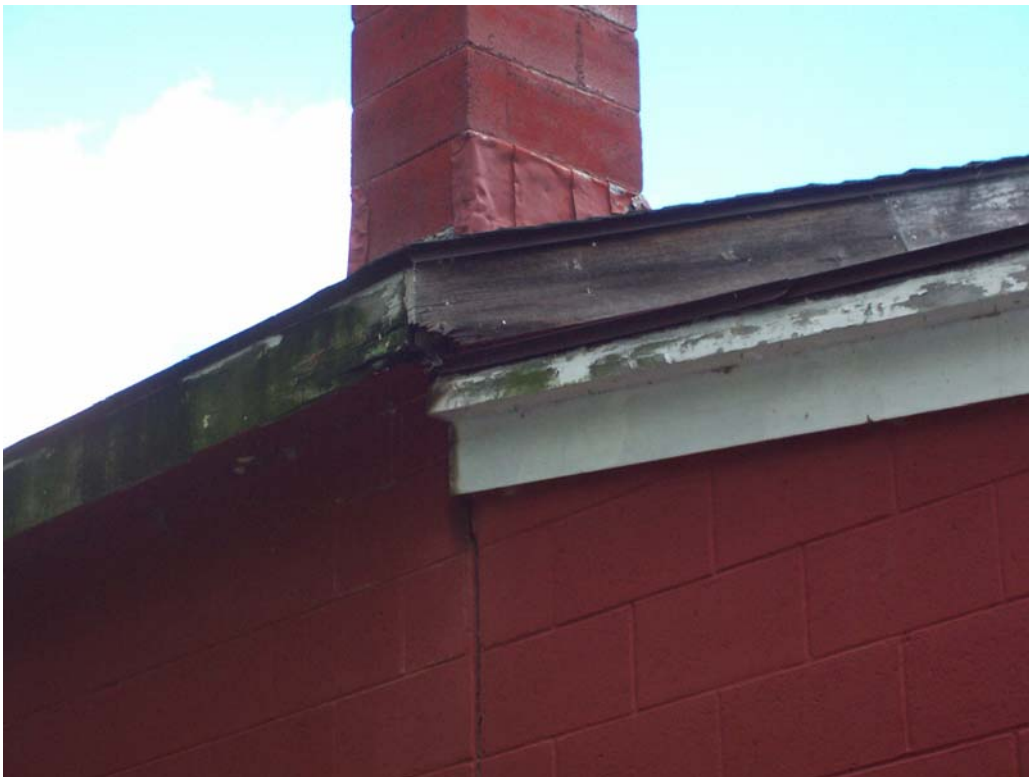
West Side – Note Rotted Trim, Peeling Paint, and Chimney in Need of Re-pointing

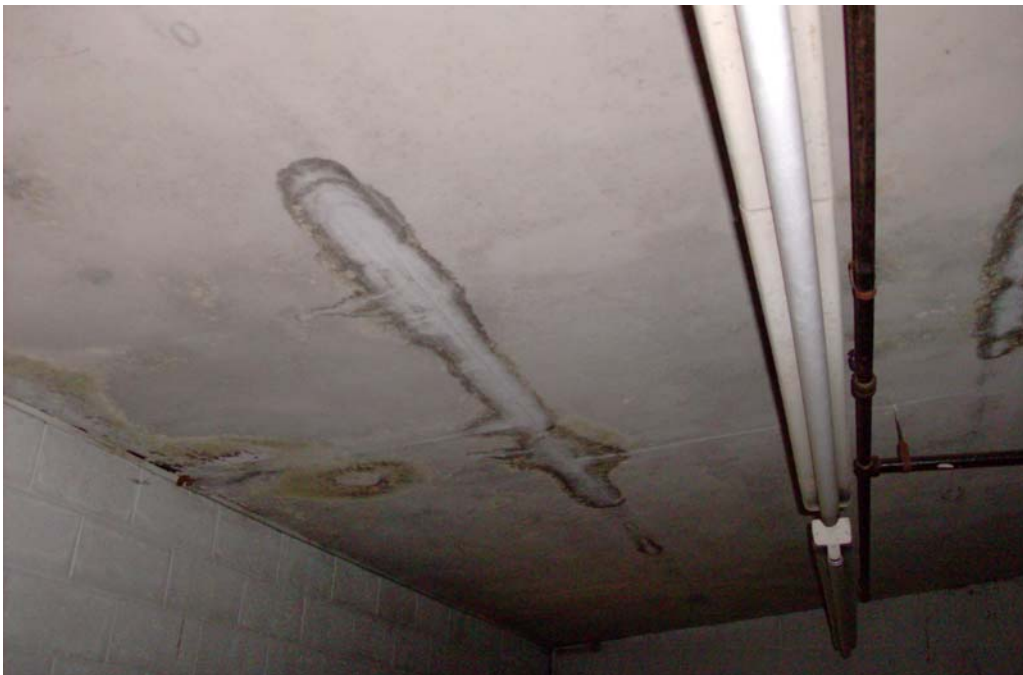
Moisture Intrusion in Storage Area

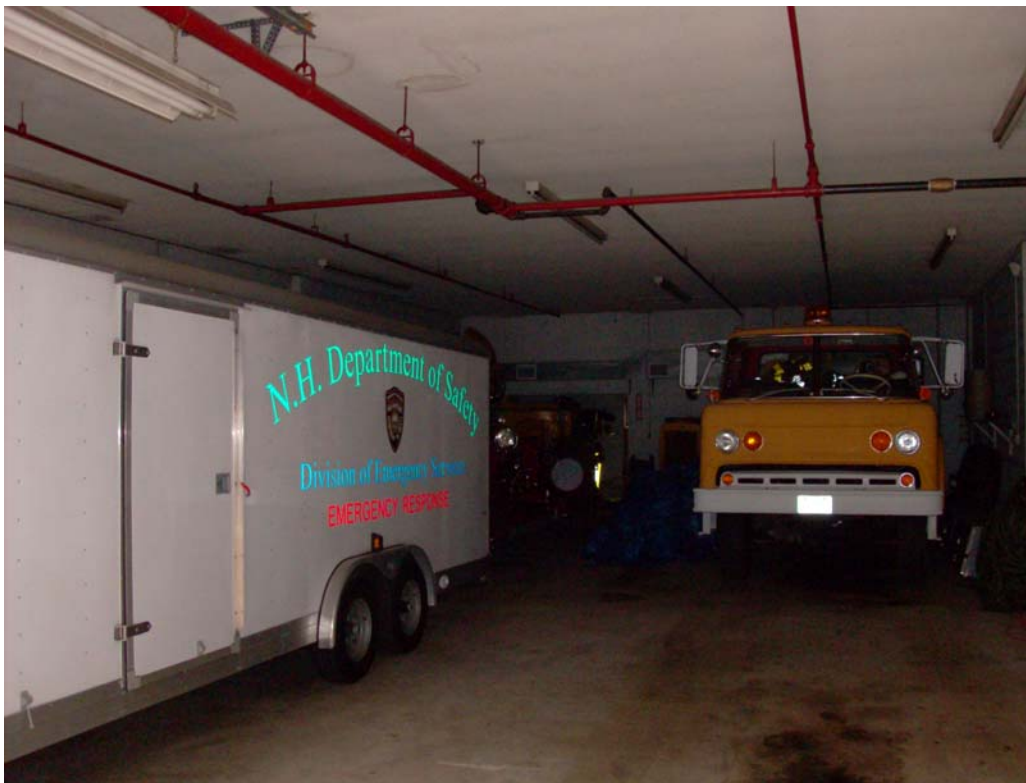
Some Moisture Intrusion Noted on Ceiling
