**FACILITY ASSESSMENTS
MUNICIPAL BUILDINGS
PHASE I**

JAFFREY, NEW HAMPSHIRE

SEPTEMBER 2008

THE H.L. TURNER GROUP Inc.

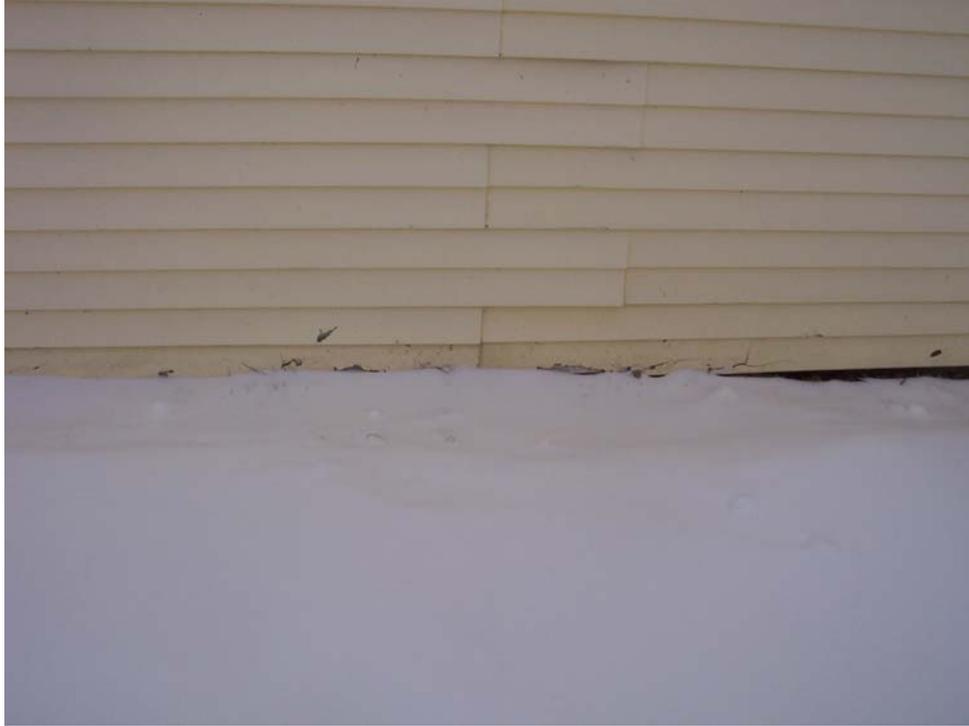
The exterior of the building is covered with vinyl siding. With the exception of several areas along the rear of the building, the siding is in good condition. The roof is a Gambrel-style roof covered with asphalt shingles. The shingles are in fair to good condition, and should not require replacement for another 8 to 10 years. Most of the windows are double-hung wood windows fitted with aluminum storm windows. The windows are in poor condition. Some are loose fitting and drafty, while others are tight and inoperable. Most of the building occupants have complained about the windows during the winter months as a source of cold air intrusion into the building. There is a large picture window at the second level along the rear or east side of the building. The seal has failed between the panes of glass, and the window should be replaced. The main door at the front of the building and the rear doors are metal clad. The metal has started to show signs of rust. On the main door, there are signs of rust bleeding through the paint. The door that accesses the rear storage area, however, is severely rusted along the bottom and is in need of replacement.

Rusted Door at the Rear of the Building

4. The building has a main door at the front and two doors at the rear. One of the rear doors provides an exit from the main conference room, while the second door provides access and egress from the storage/Electrical Room. All doors are steel clad doors with steel frames. All are showing signs of rust, but the door into the storage room is badly deteriorated along the bottom and is in need of replacement.

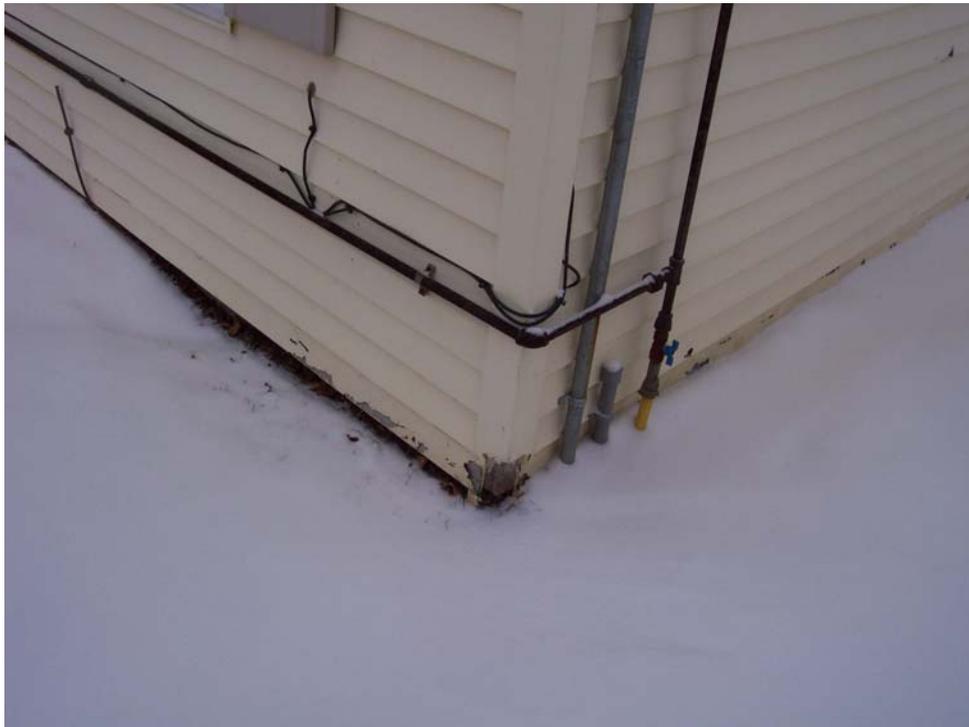
Damaged Vinyl Siding on the East Side of the Building

3. There are a few small areas along the south or rear portion of the building where the vinyl siding has been broken or otherwise damaged. These areas should be replaced.

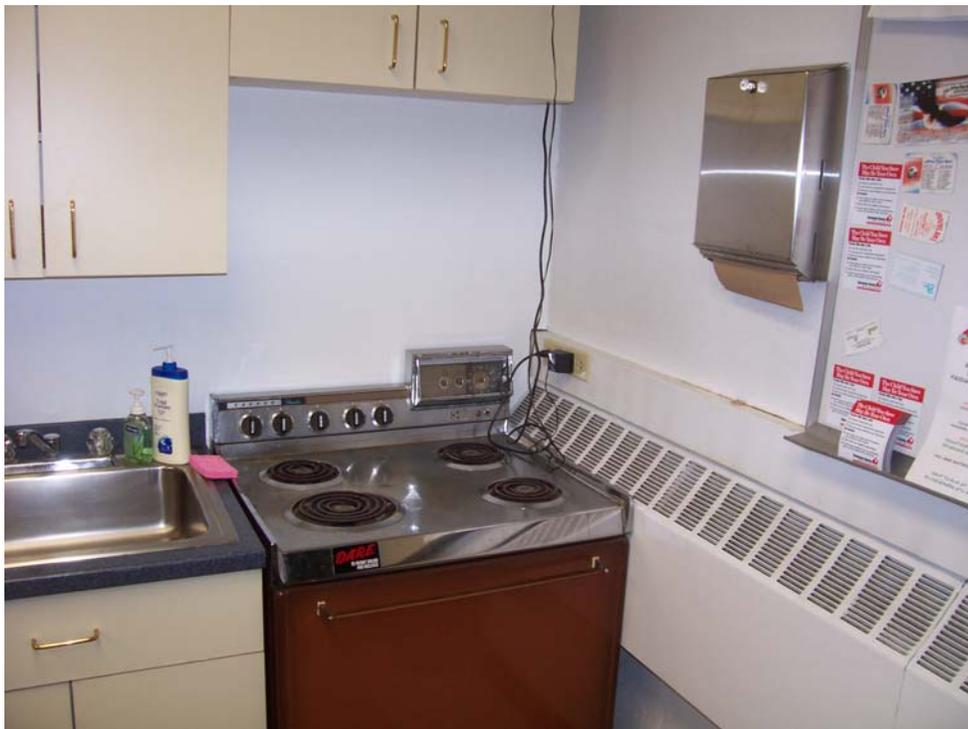
The interior spaces on the first level are predominantly vinyl composition tile or carpeting on the floors with painted gypsum walls and ceilings. All of the spaces in the basement have vinyl tile on the floors, and the walls are painted CMU block. It was noted that the tile flooring in the squad room is badly worn and in need of replacement. This particular floor is subject to heavy use and is a good candidate for rubber flooring, a product that stands up very well to high traffic. The break room consists of a stove, refrigerator, sink, soda machine, and television. Most of the appliances and furniture are outdated, and the entire space could use upgrading. We noted a receptacle just above one of the burners on the stove. The receptacle should be moved, as it is a code violation.

Plug Adjacent to and Wires on the Stove in the Kitchen

14. There are a number of receptacles that are not code compliant. For example, there are two existing receptacles located directly above a burner on the electric stove. These should be removed. A few of the receptacles at the bathroom sinks were not the GFI type. These should be replaced as required by code.

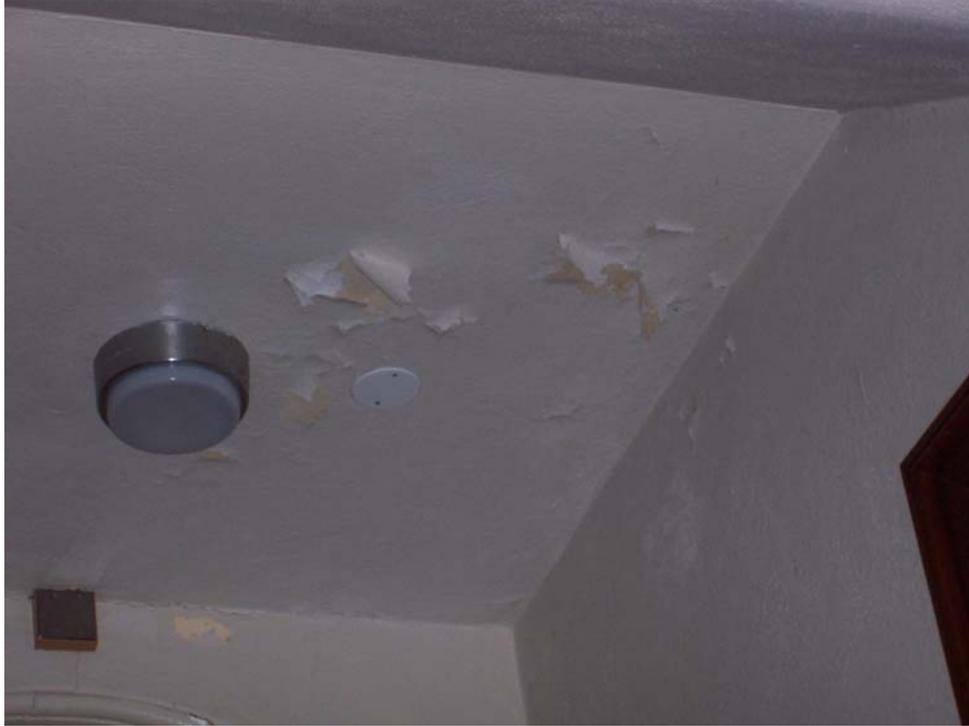
Peeling Paint in the Original Library Second Floor Ceiling

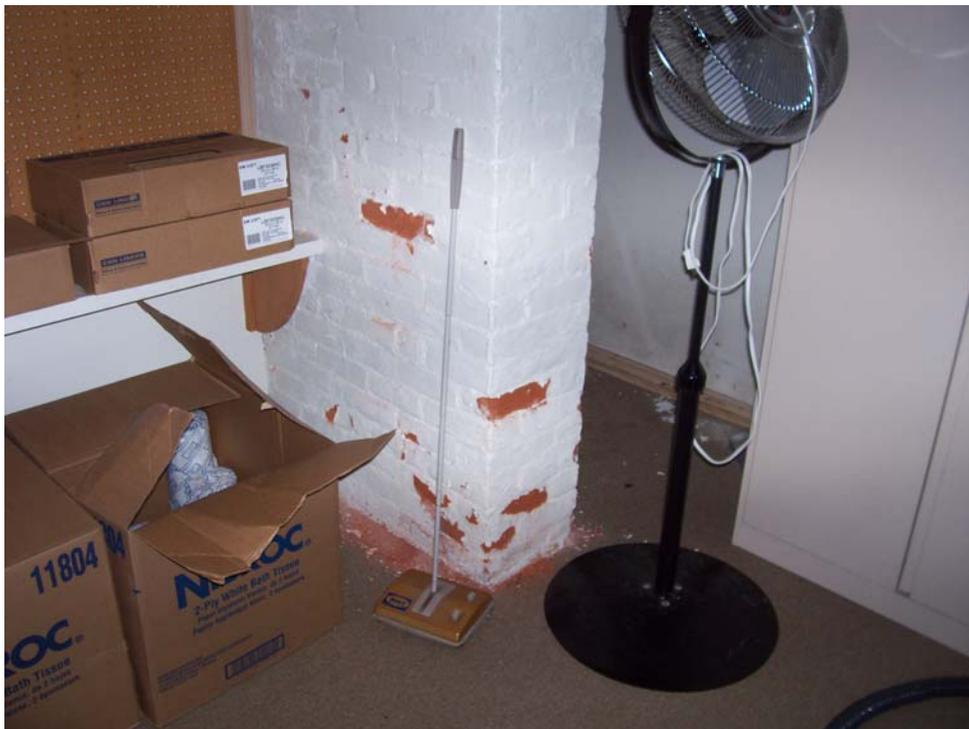
Original Library Basement Brick with Peeling Paint

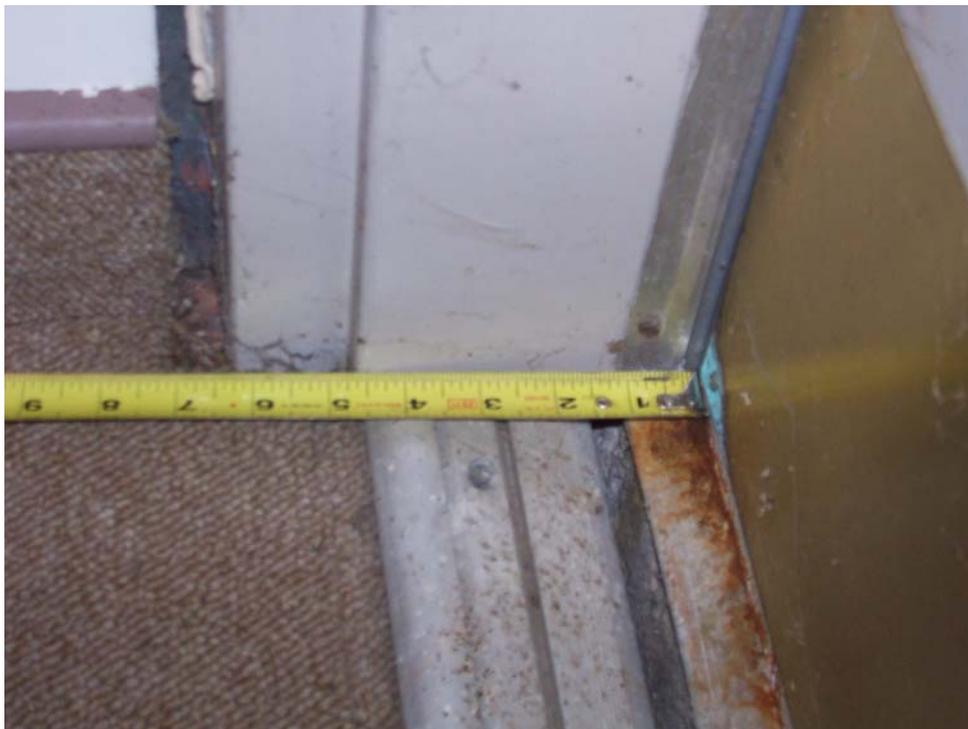
Door Threshold of Emergency Exit at Main Level in Library Addition

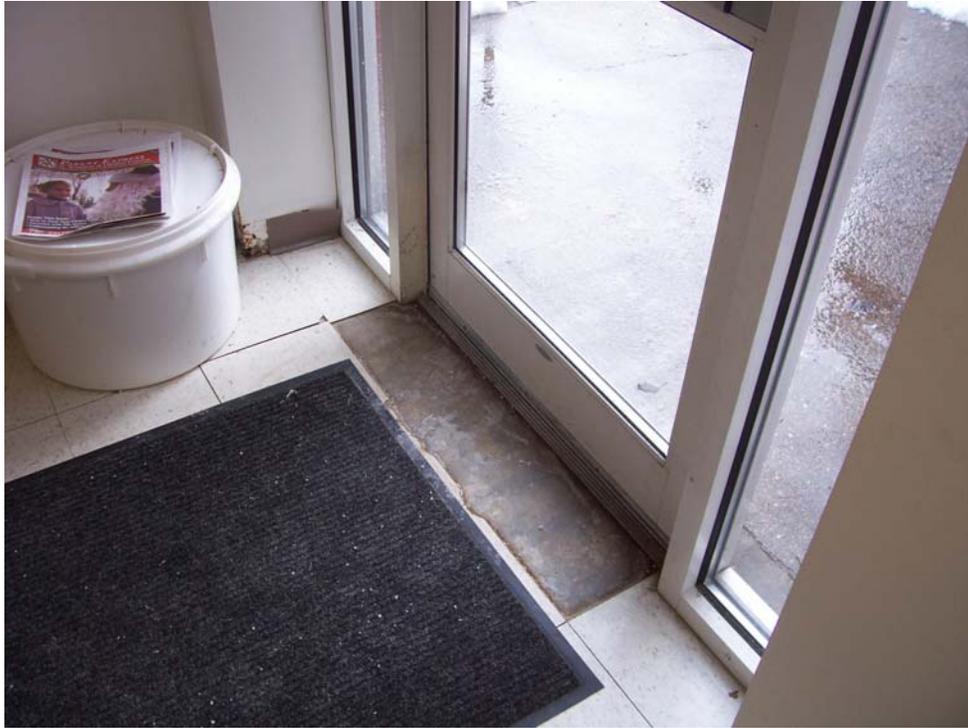
Missing Floor Tiles at Lower Level Entrance – Library Addition

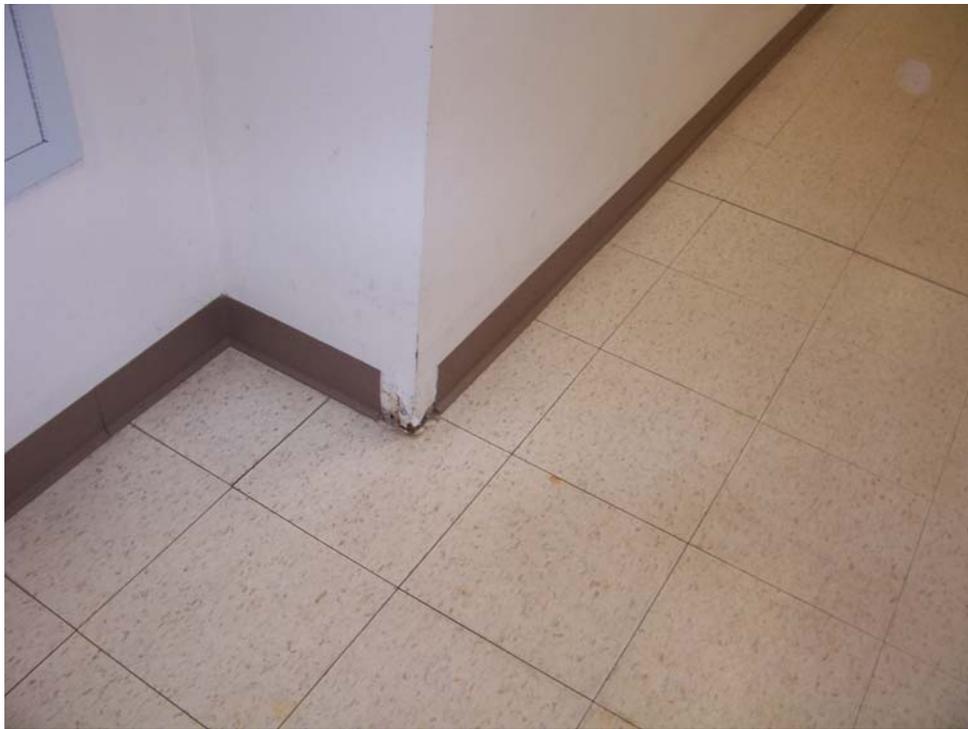
Damaged Drywall near Lower Level Entry Door
Library Addition

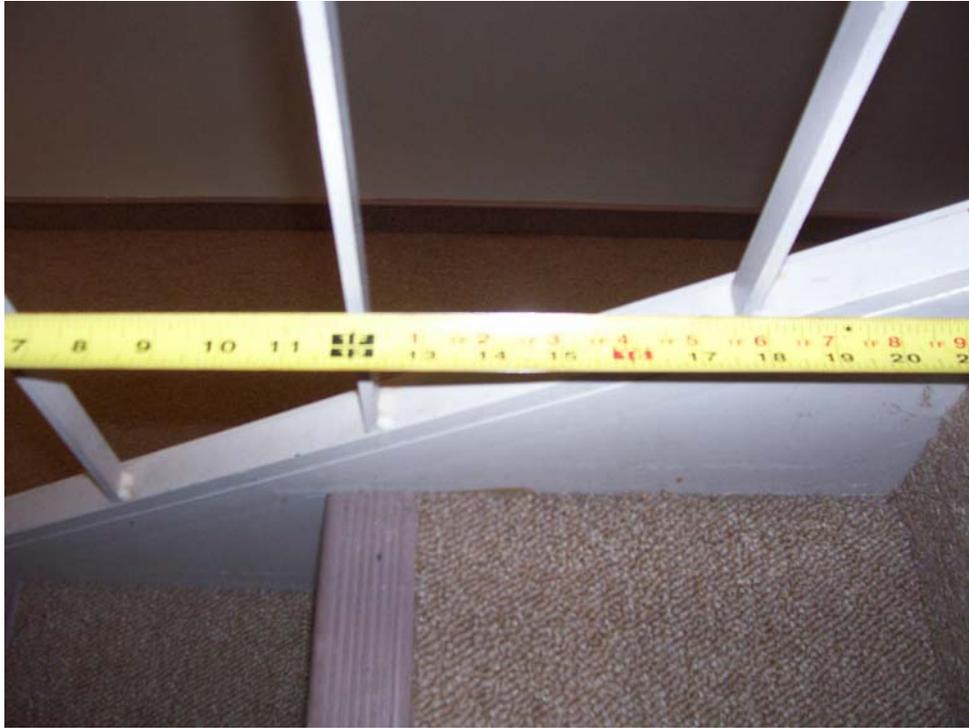
Stair Baluster Spacing – Library Addition
