**FACILITY ASSESSMENTS
MUNICIPAL BUILDINGS
PHASE II**

JAFFREY, NEW HAMPSHIRE

JANUARY 2009

THE H.L. TURNER GROUP Inc.

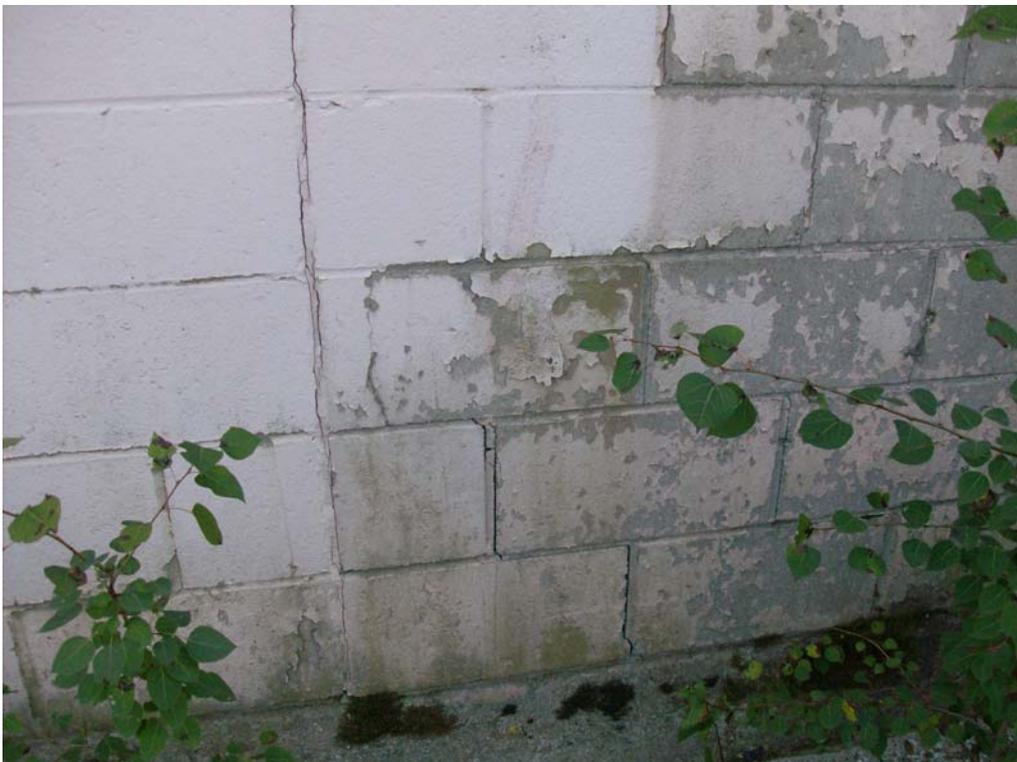
The CMU walls, particularly along the north wall or rear of the building, have some cracking at the mortar joints, and there are large areas where the paint is peeling and flaking off the wall. The lack of a frost wall makes the building very susceptible to movement from frost heaves, which may explain some of the cracks in the masonry walls. Along the lower courses of block, moss has started to grow, indicating a persistence of moisture and an inability of the block to dry out. Despite these issues, most of the block is in generally good condition.

North Wall of Garage – Note Cracking, Peeling Paint, and Moss Growth

5. Re-point the cracks in the CMU block, particularly at the rear of the building. Scrape and paint the CMU block.
6. Add additional insulation over the ceiling of the Administration wing. Improve ventilation by adding a ridge vent.

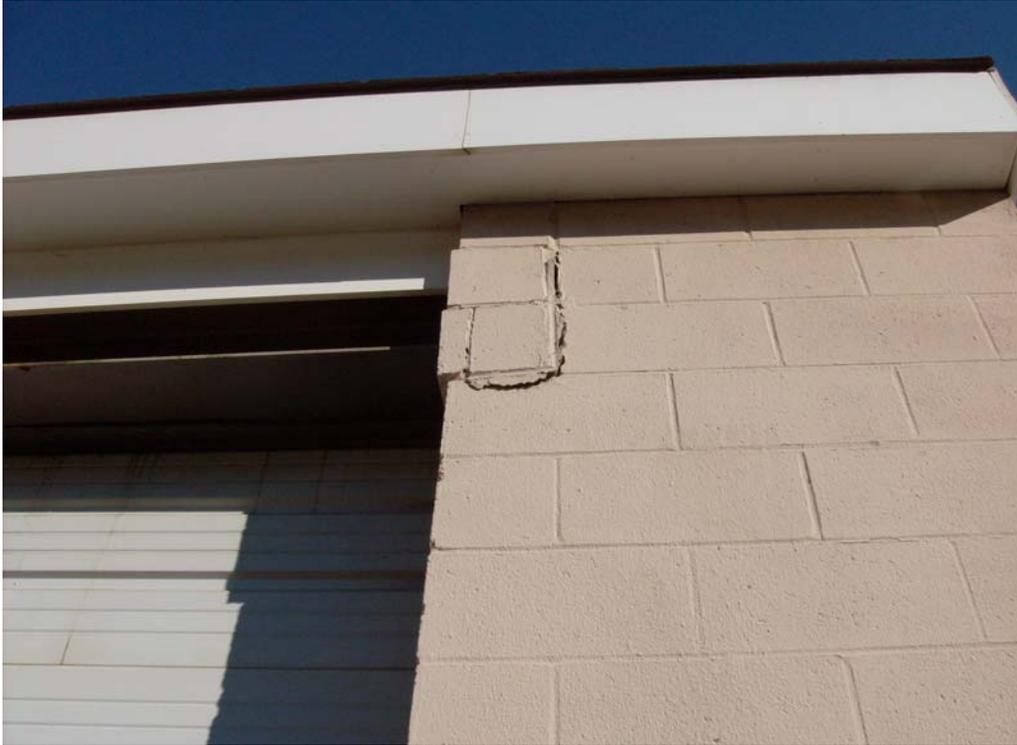
The CMU block at the header of the eastern-most overhead door is cracked and damaged. Repairs are urgently needed in this area, as sections of the block could break loose and fall, possibly causing injury. Reports from DPW personnel indicate the damage was not the result of a vehicle impacting the top of the door opening. We suspect that the damage was the result of differential movement between the CMU and the steel lintel that runs across the top of the door opening. For this type of building construction it is typical for the end of the lintel to be fixed to the CMU block by means of a bearing plate anchored into the grouted core of the block. Movement of the lintel as a result of expansion and/or contraction of the steel could have damaged the block over the years. A similar situation exists at the lintel of the western-most overhead door. Existing cracks in the mortar joints indicate that some movement has already occurred, and if left unattended, this could possibly end up as more significant damage. The lintel connection should be detailed to allow for small movements of the steel relative to the fixed masonry.

Damage at Head of Overhead Door – Southeast Corner of Garage

3. Repair the cracked and broken CMU at the header of overhead door eight at the east end of the main garage. Provide a means for the lintel to move independent of the masonry to prevent future damage.

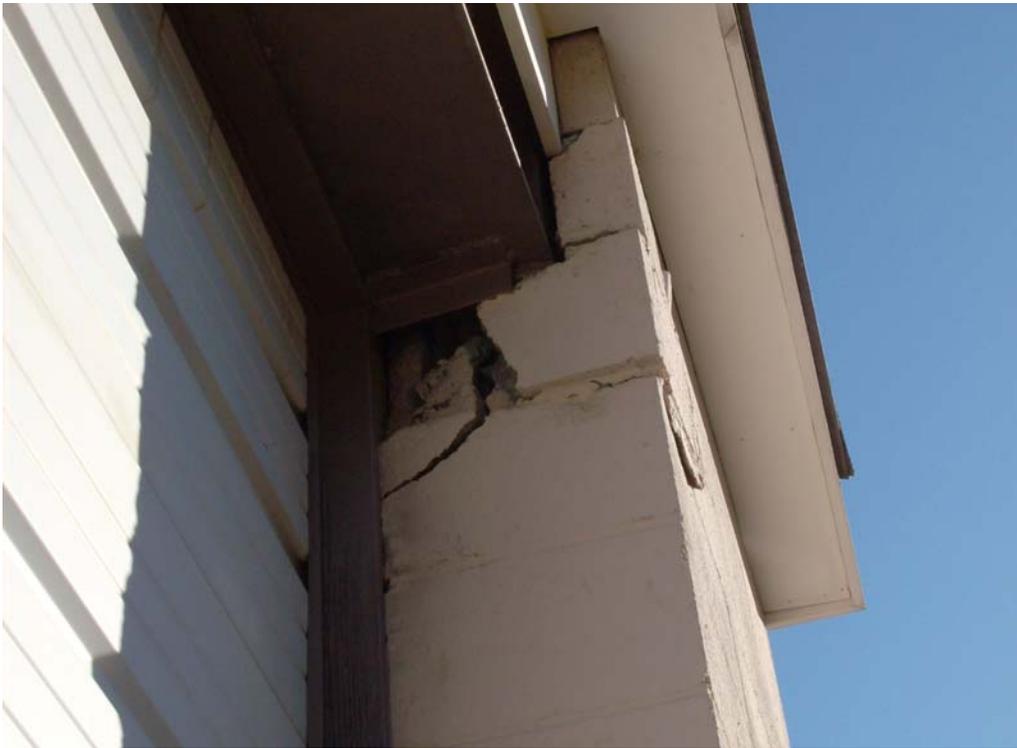
CMU Damage at Overhead Door – Southeast Corner of Garage

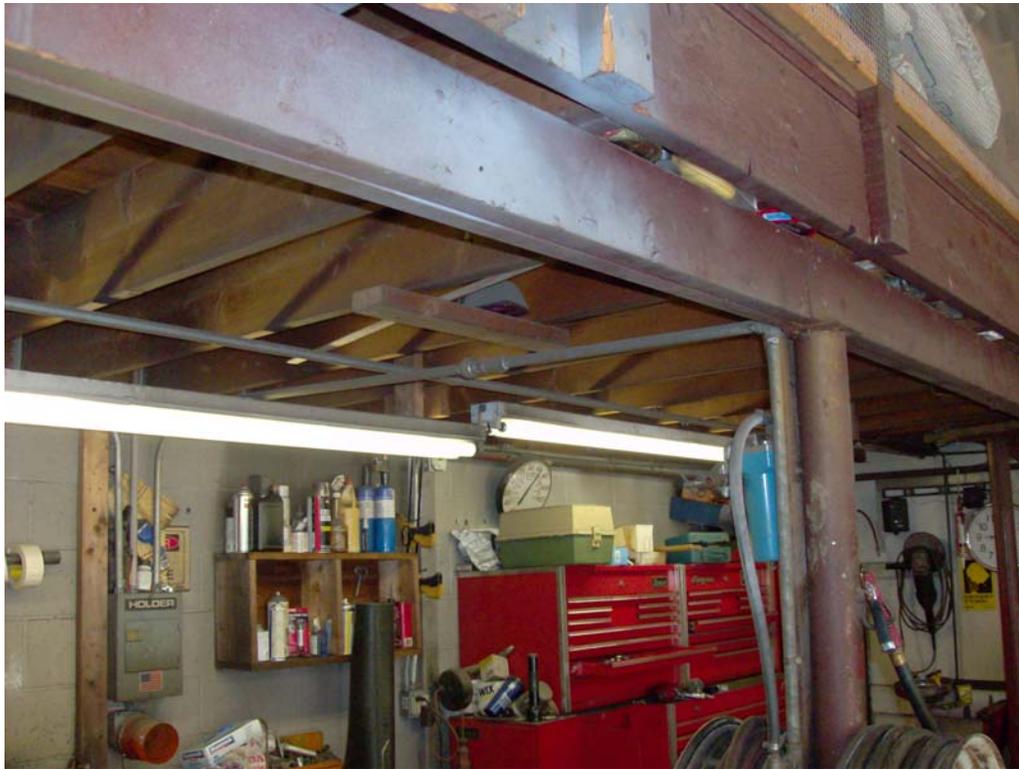
There is a wood-framed mezzanine in the garage along the north wall. It runs nearly the full length of the equipment bays. The framing is somewhat questionable in that the main beam supporting the floor joists is a pair of 2 x 8's that span over 8-feet between columns. Also, the post supporting the eastern-most corner of the mezzanine is not aligned below the support beam and relies on a cantilevered piece of channel off the post to support the mezzanine beam. It is recommended that calculations be performed to determine the safe live load capacity for the mezzanine. Eventually a sign should be posted with the load limit.

Wood Framed Mezzanine Along North Wall of Garage

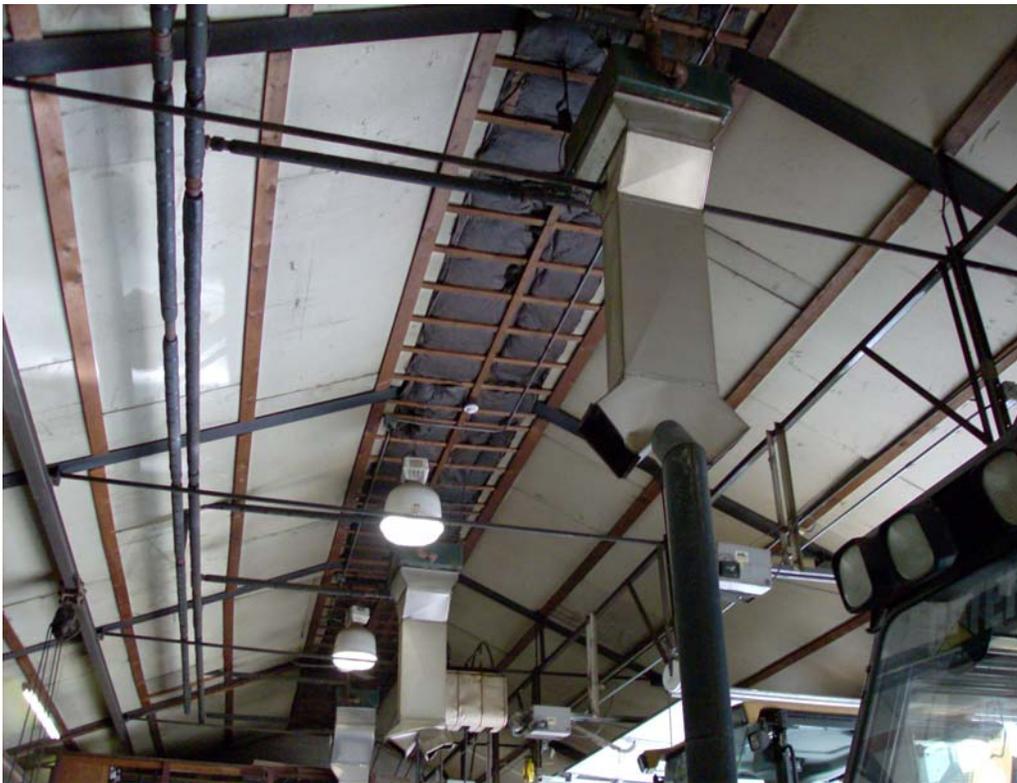
The garage area ceiling is insulated with expanded polystyrene insulation. In some areas the panels have shifted such that the effectiveness of the insulation is negated. At the time of the next garage roof replacement, consideration should be given to adding more insulation at the roof. This could be in the form of polyisocyanurate or polystyrene sheets under the roofing materials, whether it is wood sheathing with asphalt shingles or a standing seam metal roof. The result of adding more insulation to the roof means that there is a possibility that more snow could accumulate on the roof. Of course, before any insulation is added, a study of the structural capacity of the roof support members must be undertaken in order to determine if any of the members become overstressed under the weight of the additional snow load.

Insulated Roof of Equipment Bays

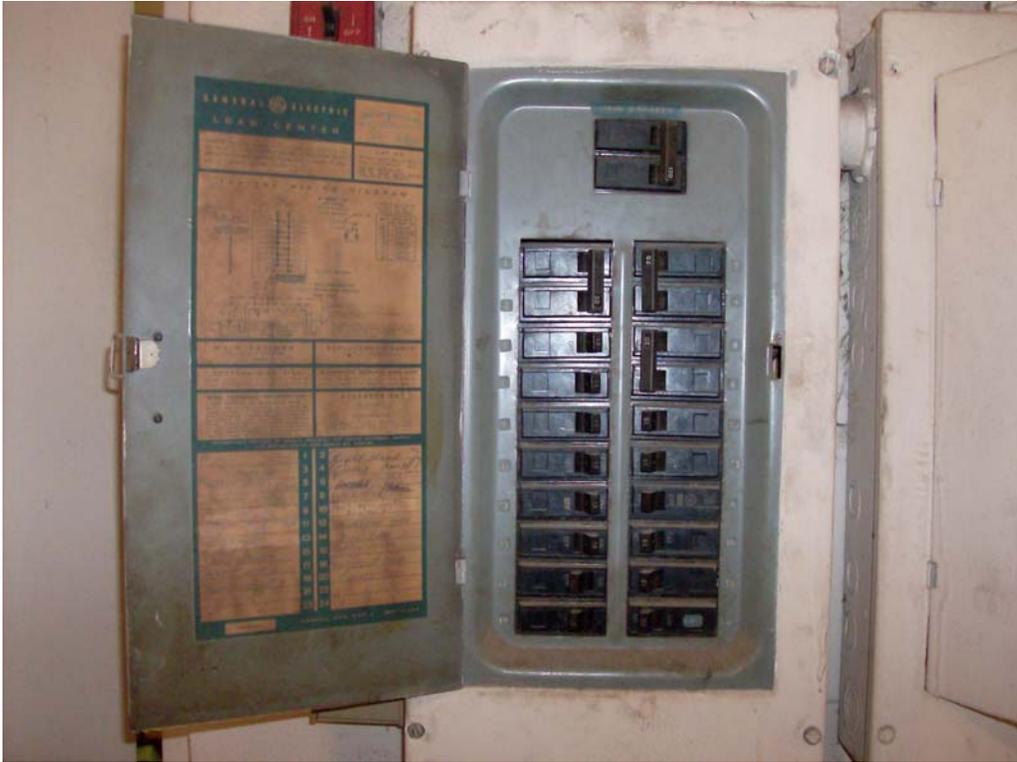
Three-phase power was added just prior to the year 2000. However, many of the original electrical panels are old and outdated and should be replaced. The lighting in the garage is a combination of 8-foot long fluorescent strip lights and a total of four large Mercury Halide lights. The existing lighting appears to be adequate.

Typical Electrical Panel

12. Upgrade or replace the existing fire alarm system to include horns and strobes throughout the building as required by code.
13. Upgrade some of the old electrical panels.

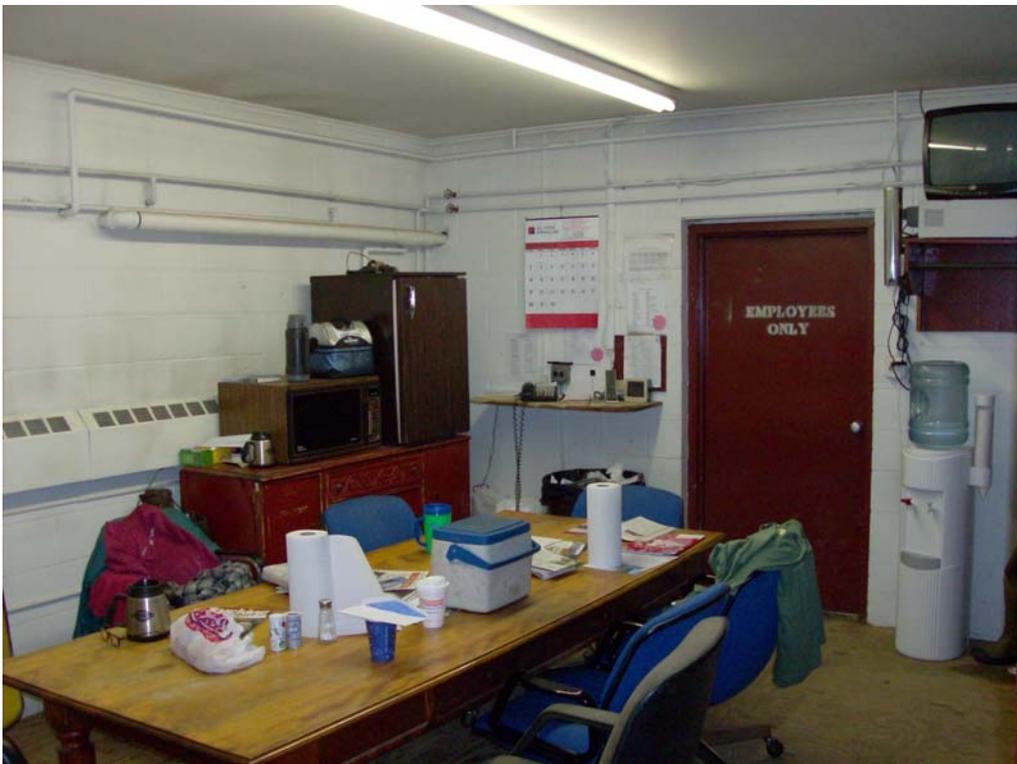
The break room across the hall needs a new floor. The existing plywood floor is worn out. We were informed that the existing concrete floor under the plywood was damaged during a fire back in 1967. Apparently, the room was originally used to store chemicals and the chemicals got onto the floor prior to the fire. Several attempts have been made to restore the floor with little success. Some feel the only alternative is to jackhammer out the floor and replace it. The available crew space does not provide adequate space for meetings and training, or for those personnel who work long hours during snowstorms or emergencies.

Break Room for DPW Workers

9. At a minimum, replace the floor of the break room. Replace the existing lockers with new lockers and re-do the entire room with new finishes, counters, etc.

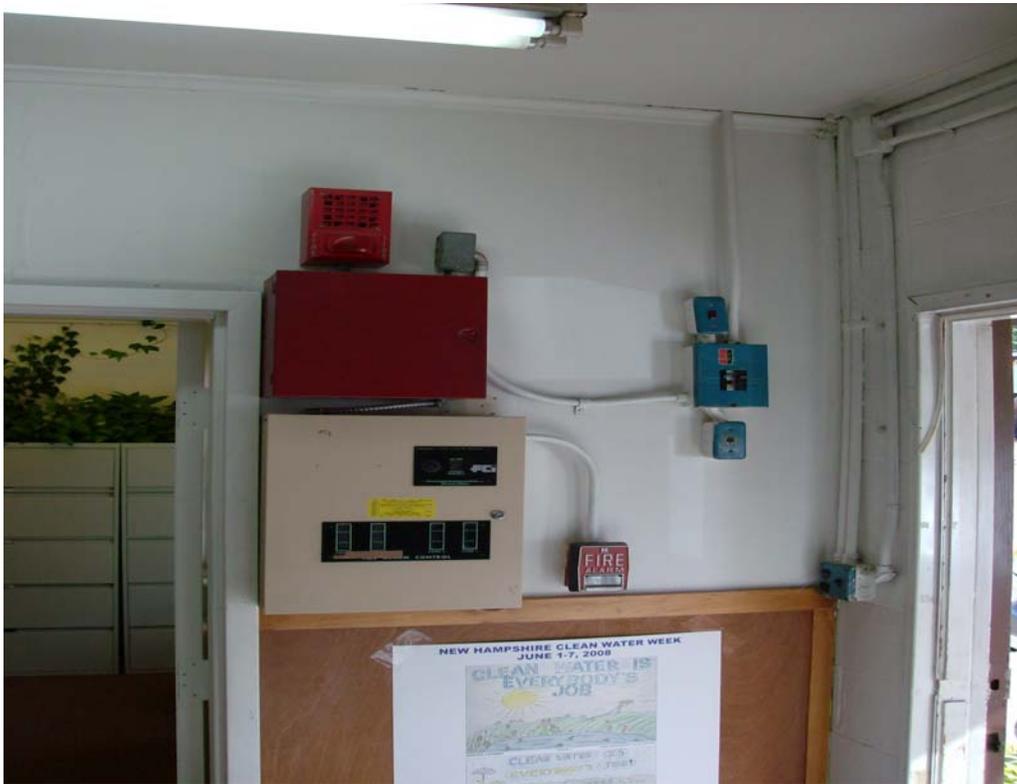
Fire Alarm Panel Near Main Entrance to Administration Wing

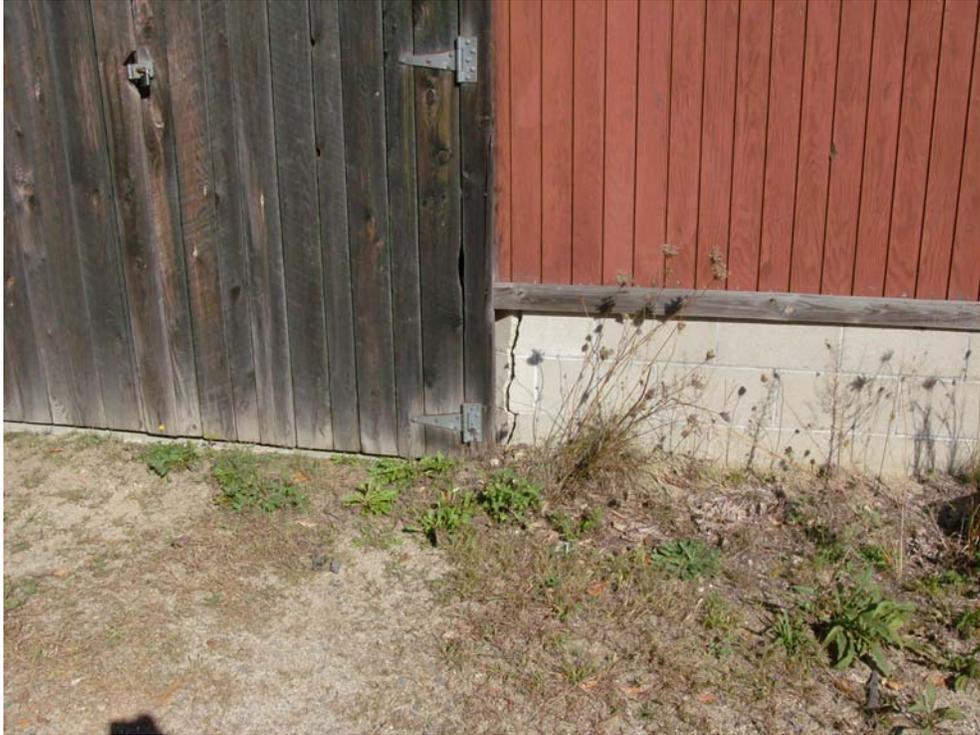
a concrete slab-on-grade. The CMU foundation wall is cracked at a few locations and there is very pronounced cracking in the walls at two of the three doorjambes. Further north is a wood-framed building that appears to be structurally unstable as evidenced by the pronounced lean of the walls. It is not known if this structure is currently being used for storage, but judging by its appearance, it is recommended that it be abandoned or demolished.

Damage to CMU Foundation of Storage Shed

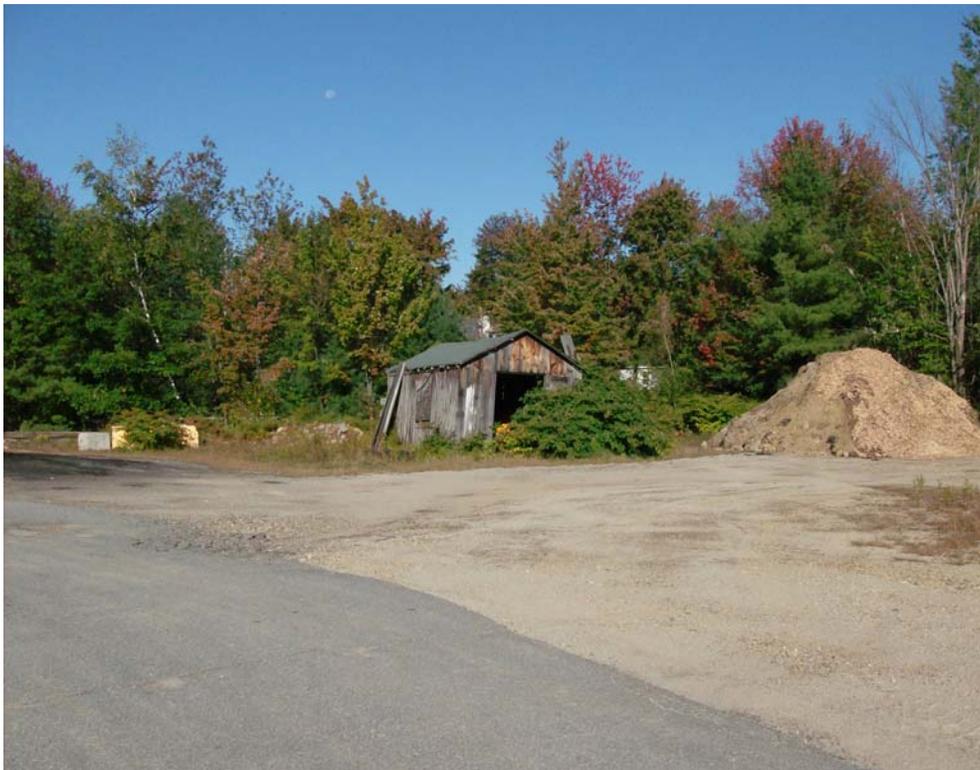
Dilapidated Storage Shed at Northwest Corner of Property

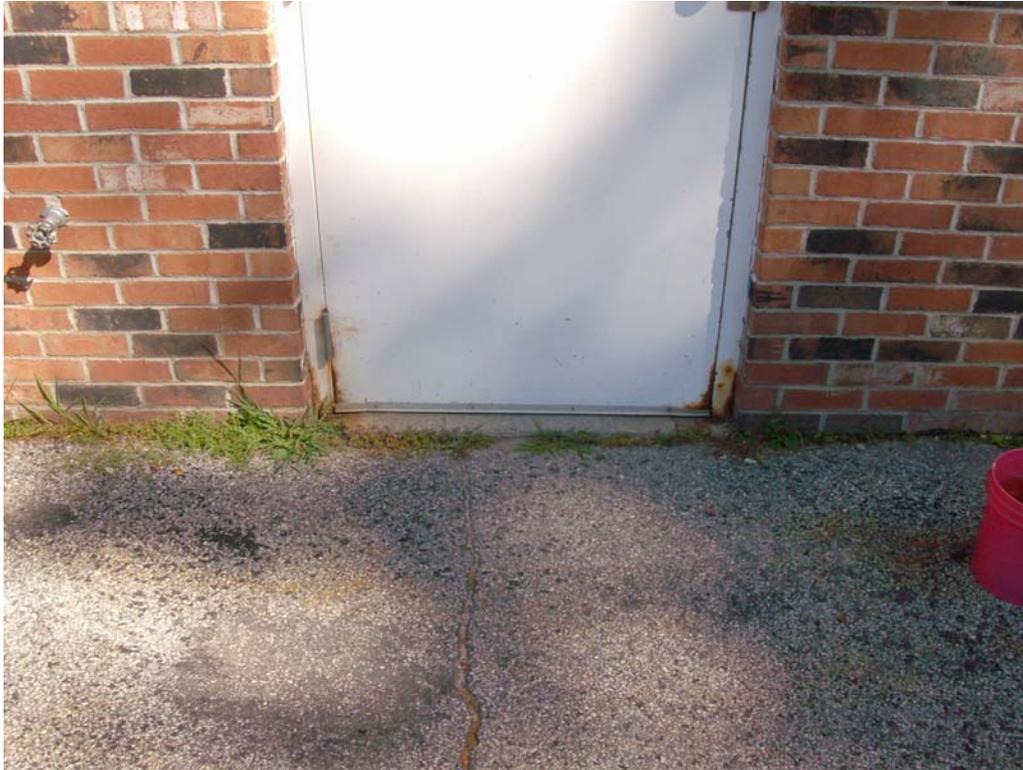
The building is constructed of load bearing concrete masonry block with a full brick veneer all around. The brick is generally in good condition, although we did notice some mortar loss on some joints, particularly on the front of the station at the lower 3 to 4 courses of brick. There are six overhead doors into the apparatus bay which are in good condition having been replaced several years ago. The steel man door at the rear of the building is starting to show signs of rust along the lower edges of the frame and door.

Man Door at Back of Station – Note Rust on Frame and Bottom of Door

1. Install new energy-efficient, double hung windows in the meeting room.
2. In the next 2 to 3 years, replace the steel man door at the rear (south side) of the station.

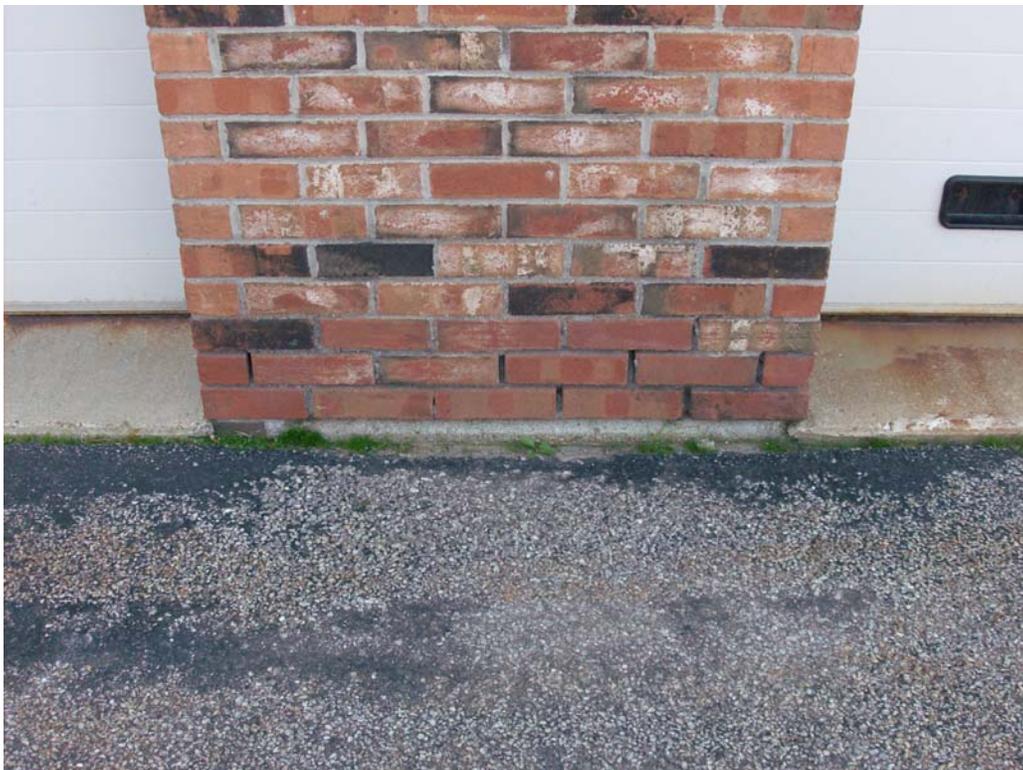
Mortar Loss in Joints at Lower Brick Courses

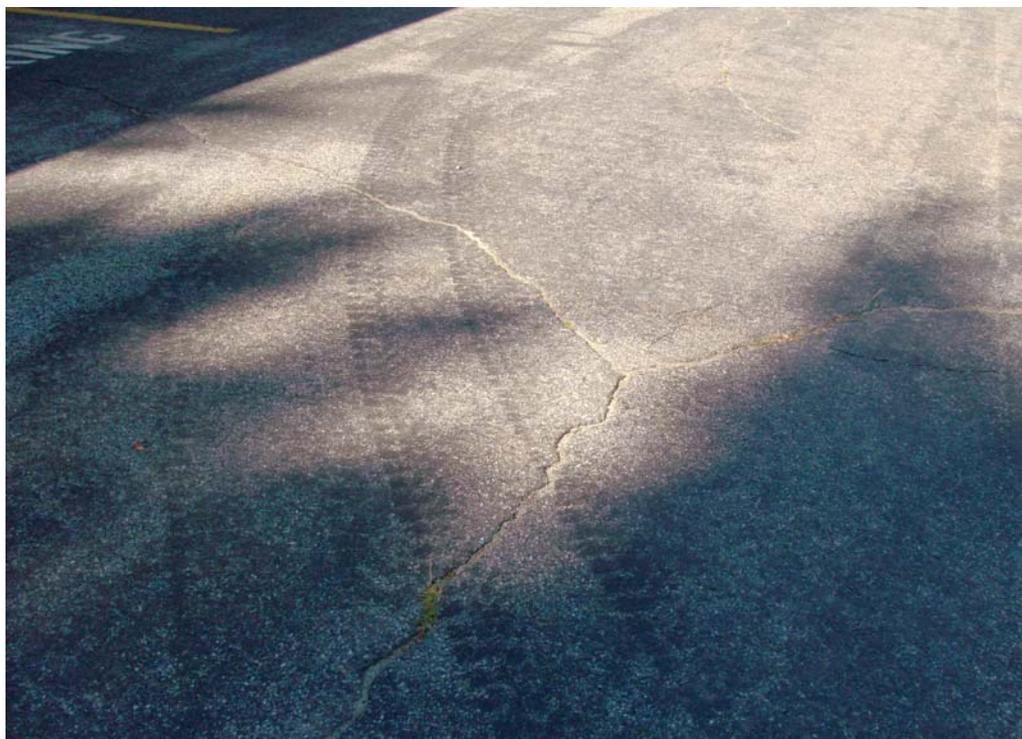
There are large paved areas in the front and rear of the apparatus bays and station. The front area of pavement, which enjoins Turnpike Road, is cracked in numerous locations. As a minimum, the cracks should be filled and the parking lots seal-coated, but the long-term solution calls for re-surfacing the lots. The front entrance is not handicap accessible due to the height of the step at the threshold of the main entrance. A ramp/apron would be required to remedy this situation.

Cracks in Pavement at Front of Station

10. Upgrade the fixtures, replace the flooring, and reconfigure the toilet stall in each of the two bathrooms.
11. Fill cracks and sealcoat the pavement, both in the front and rear of the building. In the next few years, consider the installation of a new pavement surface.

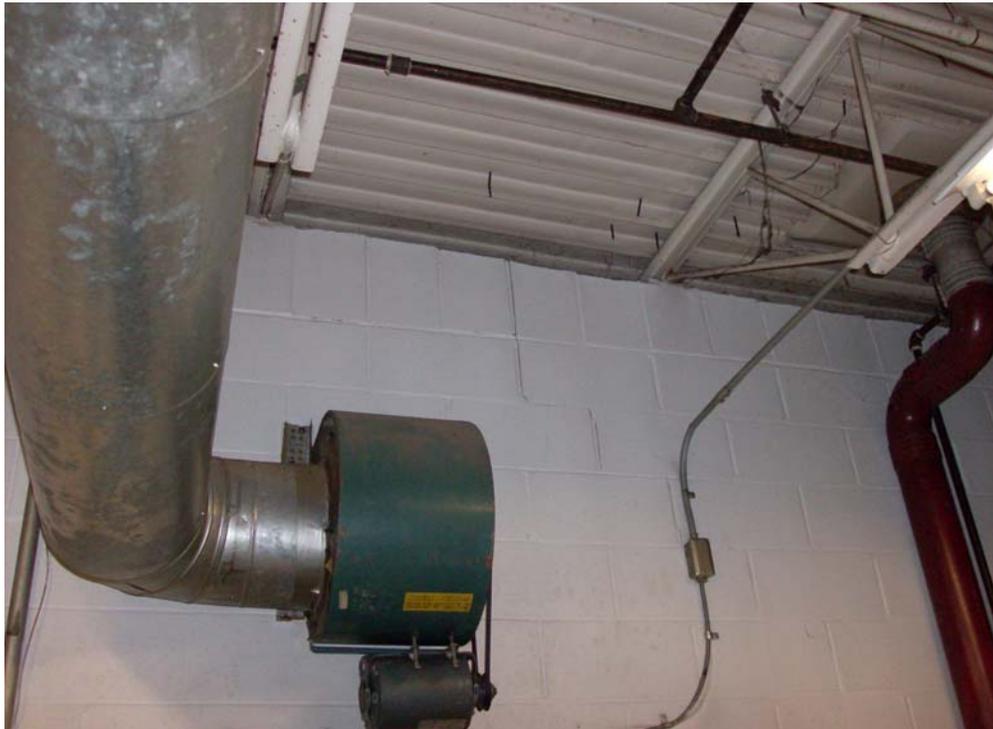
Like the rest of the station, the apparatus bay is in generally good condition. There are a few hairline cracks in the CMU, but nothing that was determined to be structurally serious. Some of the walls are stained with diesel soot, in particular the areas between the overhead doors. Most of the exhaust is handled by the "Plymovent" system, which connects directly to the exhaust pipes of the trucks. Through a series of hoses, fans and vent pipes, the exhaust is directed outside the building. There was evidence of moisture at the base of the walls, particularly near the overhead doors. The overhead doors should be weather-sealed and caulked to help prevent air and moisture infiltration. The lighting in the apparatus bay consists of 8-foot long fluorescent strip lighting with outdated T-12 bulbs. The concrete floor of the apparatus bay is in good condition with few hairline cracks and no spalling. The floor finish is very smooth, and most likely was coated with a product specifically made for sealing concrete floors. As a result, the floor can be very slippery, especially if it becomes wet.

Hairline Cracks in Masonry of Garage

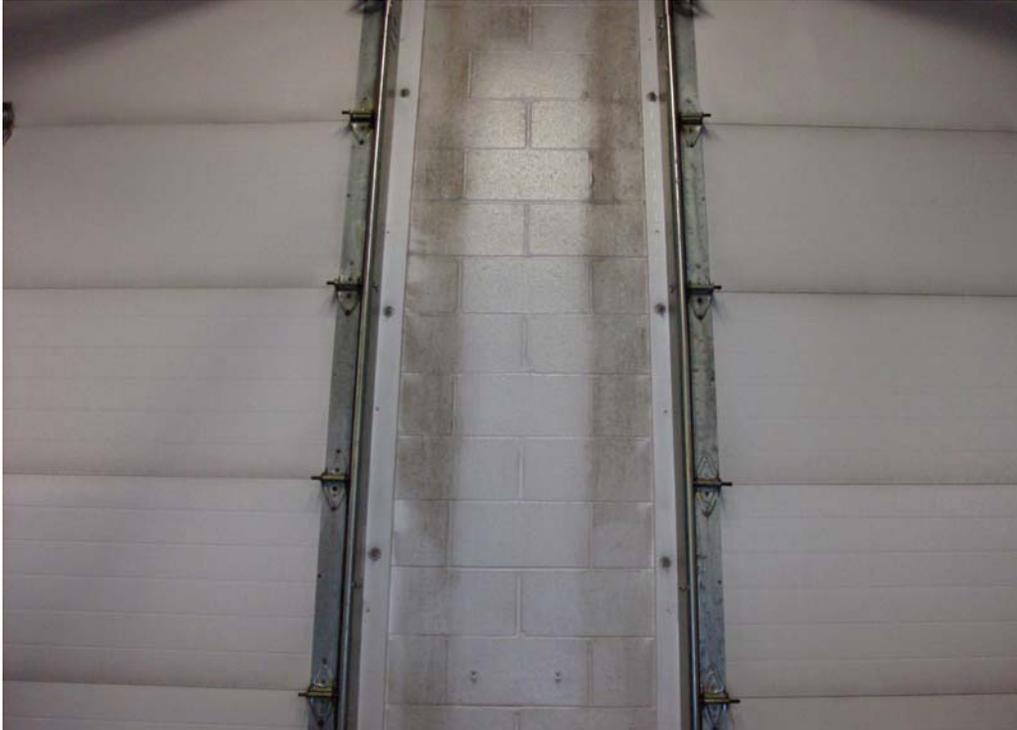
Discoloration on Walls Adjacent to Doors

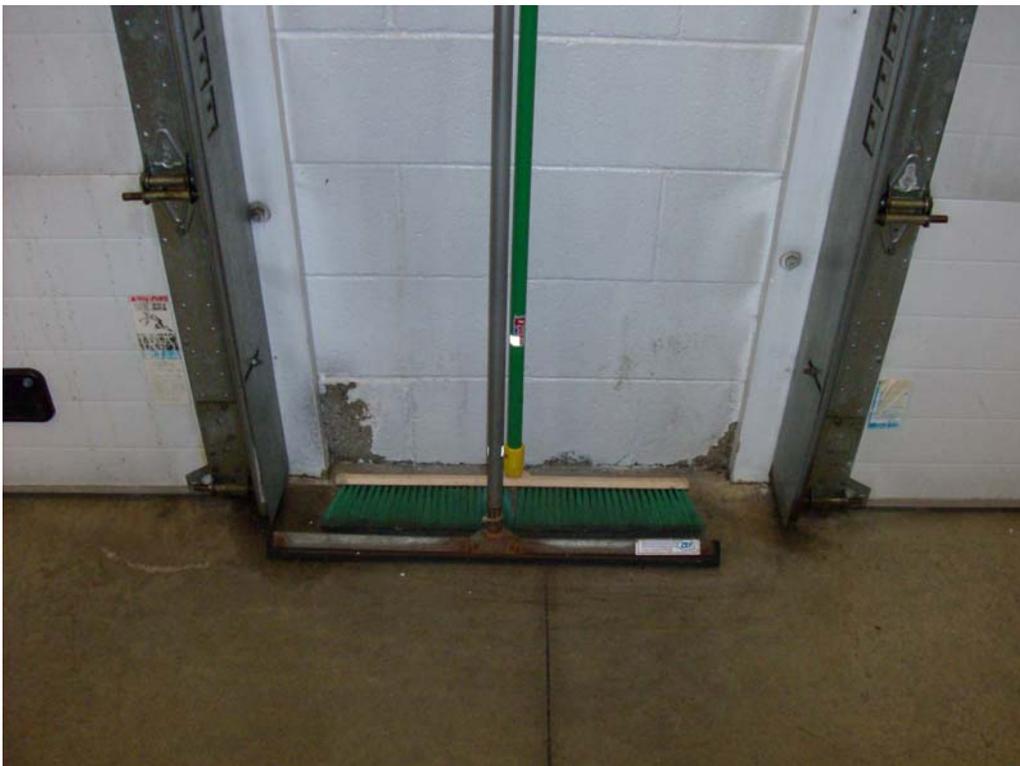
Spalling on Face of Masonry Block

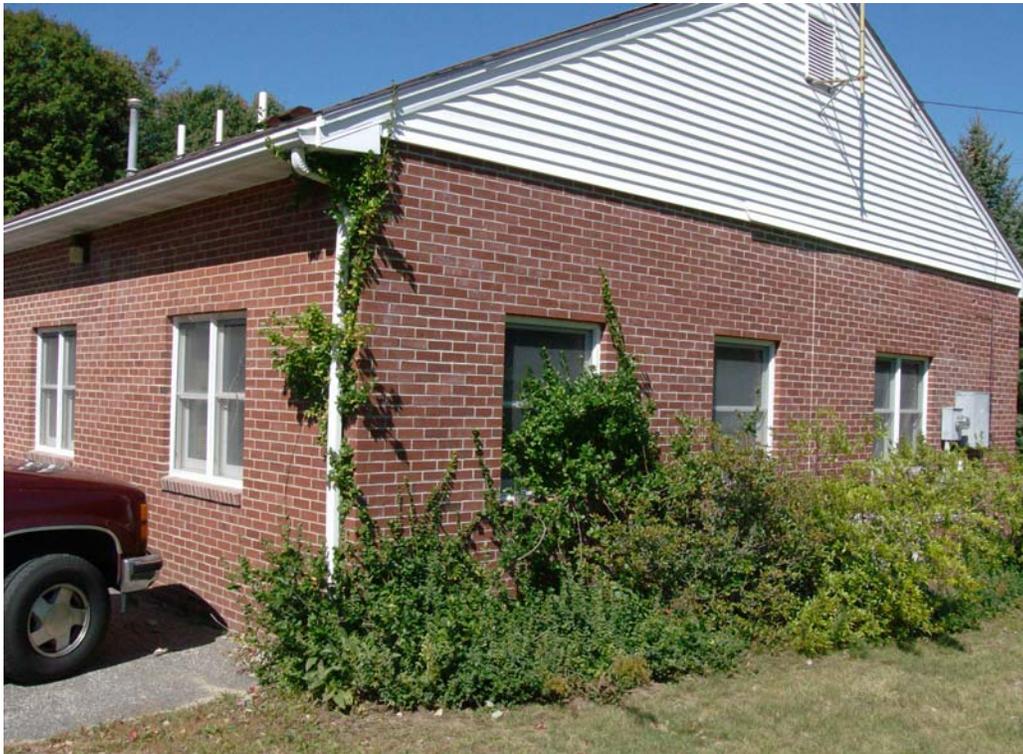
Excessive Vegetation on East Side of Building

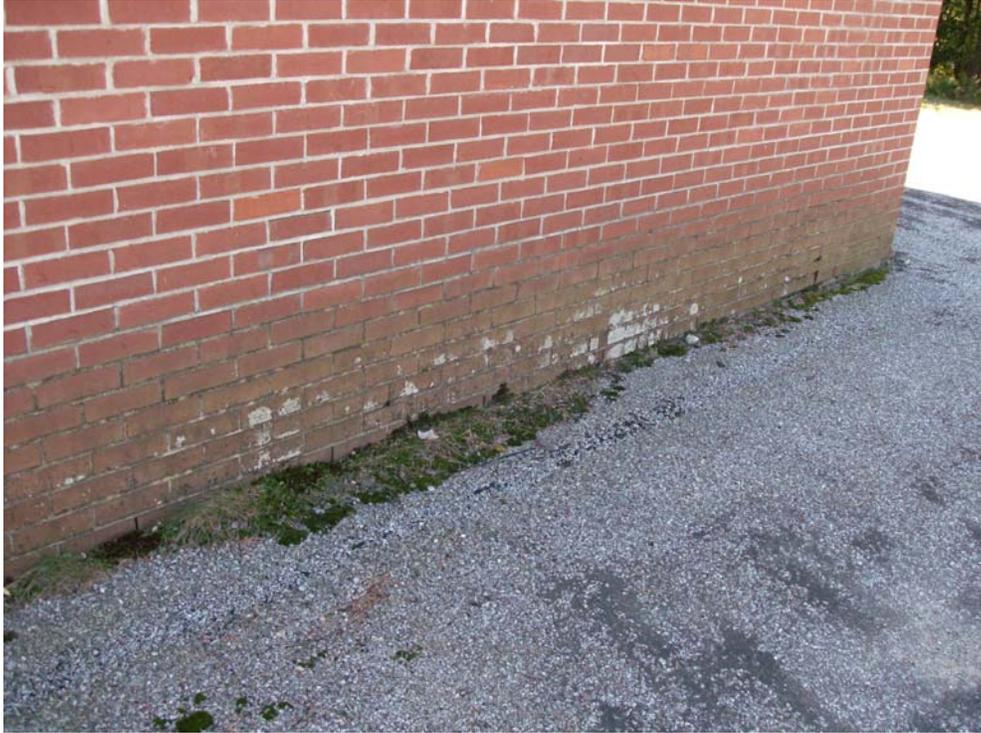
Water Damage and Moss Growth on Northwest Corner

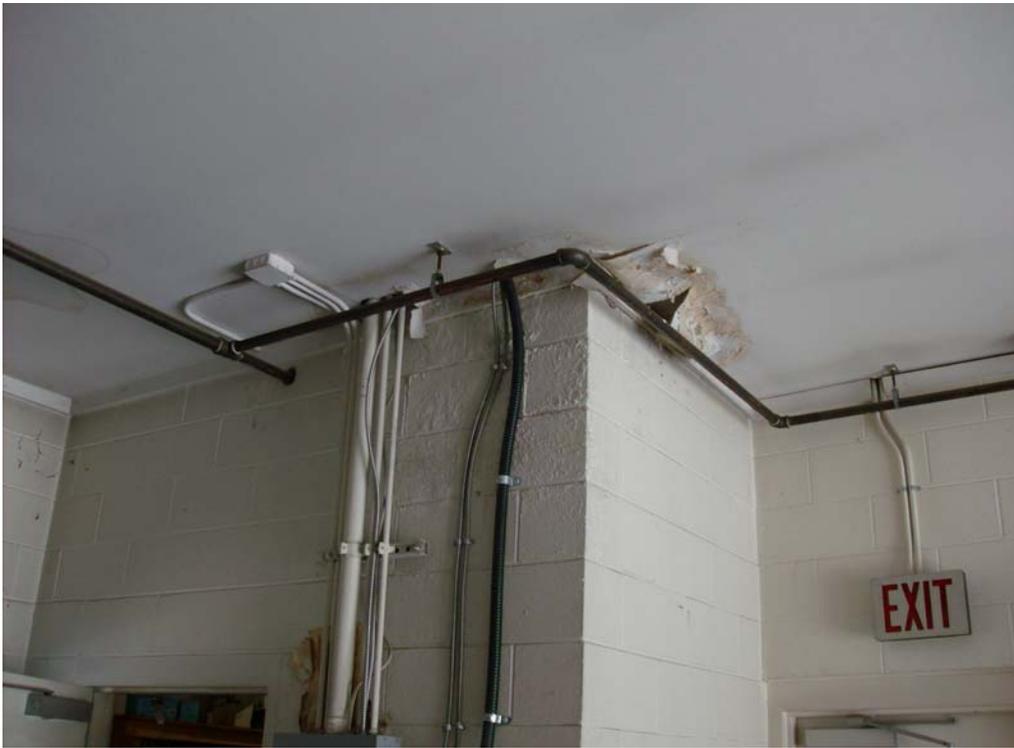
Prior Water Damage Around Chimney in Garage

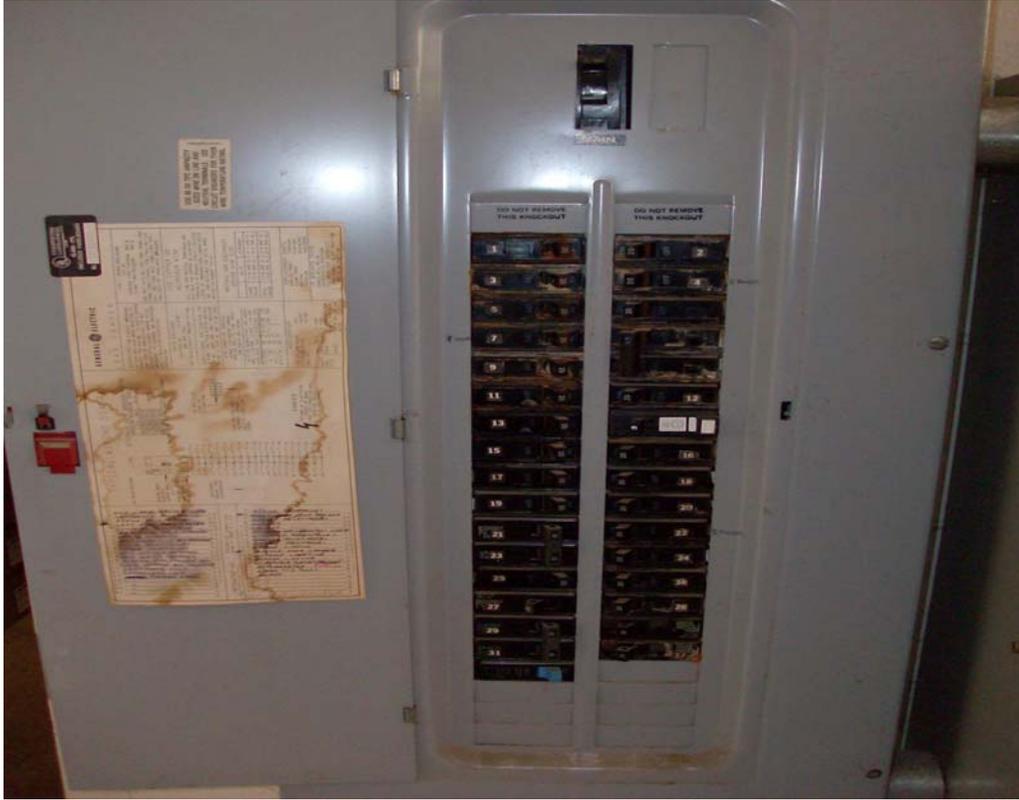
Water Damage in Electrical Panel

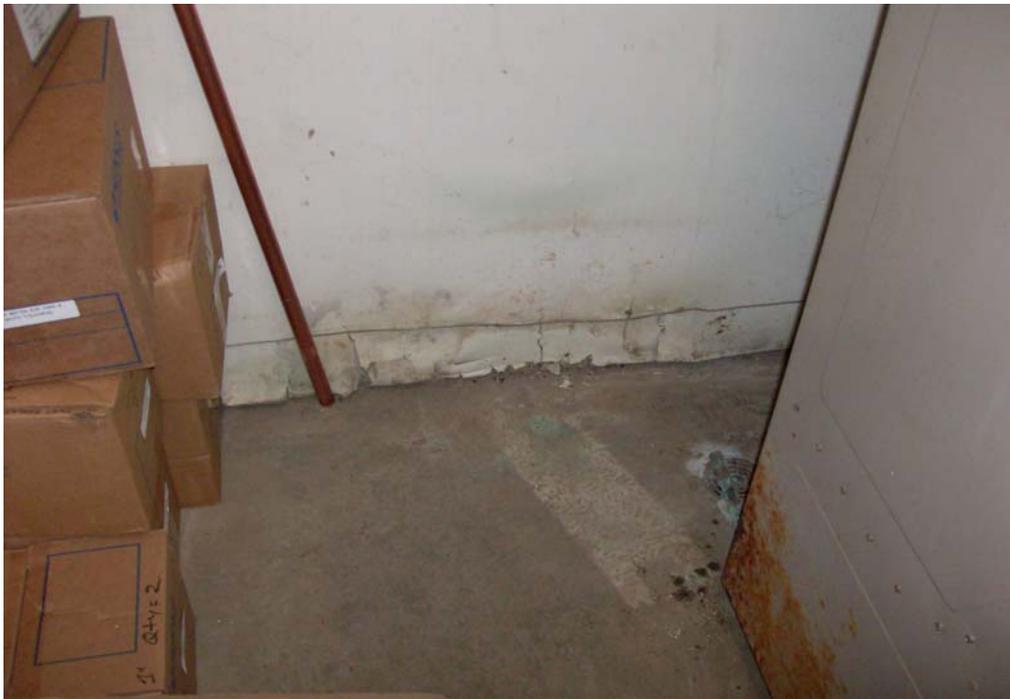
Water Damage Along Wall – May be from Leaking Water Heater

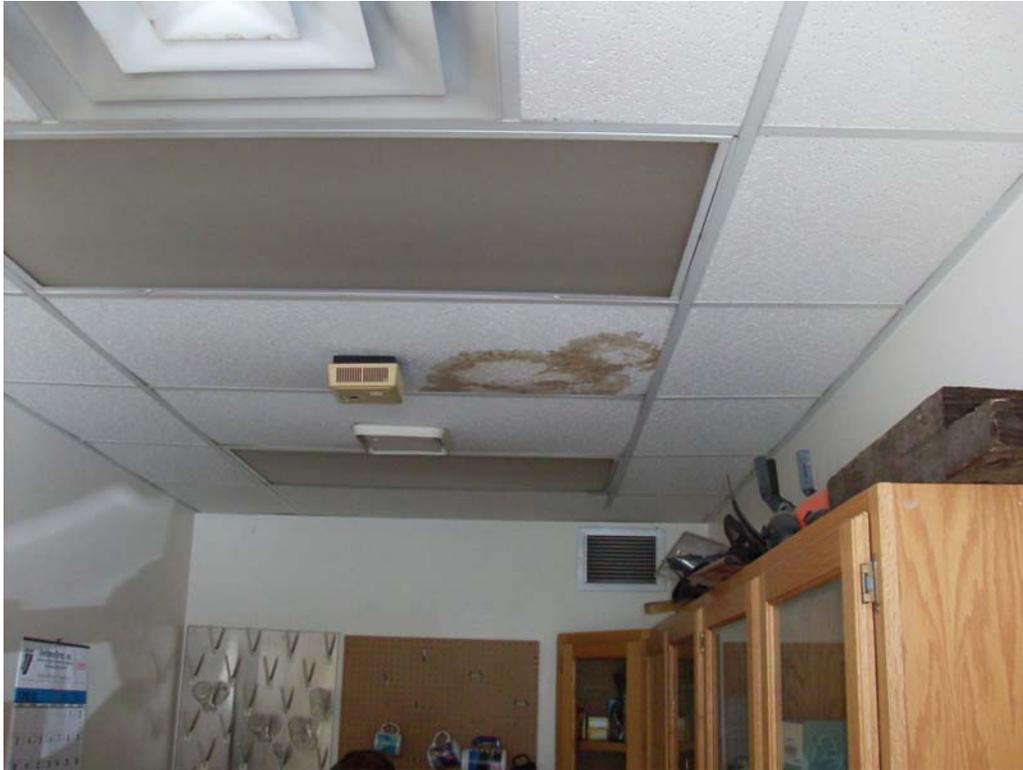
Water Damaged Ceiling Tile in Lab Area

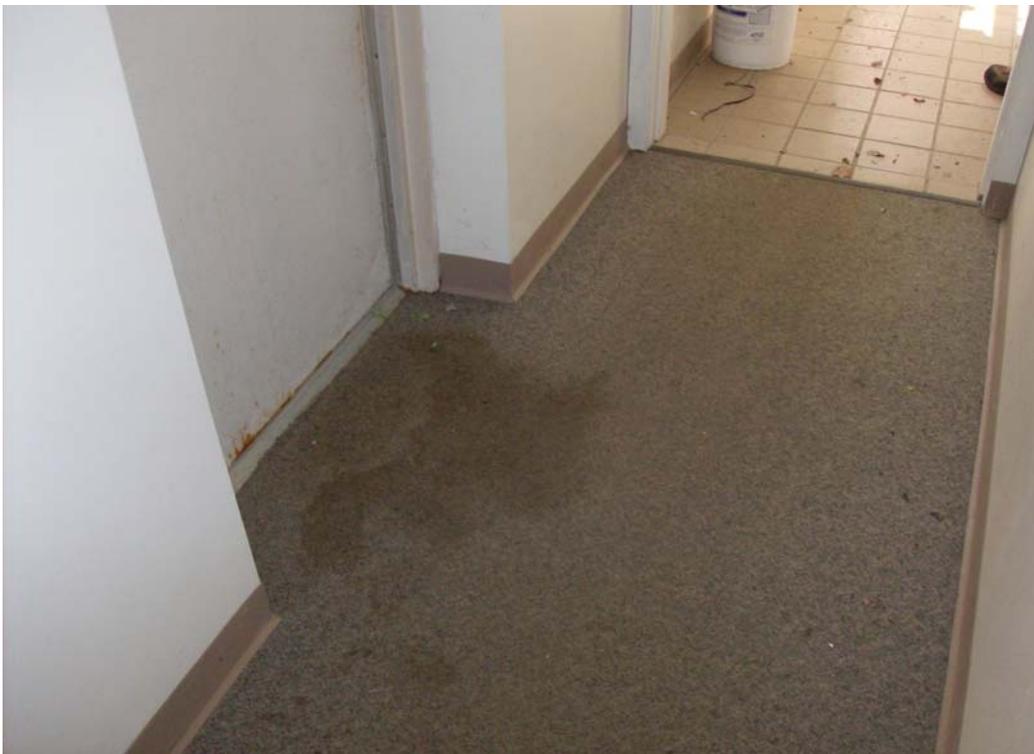
The lab and bathroom floor areas are covered with ceramic tile, and the office spaces are carpeted. The ceramic tile is in good condition, while the carpet is badly worn and stained and should be replaced.

Stained and Water Damaged Carpeting at Rear Entrance

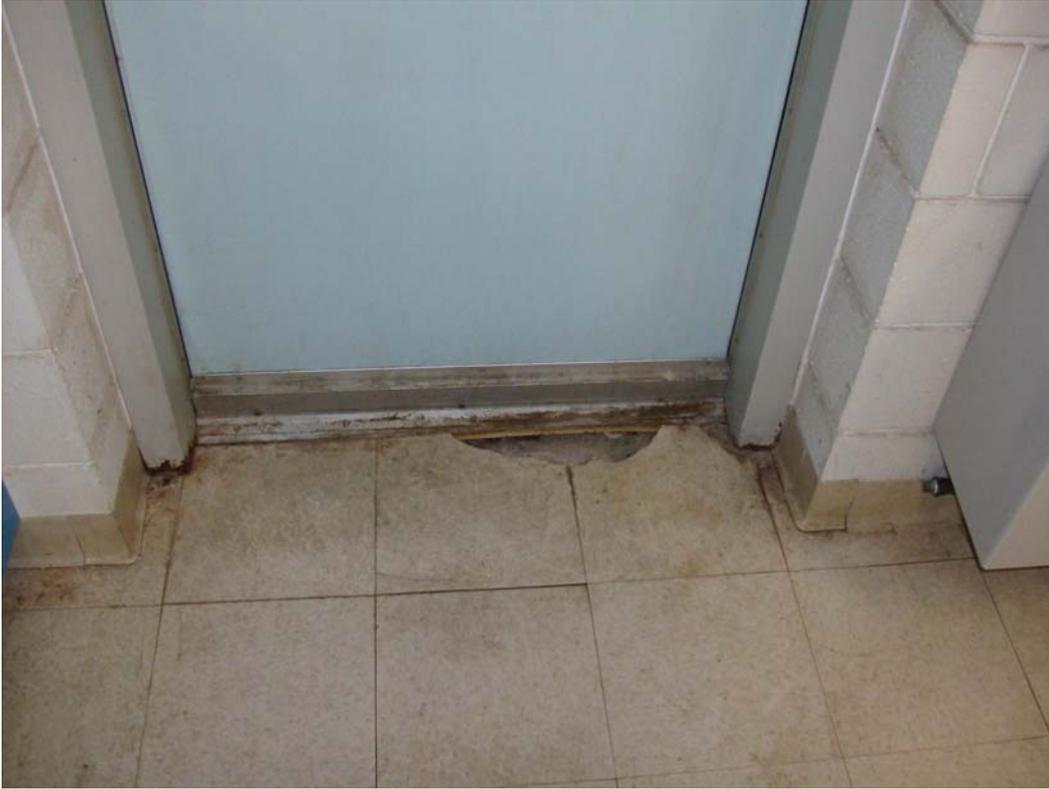
Damaged Tile at Laboratory Door

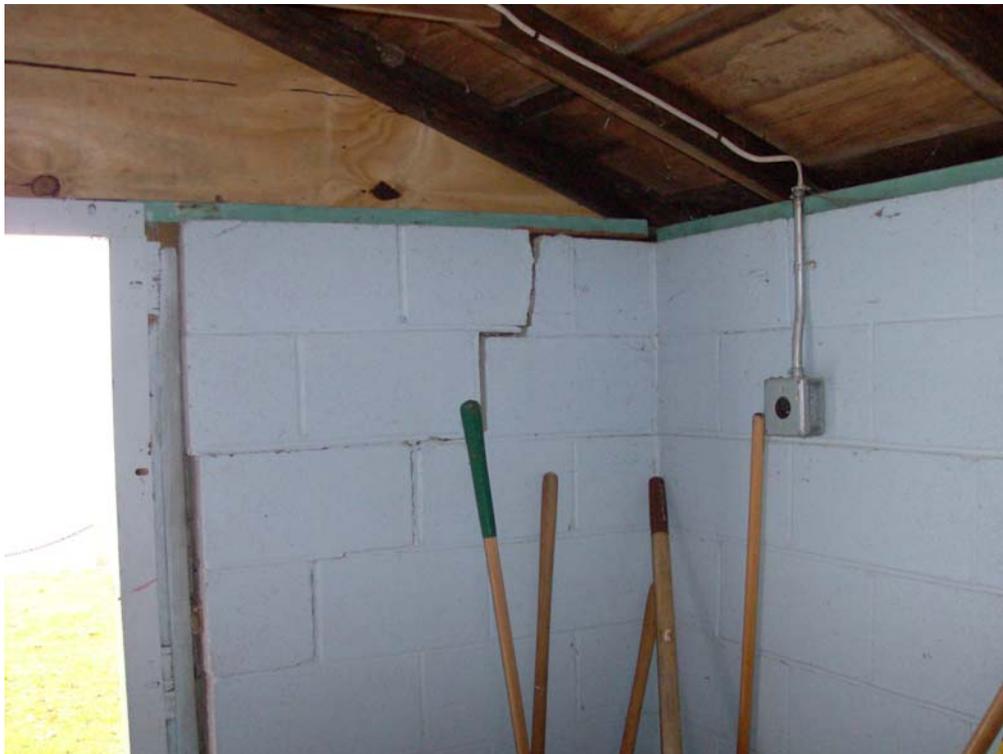
Crack in CMU – South Wall of Changing Room

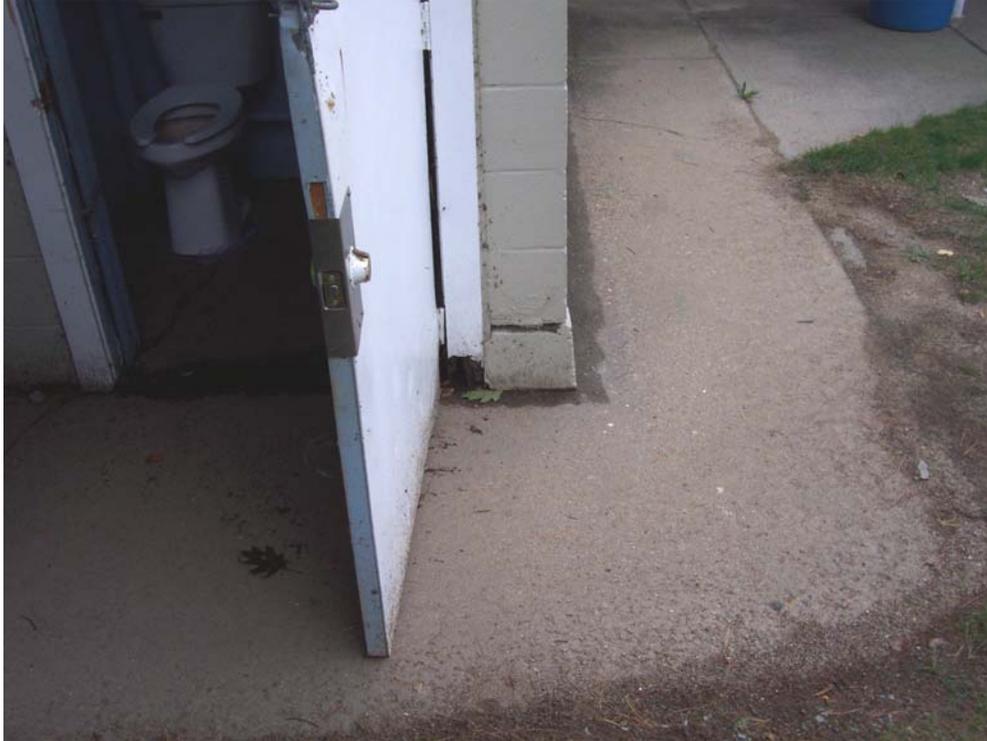
Damaged Door at Bathroom – Rear of Bath House
