**FACILITY ASSESSMENTS
MUNICIPAL BUILDINGS
PHASE II**

JAFFREY, NEW HAMPSHIRE

JANUARY 2009

THE H.L. TURNER GROUP Inc.

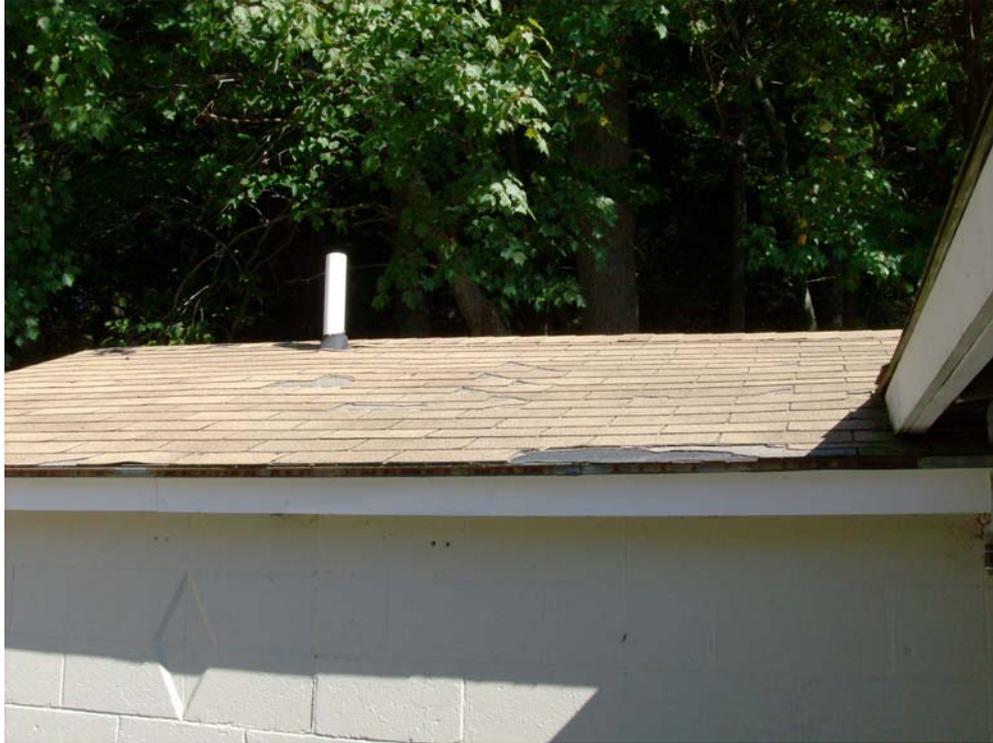
Missing Roof Shingles Over Bath House

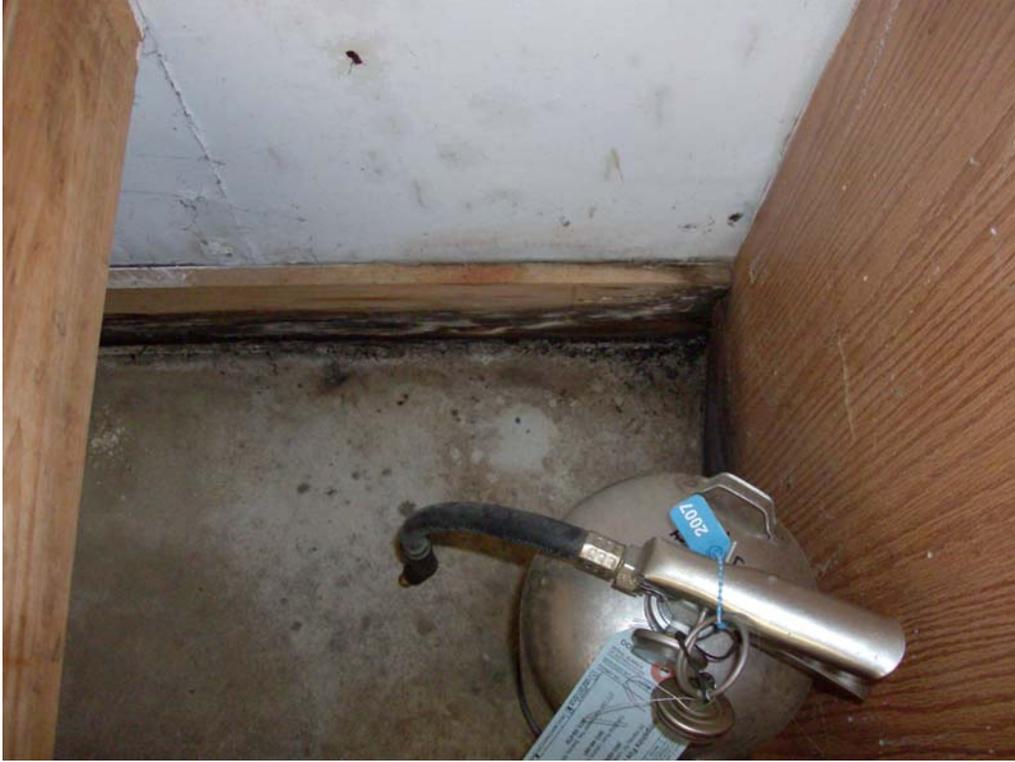
Water Damage and Mold Along Baseboard

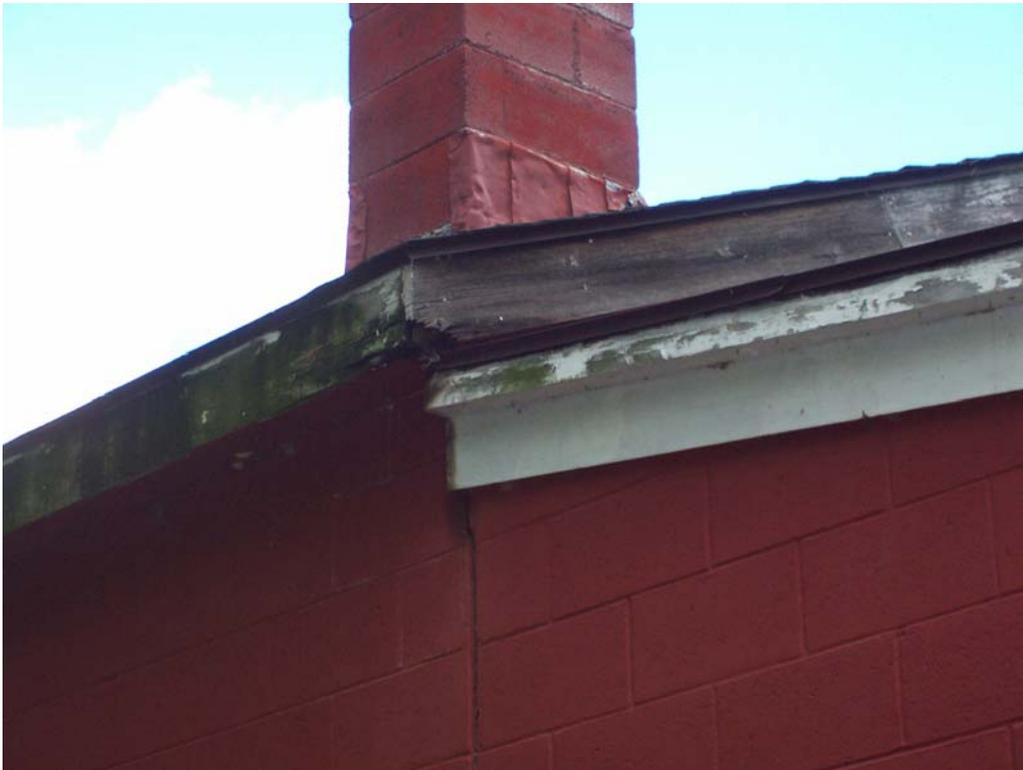
West Side – Note Rotted Trim, Peeling Paint, and Chimney in Need of Re-pointing

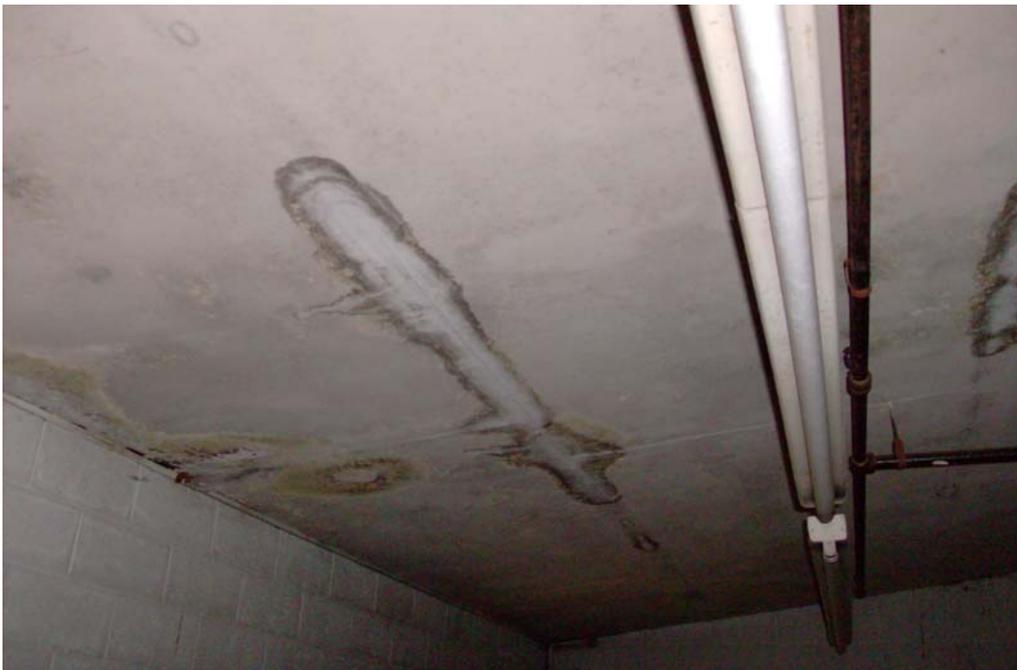
Moisture Intrusion in Storage Area

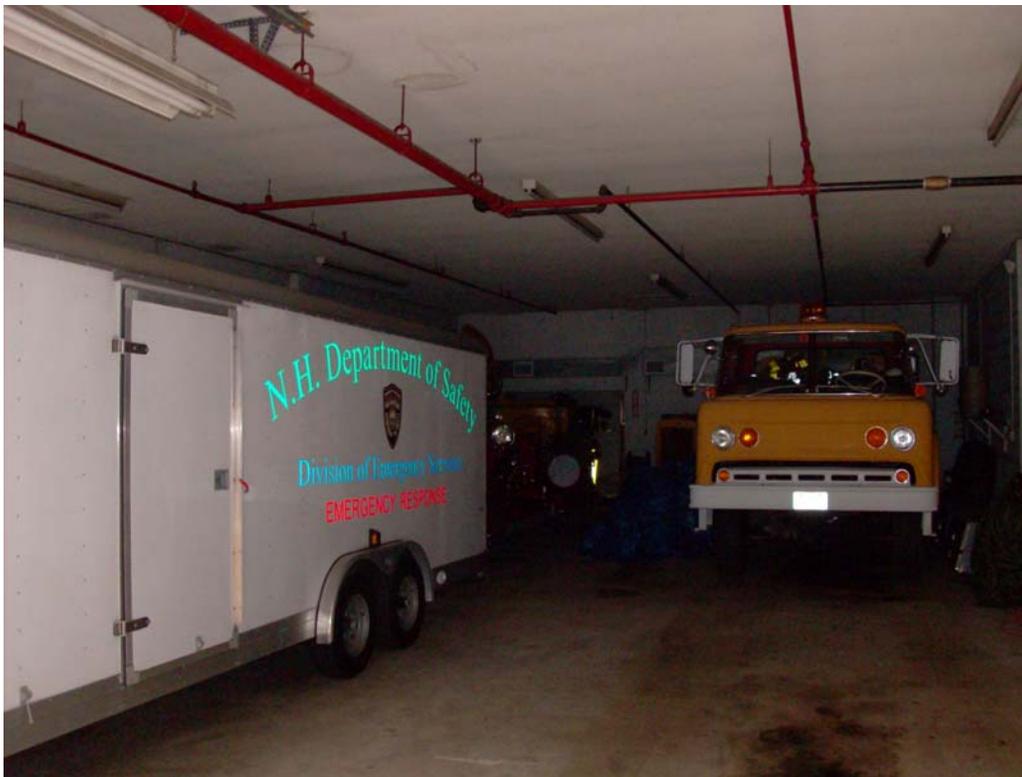
Some Moisture Intrusion Noted on Ceiling
