## **Water System Facilities Asset Management Report**

**Town of Jaffrey, NH**

March 2018

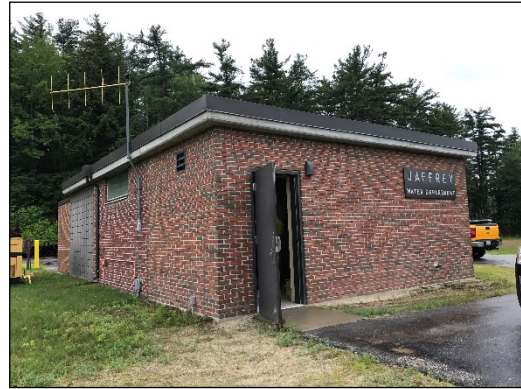
The facility has a bituminous concrete driveway and parking area that wraps around the building. The pavement is in fair condition with several areas of cracking observed in the pavement grass growing up through the cracks. The typical lifetime for new bituminous concrete is 20 years, with crack sealing recommended at least once during that period. Once pavement begins to deteriorate, a mill/overlay can be completed to provide an estimated 10 additional years of service life, or the pavement can be completely replaced. A mill/overlay typically costs around 40% less than a full replacement, but provides only half the expected service life. Therefore, full replacement is generally recommended if sufficient capital funding is available. Jaffrey should budget for crack and overlay within the next 5 years (TWF-C101-1).

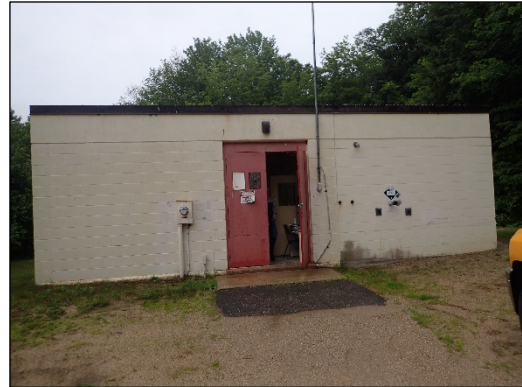
There is a swing gate at the opening of the driveway to the Contoocook Well facility to prevent vehicular access. It was open on the day the facility visit was conducted and it is not clear if it is locked regularly. There is no fencing at the site. The access drive into the site is approximately 750 feet long with the first 400 feet paved and in fair condition. Jaffrey should budget for a full replacement of the access road in 5 to 10 years.

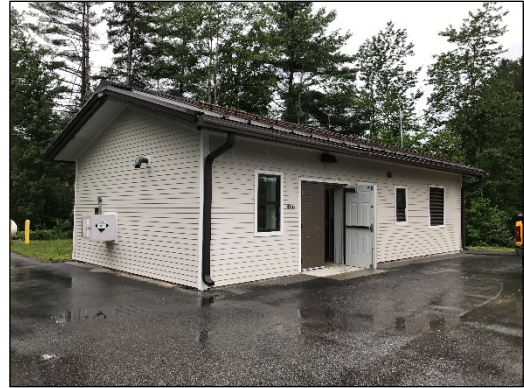
The facility has a paved driveway that provides access to the front and south side of the building. The pavement and site appurtenances are in good overall condition. Maintenance of the pavement by sealing cracks is recommended (SWF-C301-1).

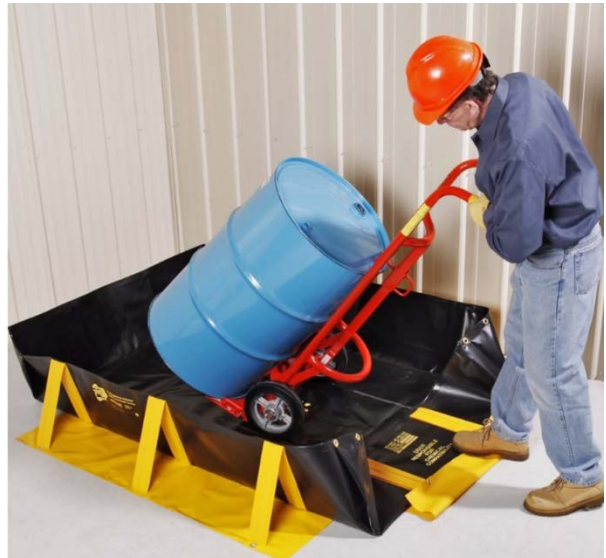
Jaffrey utilizes 55 gallon blended phosphate drums for the phosphate feed system. The drums sit on 8" high pallets in the west side of the chemical room. The 55 gallon drums are moved onto the pallets utilizing a ramp and hand trolley. The operator noted that the ramp does not fit well into the space and it is awkward moving the drums up onto the pallet. There are manufacturers that now make secondary containment vessels which have sides that can be folded down in order to move drum tanks into and out of the containment. Jaffrey may want to replace the raised pallets with one of these collapsible-wall containment vessels (SWF-P306-1).

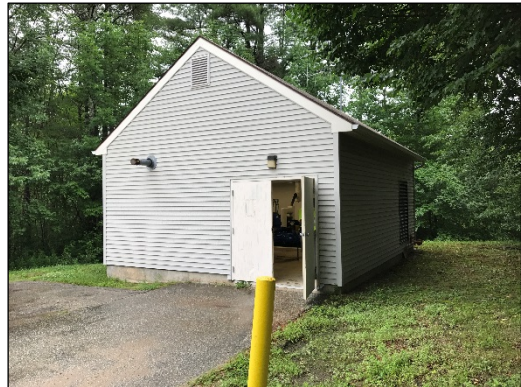
The small bituminous driveway and parking at the facility is in good condition with some linear cracks observed between the main pull-in area and the parking area and at the edge of the driveway apron. Jaffrey should plan for repaving of the parking area in 10 to 15 years. The building is locked with door contacts present on the doors, but there is no fencing around the site. There was no sign of vandalism or trespassing at the site and the building is in a residential area. Given that the building is fairly inconspicuous in its location, there is likely no need to add additional security measures here unless trespassing and vandalism become a problem in the future. It was raining the day of the site visit and some water was ponding outside the entrance of the facility. The grading here should be fixed when the parking lot is repaved.

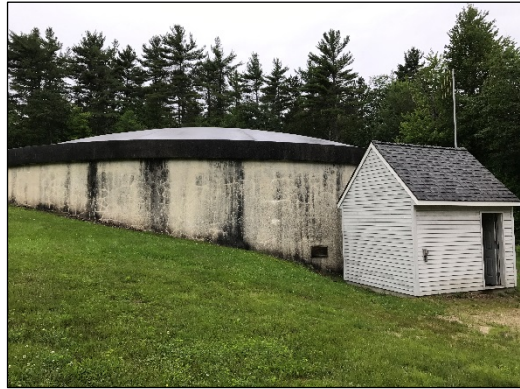
The area around the tank is well-maintained and trees are cut back to prevent any limbs from falling on the tank. The site does not have a gate or fence to prevent unauthorized access and there were some signs of trespassing, but no vandalism was observed. The tank hatch is locked, and the onsite building is locked with door contacts installed. The Town may want to consider adding fencing and/or no trespassing signs to the facility to prevent unauthorized access (BT-C502-1).

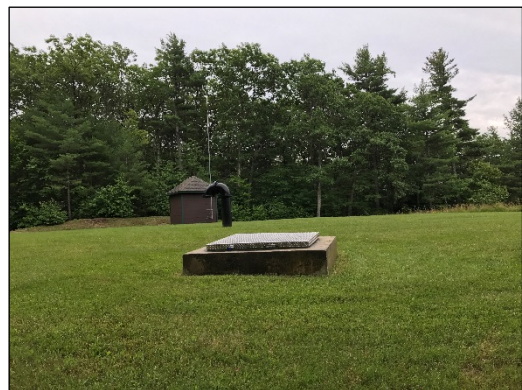
There is a swing gate at the entrance to the Poole Tank site which prevents vehicular access but there is no fencing to prevent trespassing on foot. Beer bottles were present adjacent to the facility gatehouse, indicating trespassing, but there were no signs of vandalism.
