W.W. Cross Property

Jaffrey, NH

Phase II Environmental Site Assessment

April 10, 2019

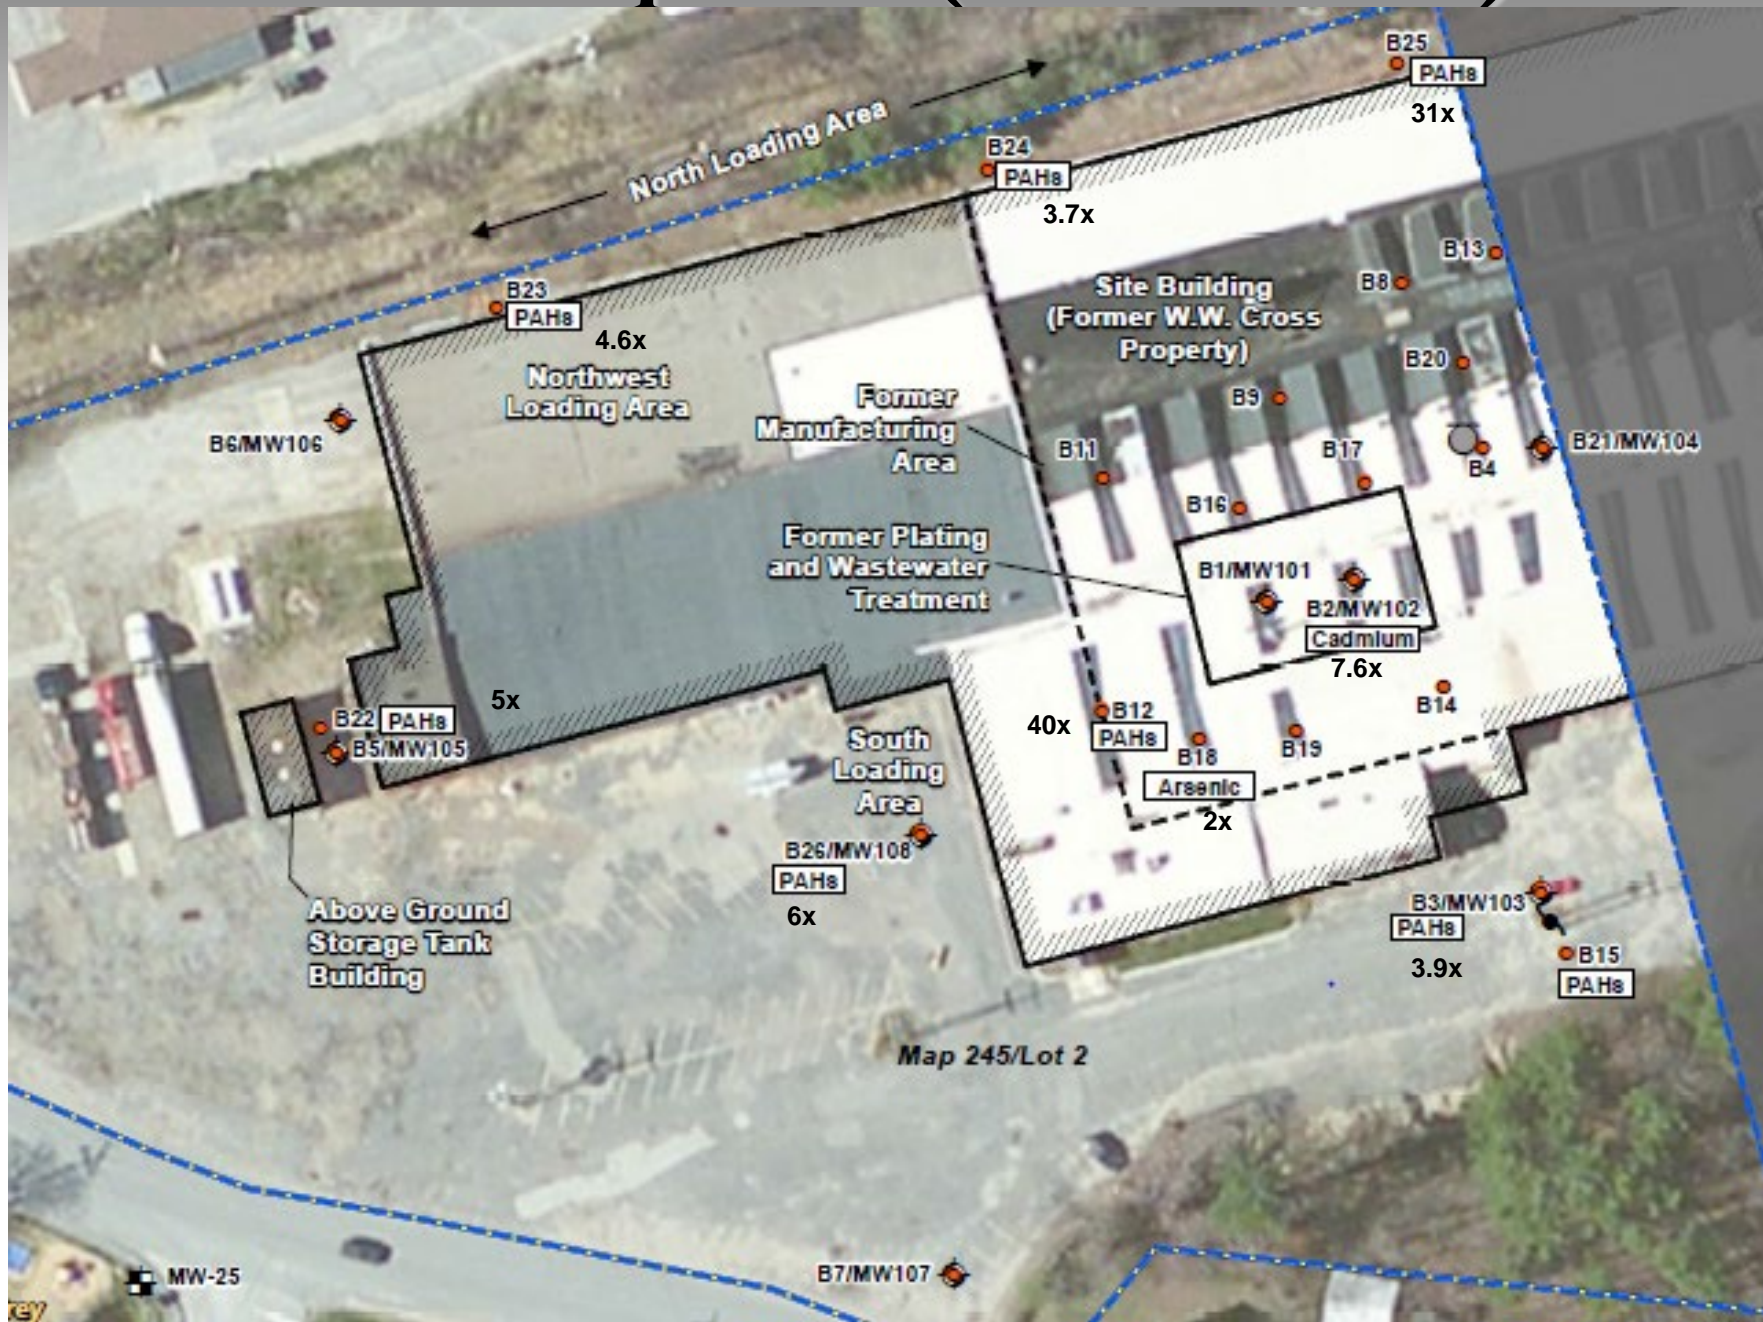
Soil Impacts (above SRS)

- Cd, cyanide and PCE impacts to soils and/or groundwater in proximity to the former plating and wastewater treatment area;
- PCE impacts to groundwater;
- PAH impacts in the area of B12 and B26, and naphthalene impacts to groundwater; and
- PAH impacts to soil in the area of the inactive No. 6 oil AST.

Recommendation:

Further Investigation of...

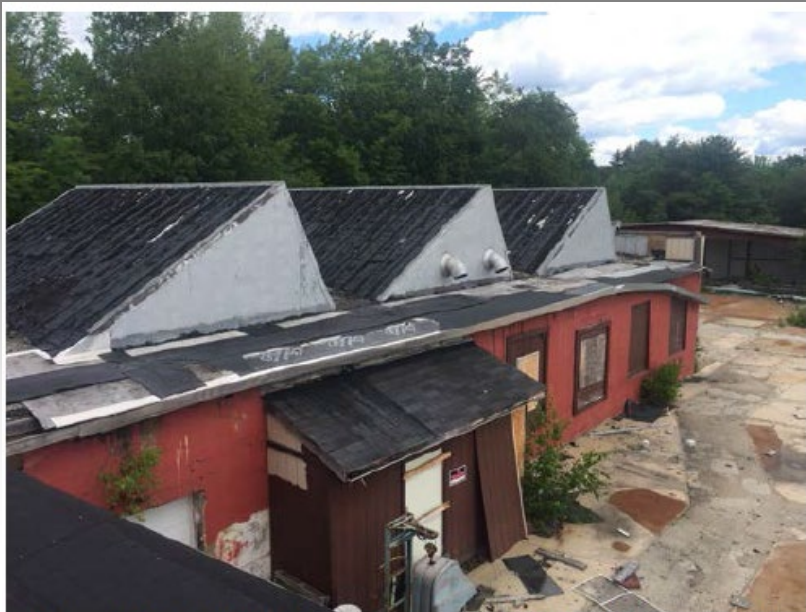
Photo 17 (6-27-17): View of “saw tooth” skylight area with ACM roofing applied to the shallow slope, and ACM flashings.

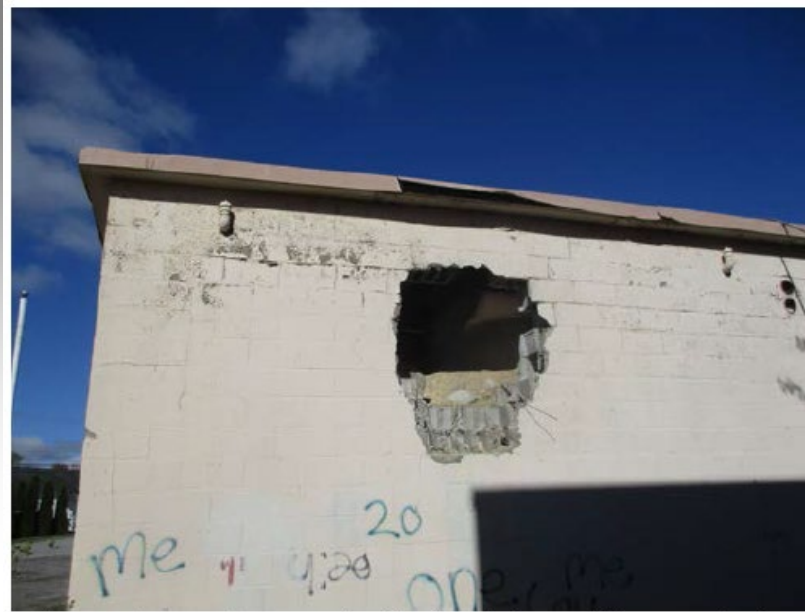
Photo 4 (6-27-17): Vermiculite insulation within AST bunker (sample set 62); ACM (Tremolite) found to be present.

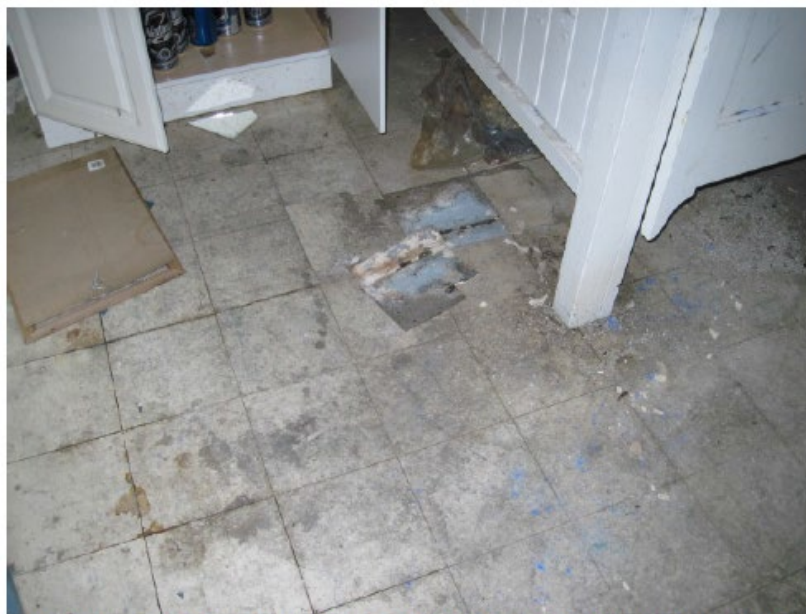
Photo 10 (6-27-17): ACM 9-inch floor tiles (sample set 09) located in bathroom within Site Building Room 22.

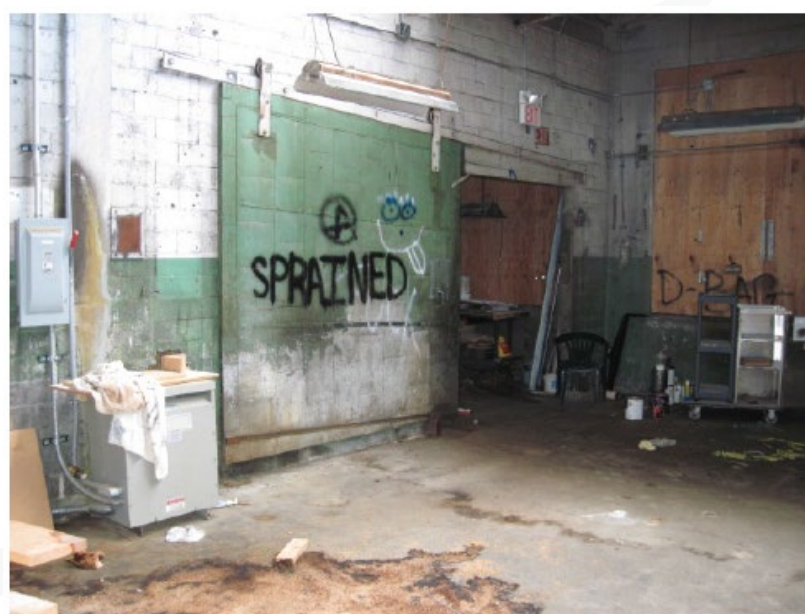
Photo 14 (6-27-17): One of several fire doors observed throughout the Site Building interior (PACM).
