SPACER PAGE for numbering

Part One: Introduction

Part Two: Jaffrey Building Assessments

Part Three: Audit Summary and Recommendations

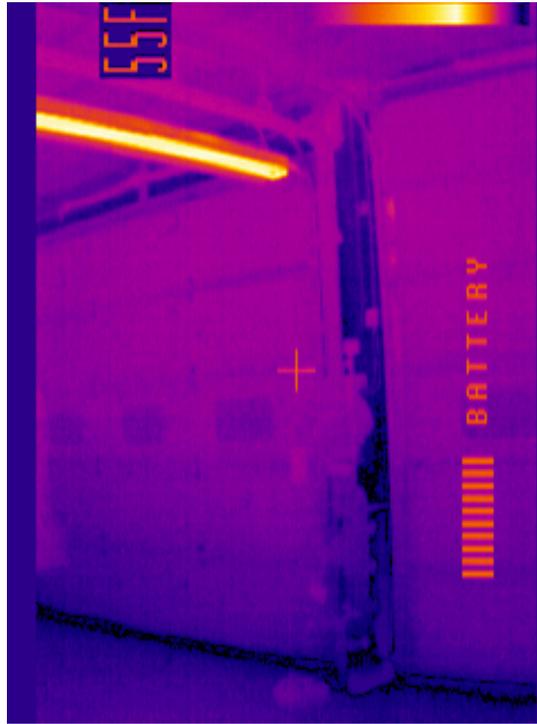
Champion Overhead Doors from Dummerston, Vt. are in good condition. According to the Turner Report, doors were installed around 2006.

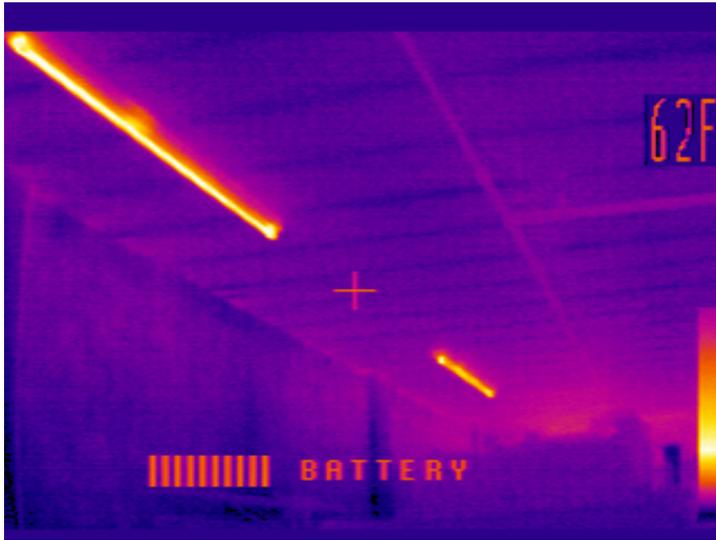
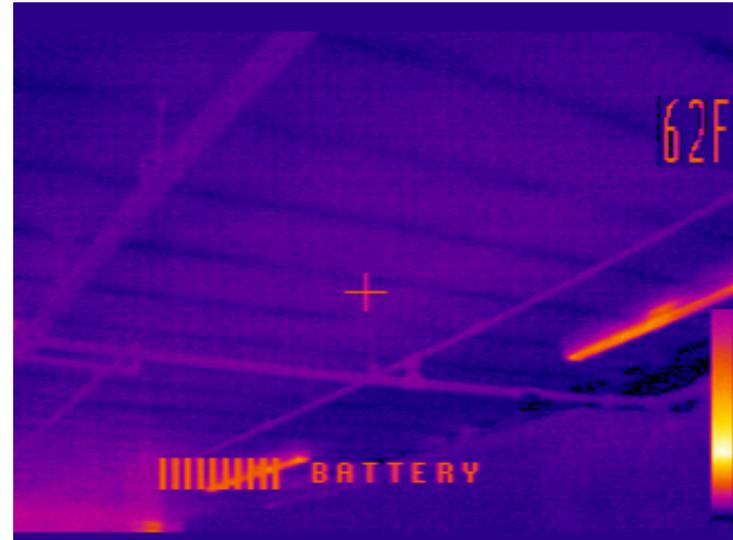
Ceiling insulation levels are unknown due to not being able to access the attic hatch. Clear thermal bridging indicates insulation is in cavities only and the Turner Report states “a limited amount of insulation in the attic space.”

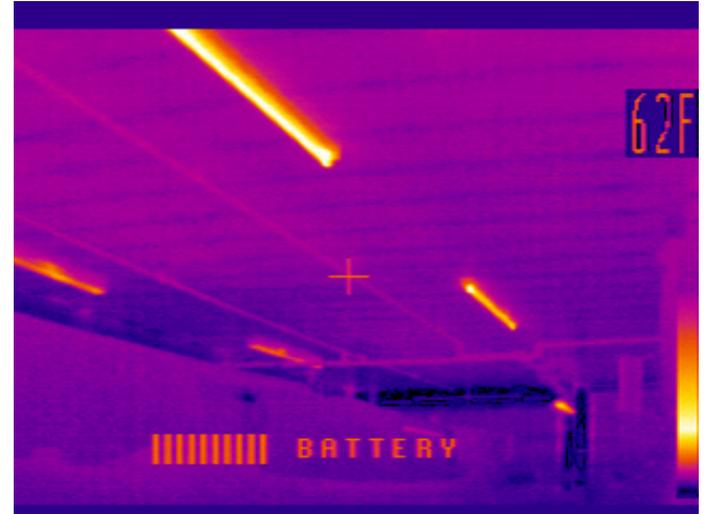
Attic has been heated by the sun and now warmer than the bays. Bright colored hatch edges indicate warm air infiltration around an unsealed hatch.

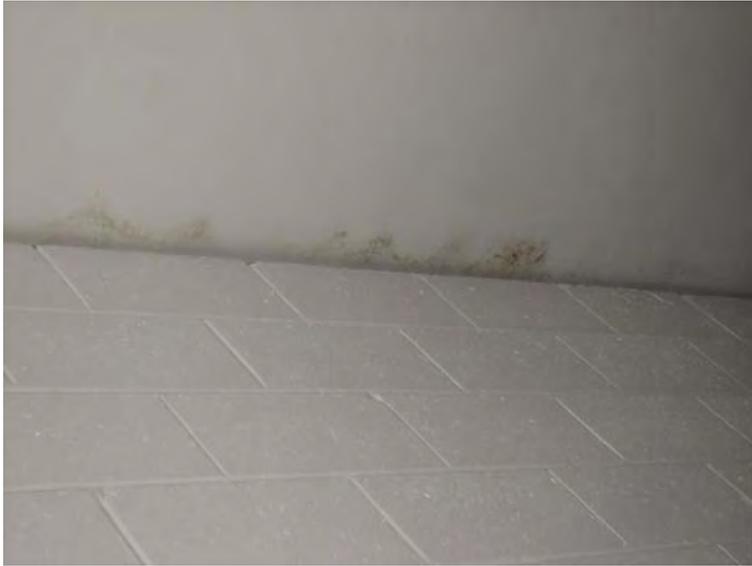
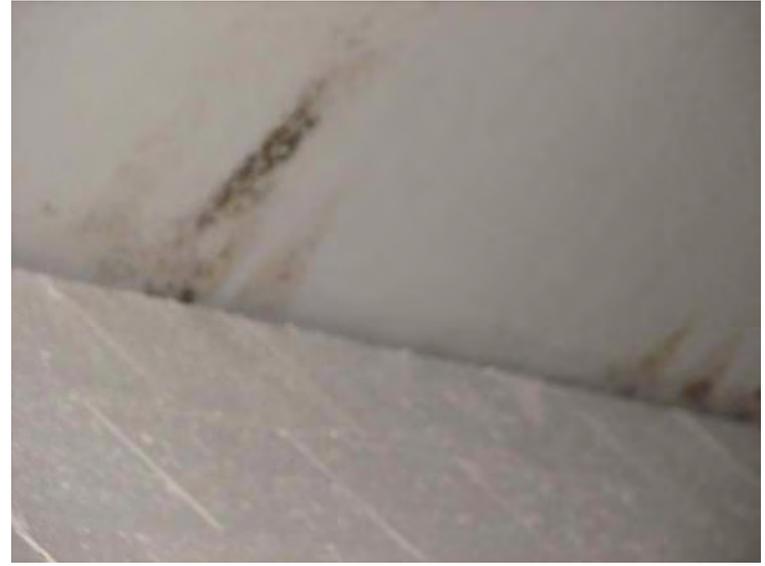
Indications of air transported moisture at transition of roof and wall.

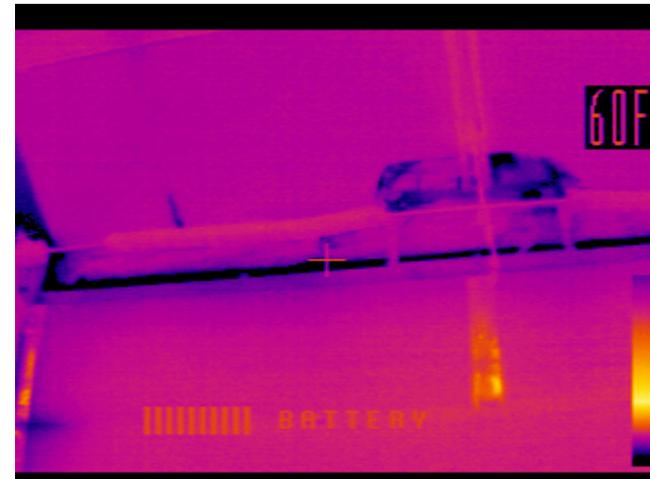
Doors are in fair to good condition and may have an effective value of R6, though large gaps at top, bottom, and sides have a significant impact.

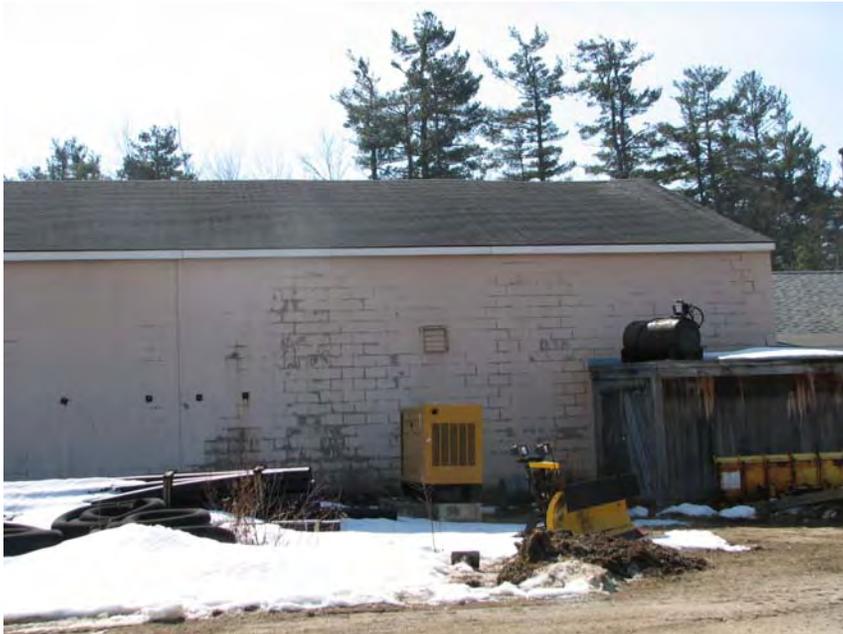
Diesel generator.

Uninsulated walls show
conditioned of paint and wear.

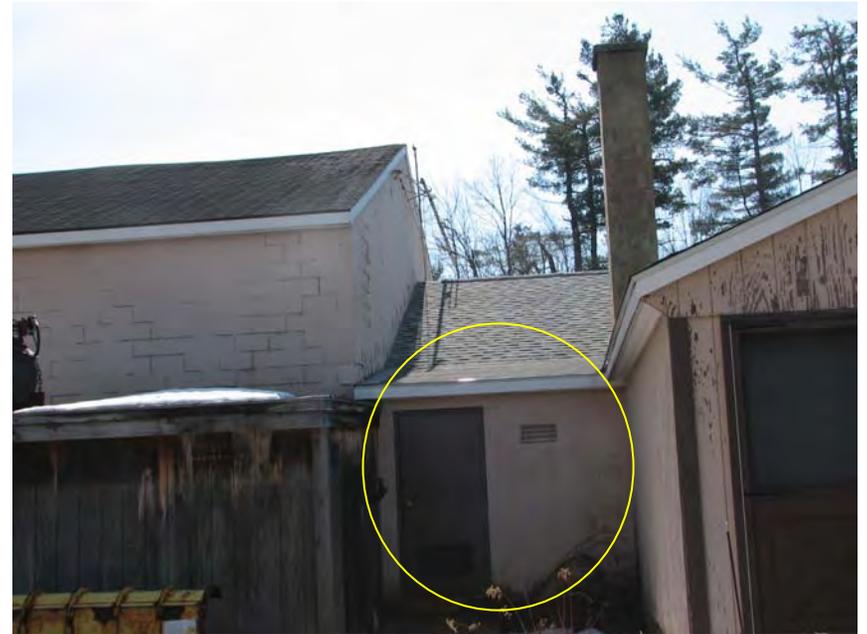
Basically an outdoor boiler room with low shed
roof. Significant heat loss, but at least it melts
the snow off potential collection point.

Cracking and breaking blocks as reported by H.L.Turner, Inc.

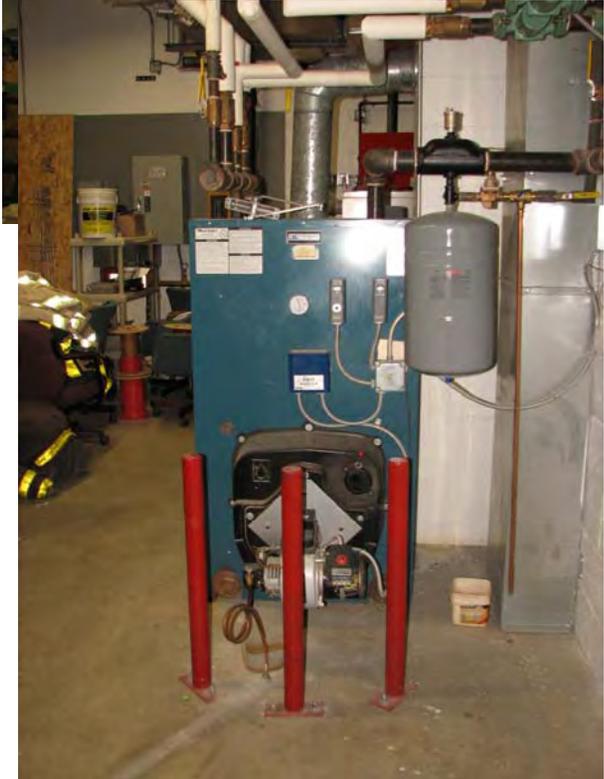
3 zones and water heater

Burnham Oil Boiler installed 8/2000 Gross 483MBH Net 420MBH
4.2 GPH 83%AFUE Carlin Burner 31CD water temps L-170 H-210

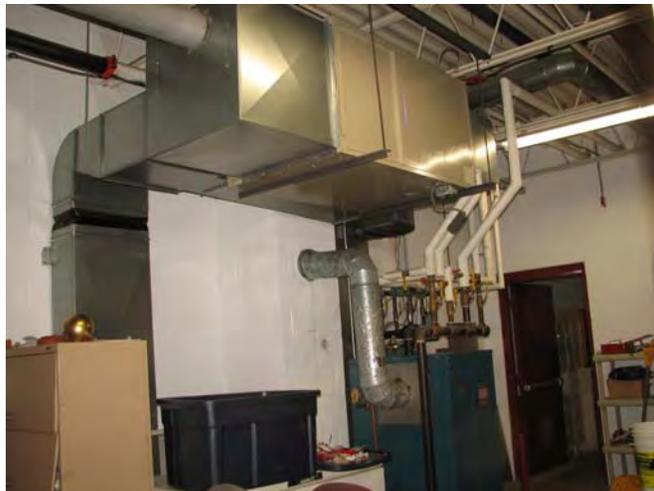
Code compliant Plymovent Vehicle Exhaust

Auto release tail pipe exhaust system great improvement. Still, hot engines also emit a variety of chemically filled fumes and petroleum particles. Building also can have high levels of moisture which is not exhausted through this system.

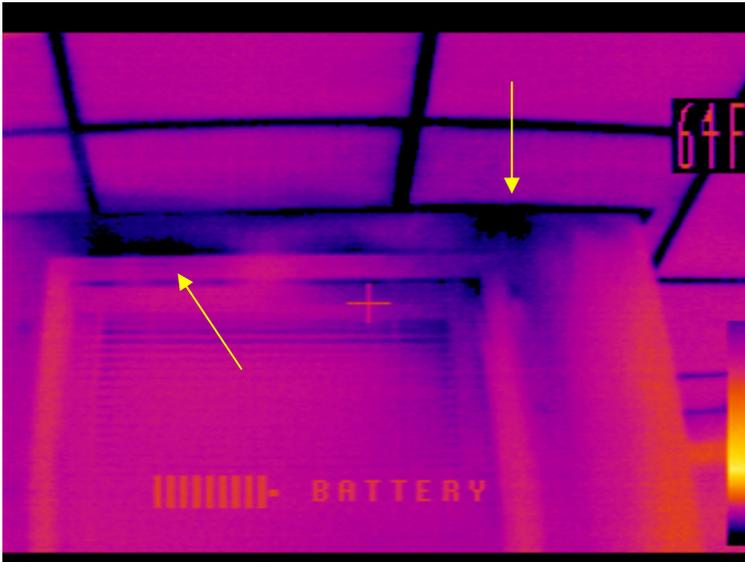
This air leakage is coming from both the attic and the rough window opening. Note the coldest part of the pattern to determine direction.

Air seal to reduce heat loss and the corner will be warmer on its own!

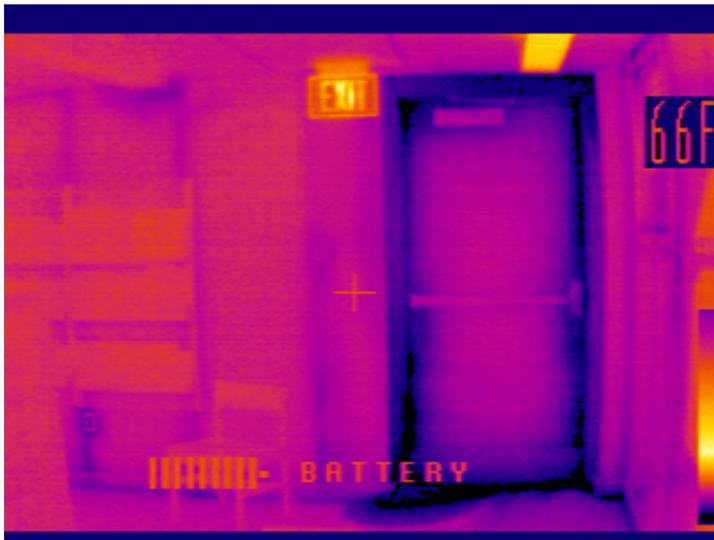
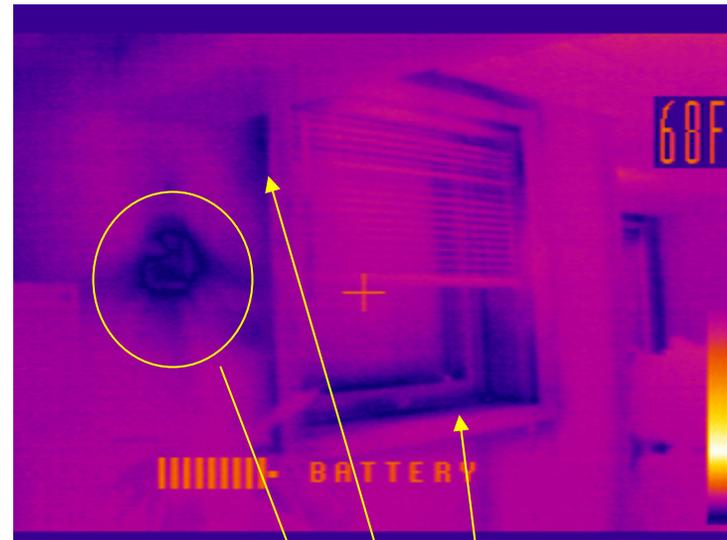
Dark colors indicate colder surface temperatures.

And the reality is, newer buildings are often leakier than many older buildings.

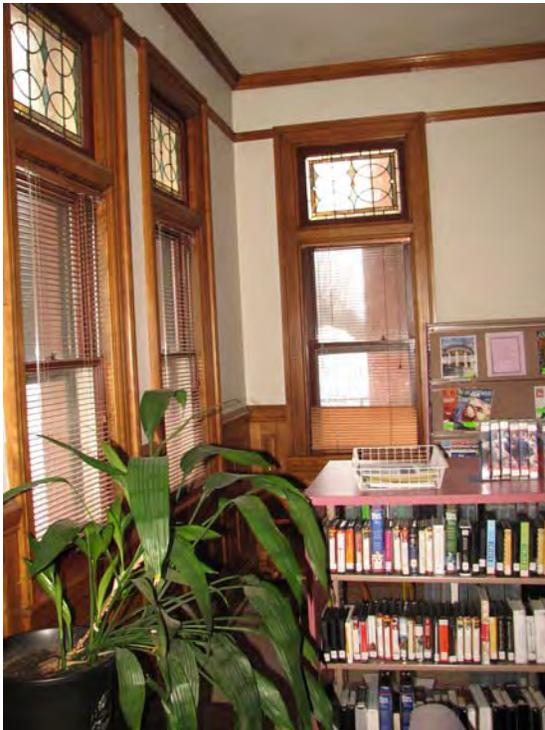
Note the dramatic difference between the fixed panes and the windows, and walls, below. And they add up in surface area as well!

Recommend interior, thermal pane, air sealed, storms on all fixed panes, and to consider removable interior storms for the operable sashes.

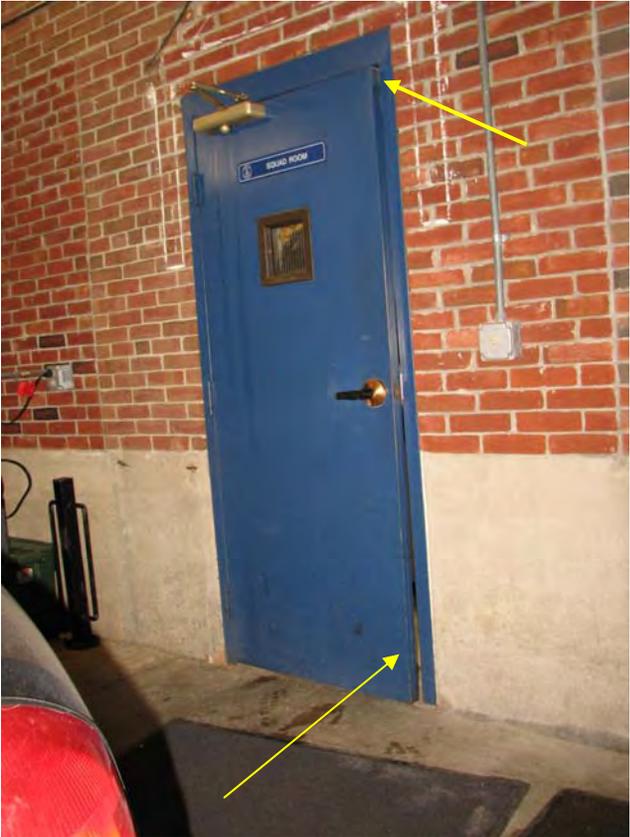
This door is warped beyond repair and is a top candidate for replacement especially as this is a first line of defense against garage fumes entering conditioned occupied space.

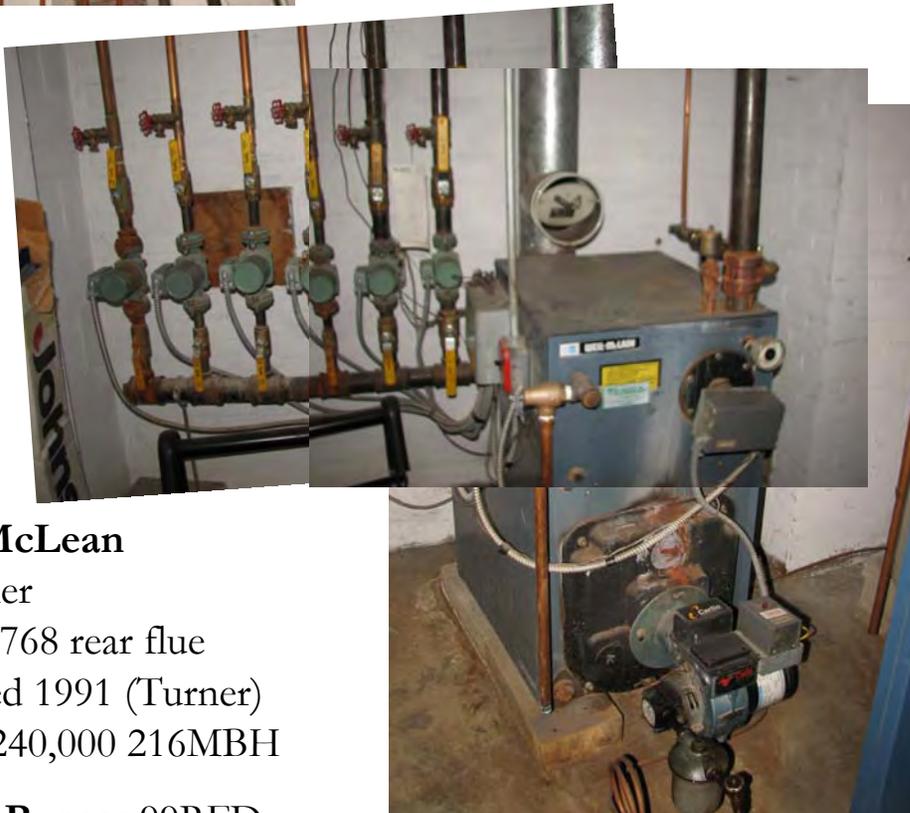
Heating Equipment

Weil McLean
68 Boiler
Model 768 rear flue
Installed 1991 (Turner)
DOE 240,000 216MBH

Carlin Burner 99RFD
150x60B

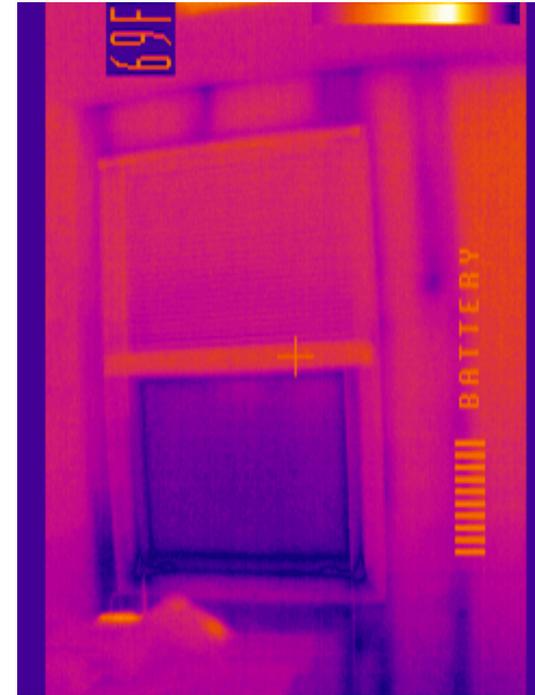
Windows

The only two windows are wood double pane with an estimated R value of 2.1. With the lites in the doors, glazing represents approximately 30 sf and just over 1% of wall surface area. Air leaks in at the corners and behind the trim through the rough opening. An effective caulk and weatherstripping would be a cost effective approach to improving these two windows.

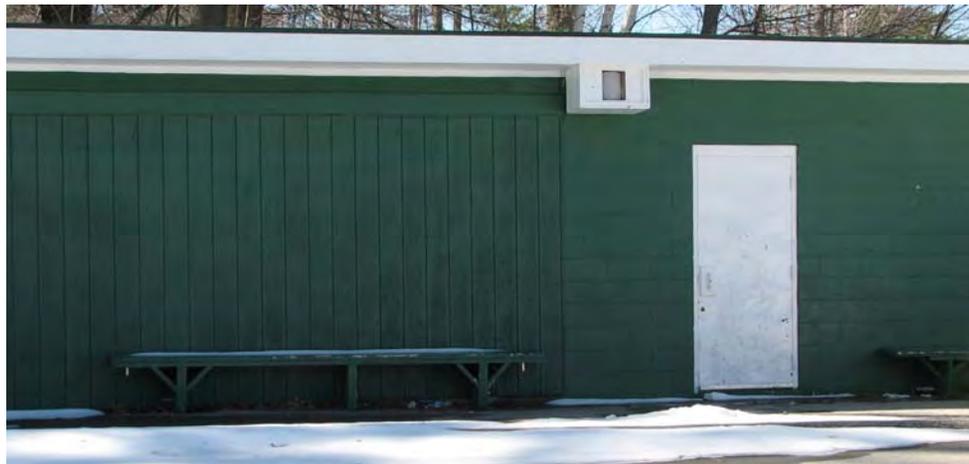
Two sides of the wall have draining capacity, while pavement comes right up to the slab edge on two sides. Best practice would involve breaking up the pavement about 2 feet from the building and installing a perimeter drain near the footing and washed stone. Importantly, it would also allow installing a moisture barrier and insulation at the edge of the slab down to footing if possible. The Tuff N Dri and Warm N Dri system is recommended. A slight paved ramp can be reinstalled at the doors.

Drainage can also be installed along the back if not already present.

Installing drainage, a moisture barrier and insulation is recommended prior to insulating the exterior of the building. While a good thing to do anyway, the expense would not be justified except to protect the insulation board and further insulate the slab.

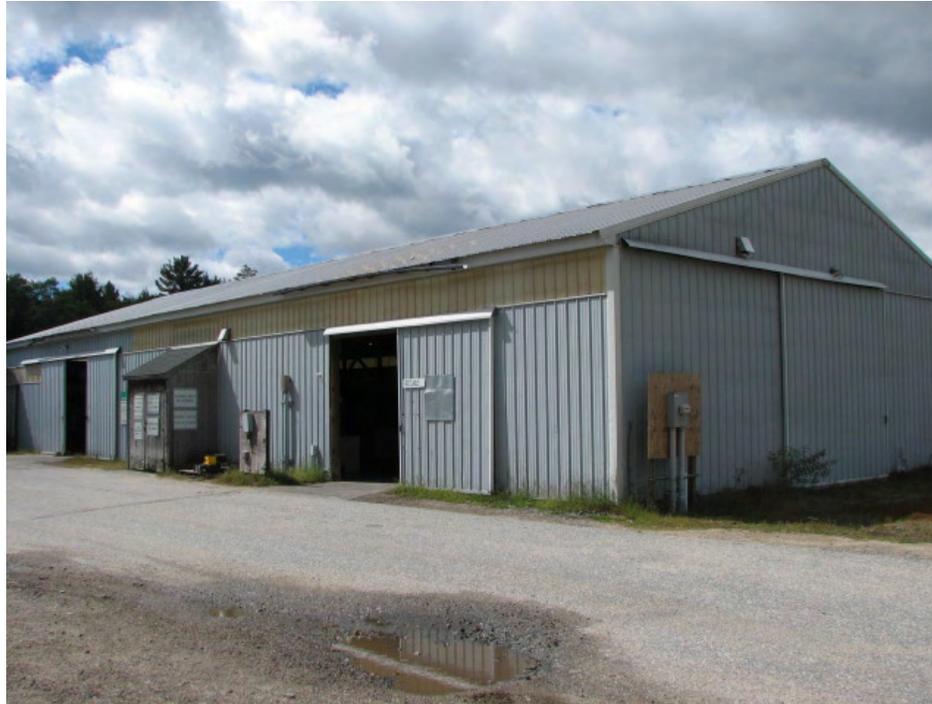
Old Sharon Road

The building is a 1980's, 40' x 100', uninsulated metal building, framed as a 4"x6" pressure treated pole barn, running north/south. The 4" slab was poured with a frost wall. Heat is provided by overhead propane tube heaters.

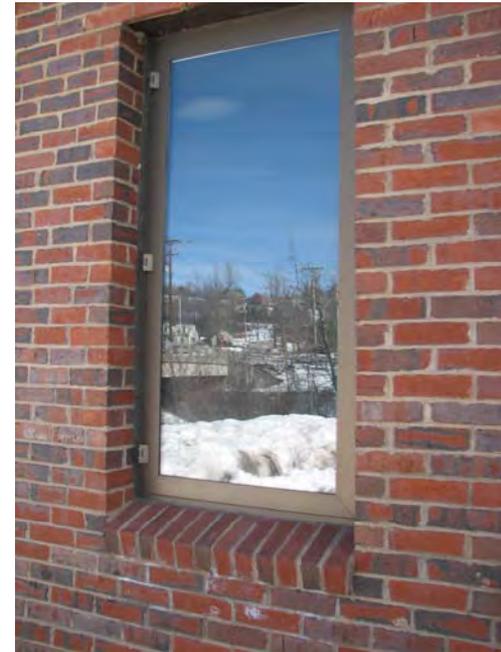
Windows

Window glazing accounts for less than 6% of the entire wall surface area from 6 casement windows and glass entry. The expense of replacement would take a long time to recover. However comprehensive air sealing would be a cost effective improvement.

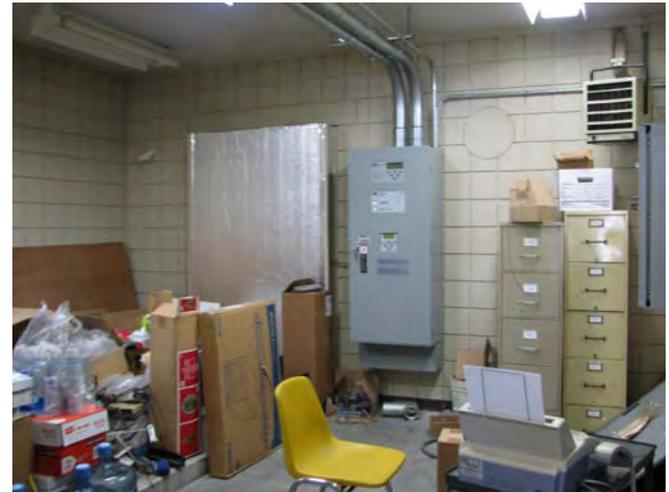
These foam panels were a good choice for covering the large vents previously needed for a generator in this room. However, without being sealed in place, a huge amount of heat is lost (gained).

This attic hatch is left open so that conditioned air can keep pipes located in this attic from freezing. This is perhaps the greatest single source of heat loss in the building. Since IR indicates that there are anomalies throughout the ceiling and that comprehensive air sealing

and insulation will have a significant impact on reducing energy use, sealing and insulating this hatch is an important goal. However, the more effective the ceiling insulation/air barrier – the colder the attic will become and the greater likelihood for freezing pipes! There are four options: 1) Do nothing and waste a lot of energy 2) Re locate the pipes in the attic to directly above the ceiling and encapsulate them at the bottom of the insulation layer 3) Bring all water pipes within conditioned space – ie run along the top of walls to bathroom and lab 4) Redefine the envelope at the roof plane and bring this entire attic into conditioned space.304

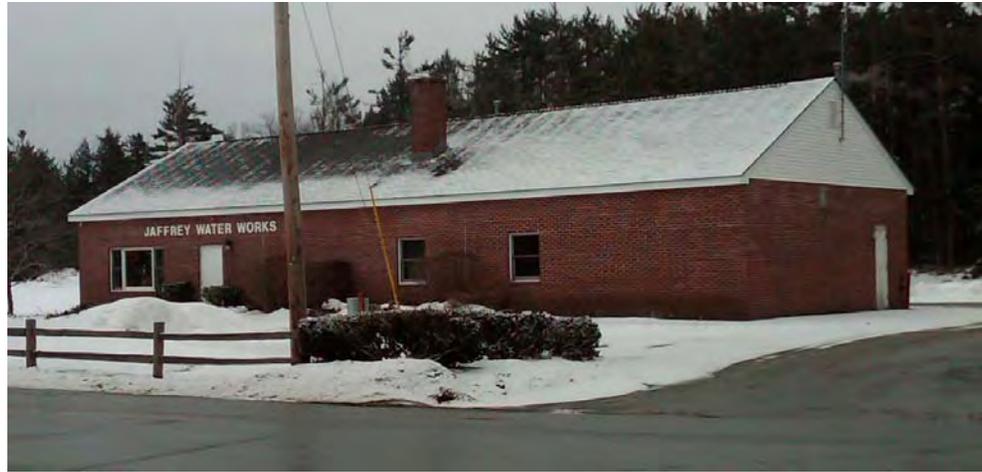
Snow melt patterns on roofs can indicate heat loss. Often, as is the case here, there is some insulation in the attic or ceiling to reduce heat moving to cold, but no air barrier to stop warm air from rising. The area on the left is above a drop ceiling without a continuous air barrier. The roof area to the right is above the garage bays with a drywall ceiling with a few unsealed penetrations. Adding insulation to the attic will often reduce energy use, but often air sealing all the gaps and cracks in the ceiling can save even more and make your insulation more effective!

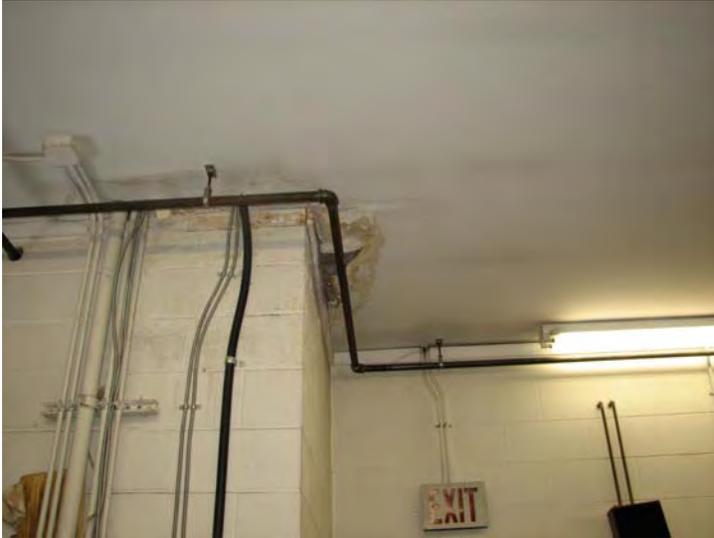
Garage Ceiling

Damage from past water leakage are a constant source of air leakage and heat loss.
