Jaffrey Town Offices Energy Assessment March 2009

Energy Performance Assessment Preface

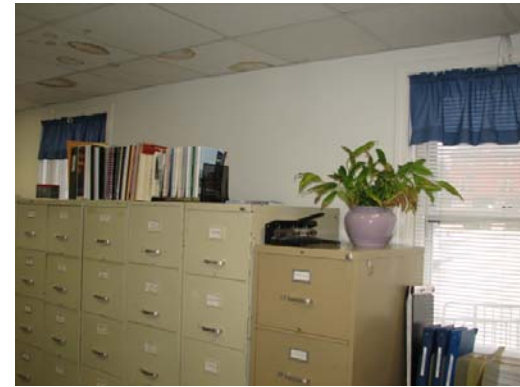
Darker colors – even if faint - depict cooler surface temperatures. Dark straight lines often show location of framing lumber in an insulated wall because wood conducts heat more rapidly than the insulation in the wall cavities – between the studs. In an un-insulated wall, the studs are lighter because the wood resists heat transfer more than the empty – darker - cavities. When a highly conductivity material, such as wood, glass, or steel, is in contact with both the interior and exterior finish surfaces, it is called “thermal bridging”. Corners and top plates can create colder surfaces because of multiple studs and/or air infiltration.

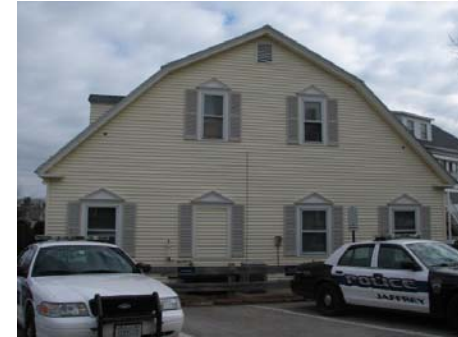
Radiation plays a key role in heat transfer both into and out of a building thorough windows especially. Solar heat gain thorough windows increases cooling costs as heat radiating out windows in the winter (right). Infra red cameras do not always accurately record glass temperatures or other reflective surfaces, due to properties of emmisvity, but can give a good sense of warmer – or colder surface temps.

Of special note is the heat loss from the attic vent. This photo was taken early morning on a cloudy day, before solar radiation had impacted the attic temperature. The heat depicted in the vent is almost entirely from conditioned space or heating ducts below.

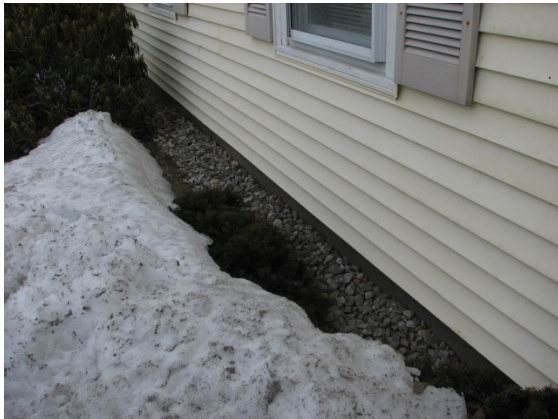
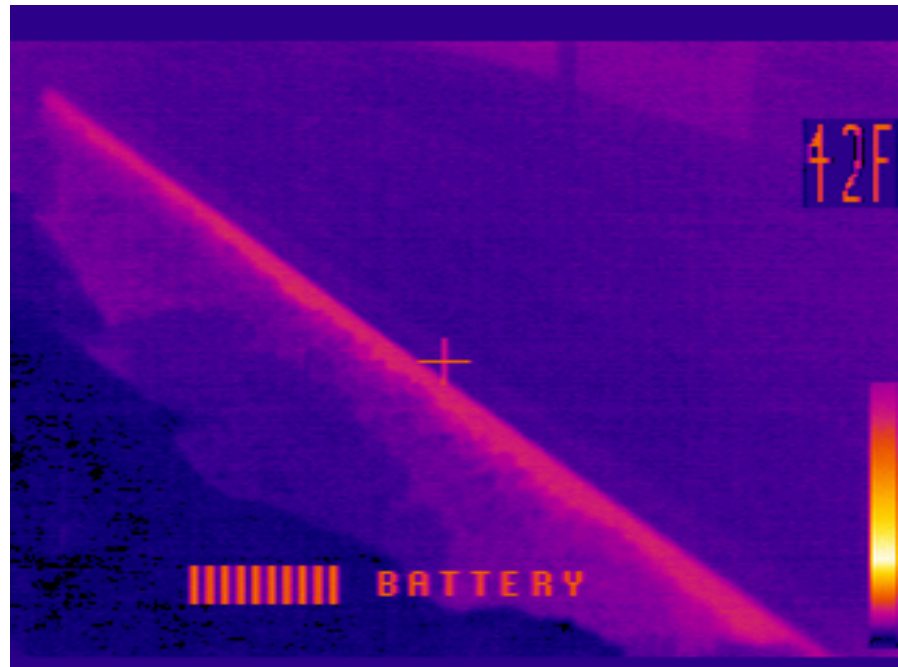
Slab Foundation – Uninsulated

Now required by code, heat losses through uninsulated slabs and foundation can be substantial. A deep energy retrofit scope would include accessing this slab edge and installing rigid insulation appropriate for exterior, below grade applications.

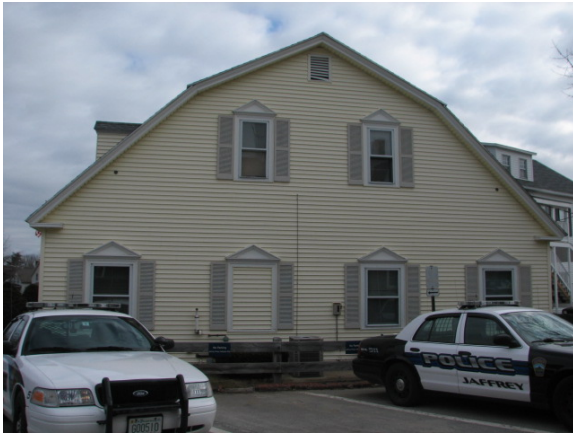
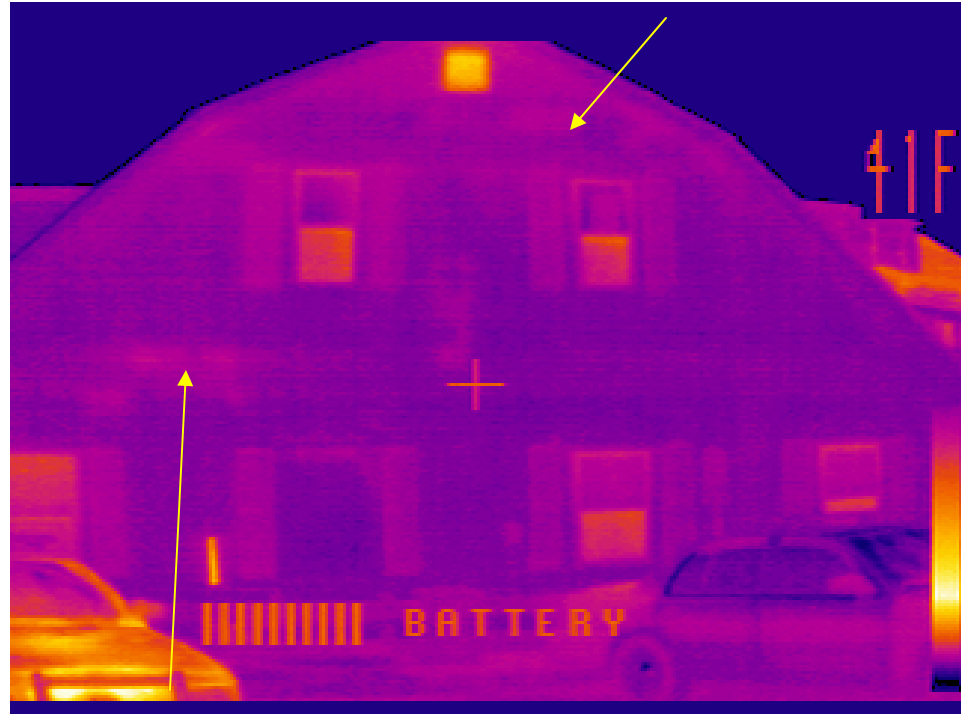
Walls

Structure includes some post and beam with 2x4 walls. Approx 70-80% cavities have 3 1/2" fiberglass batts – remaining cavities are either uninsulated or fiberglass is so compromised as to be less effective than intended.

Area between floors with heating ducts and one of the air handlers is especially lacking, as is above the ceiling on the 2nd floor, though very difficult to access. Equally or more important to gaps in insulation is the lack of an effective and continuous air barrier. Ice dams are more often caused by warm air rising which is the case in this building as indicated by the image above.

1. Remove all fiberglass on exterior wall in chase between 1st and 2nd floor. Spray 2 part 2” urethane foam in cavities and over wall studs to create a continuous air, moisture and thermal barrier and cover with intumescent paint for 1 hour flame rating. Effective R12 cont Est Cost \$2800

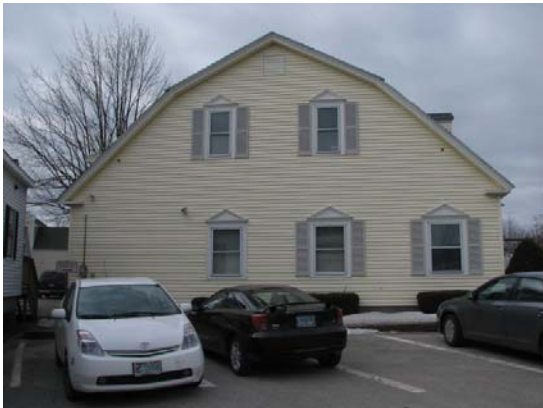
Similar patterns on opposite end.

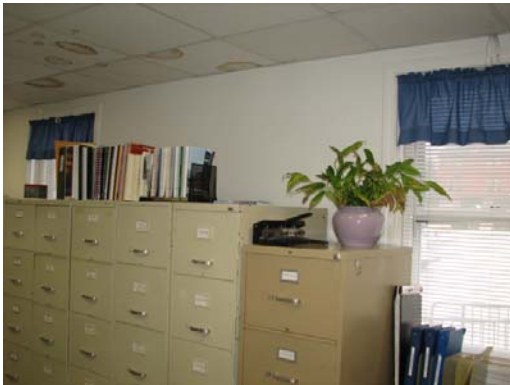
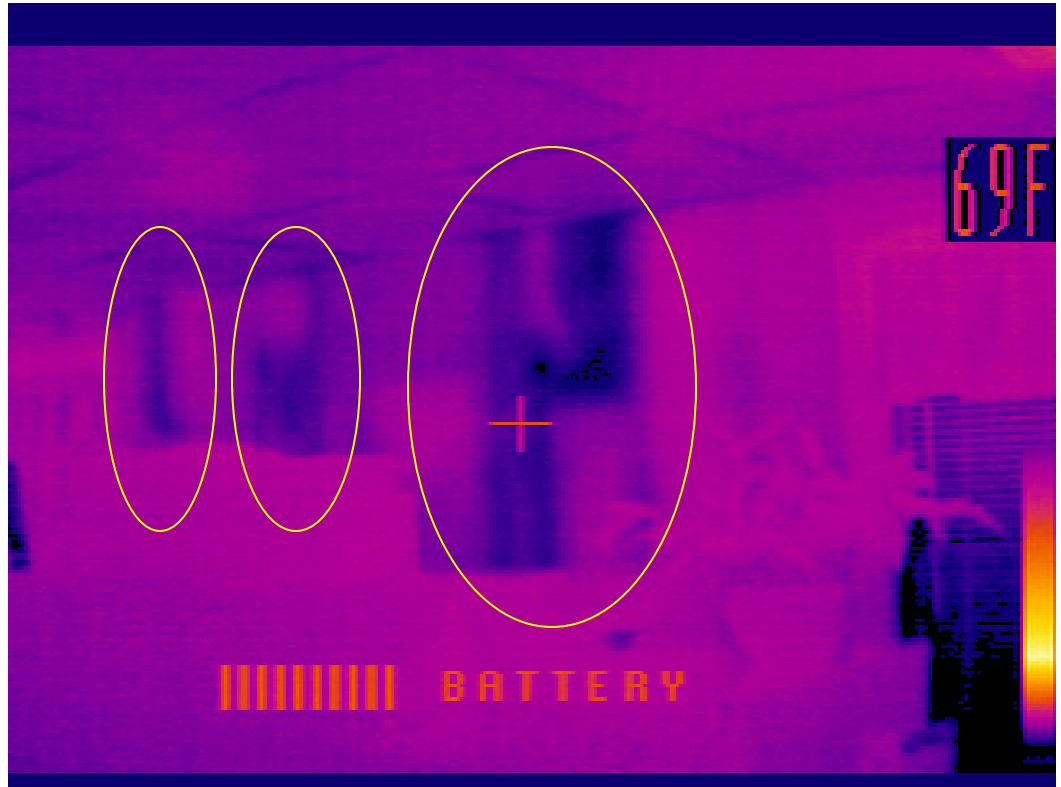
Cavities without insulation.

4. Spot fill wall voids over 1 ft2. Est Cost: \$350
5. Replace window units with quality wood/alum clad max U.33 and max SHGC .4.. Est cost: \$14,250

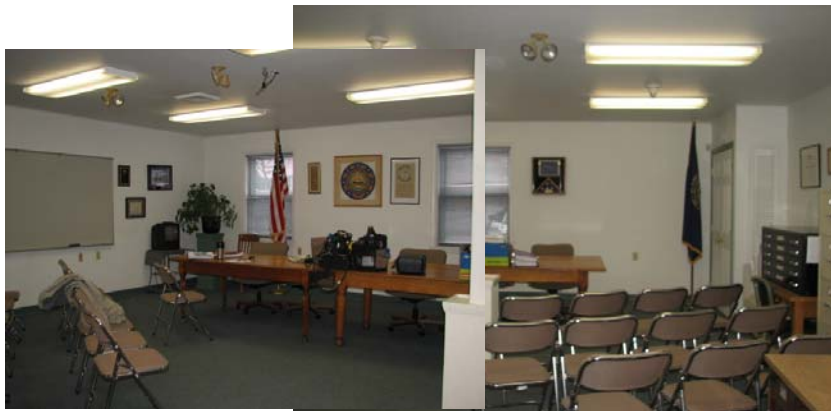
Rivco windows do not fit tightly and are a substantial portion of overall air infiltration.

However these windows may be the exception to the rule. They are especially low performers; and many do not close completely nor not fit the rough openings well which would require such heroic air sealing efforts that full unit replacement with high quality windows is advised.

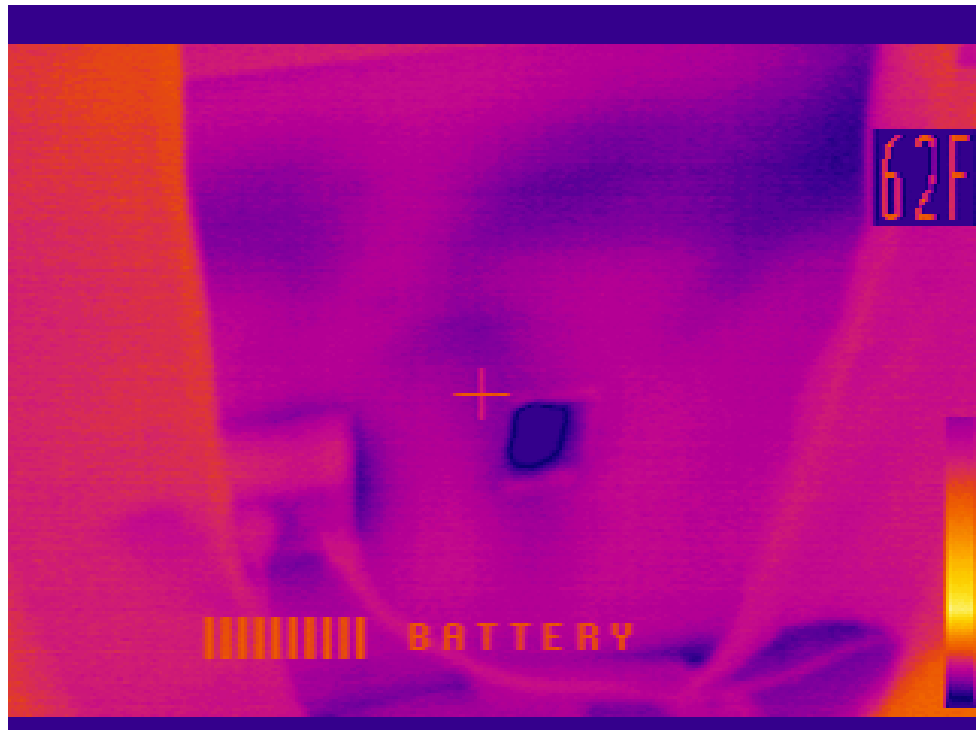
The ceiling chase between 1st and 2nd floors. Missing insulation, air barrier and leaky heating ducts.

Further, any duct work or heating delivery systems should be air sealed with mastic and insulated to R6 and included within the thermal envelope. Est. cost: 750.00.

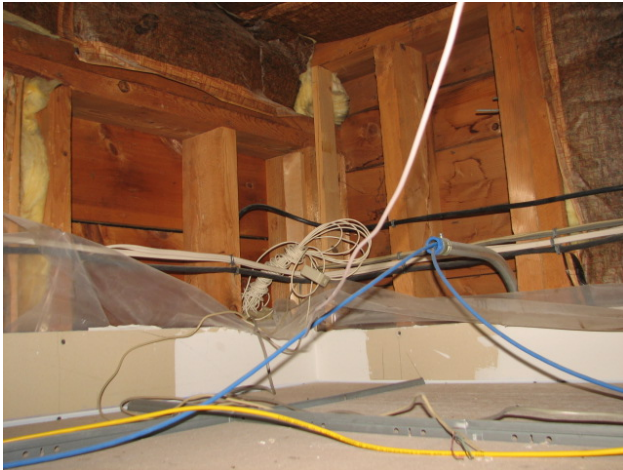
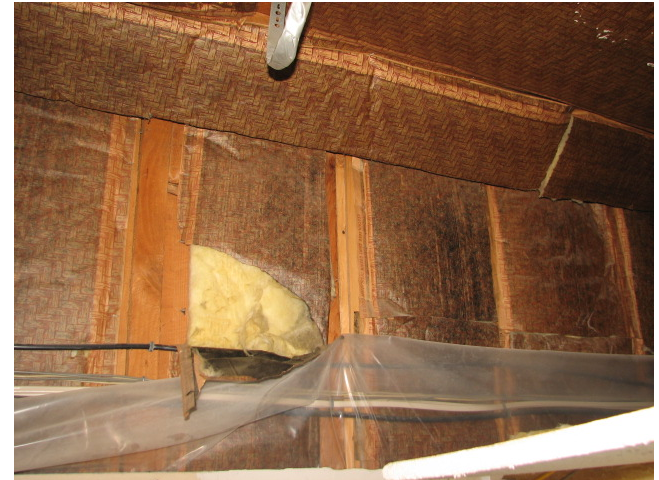
Chase above 2nd floor lacks air barrier and insulation levels vary. Significant amount of air blown fiberglass particles in air even without HVAC system on. Ducts located above and outside the thermal envelope are a source of considerable heat loss.

2. Gut existing fiberglass insulation above second floor. Several options exist but all of them labor intensive as there is a jungle of wires, pipes and ducts in a narrow area. Several options were suggested by HL Turner Group. It is recommended that a rigid air barrier be established in direct contact with an effective thermal barrier and that the enclosure control layers be moved to the roof slopes – ie air, moisture and insulation layers be located at the roof slopes with insulation on the interior and exterior. Strap the 2x6’s with 2x’s for a cavity depth of 7” , cover with 1” XPS and dense pack cellulose for an interior R-30. End walls will also need to be strapped and filled and gable vents sealed. The goal is a cold, unvented roof assembly. Est cost: for new installations: \$7,500 ROUGH guess at gutting and wire management: \$3500. (Note: engineering concerns around snow loads still need to be explored – or consider Tier 2 upgrade)

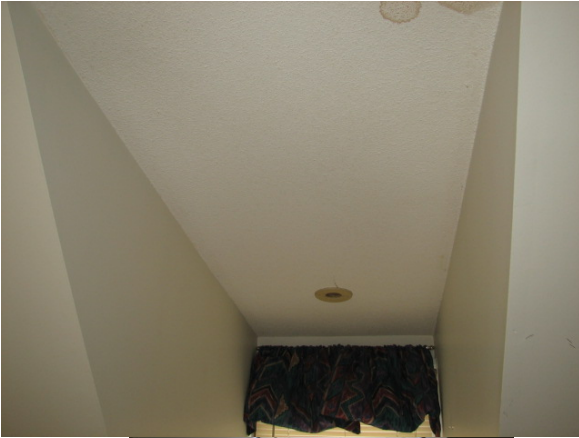
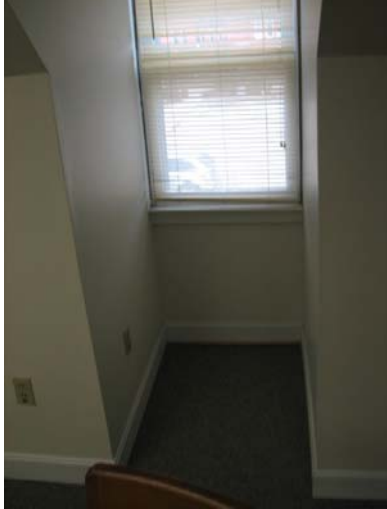
Significant gaps in both air and thermal barriers – which also results in deficiencies in moisture management.

3. Remove fiberglass behind all knee wall areas and accessible slopes. Install 2” thermax on slopes and dense pack cellulose behind. R28 cont Est Cost: \$3200

For either option, I recommend yanking out slope and end wall fiberglass and using either spray foam or dense pack cellulose in the slopes and covering with 2" thermax but only for Option A. Creates an effective air and moisture barrier and far superior thermal barrier.

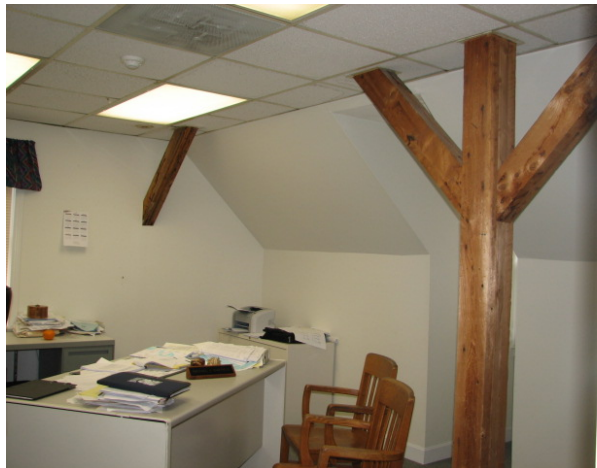
Warm air rising and pressure dynamics

Evidence of “warm air rising”. However, air sealing at both top and bottom of a building reduces this kind of distribution pattern – as will proper balancing of supply and return air. High performance buildings with effective and continuous thermal and pressure barriers do not experience significant temperature differences between floors on low rise buildings. For even greater comfort, zonal distribution, and energy efficiency, installing hydronic system with wall panel radiators is recommended.

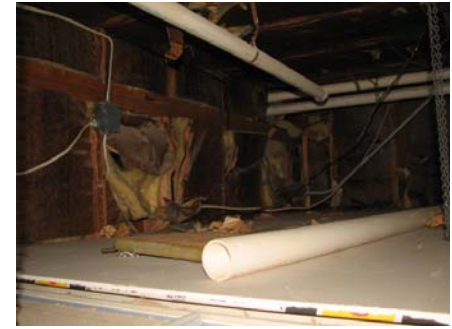
1st floor ceiling above vault.. Location not known to employees.

Emergency disconnect above ceiling tile, also unknown.

Employees complained of often being cold.

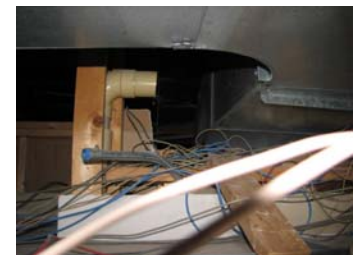
Insulated flex ducts are crimped in some places; duct tape

Used for air sealing – has dried and peeled back in places. Mastic recommended for all sealing all joints in ducts.
