**FACILITY ASSESSMENTS
MUNICIPAL BUILDINGS
PHASE I**

JAFFREY, NEW HAMPSHIRE

SEPTEMBER 2008

THE H.L. TURNER GROUP Inc.

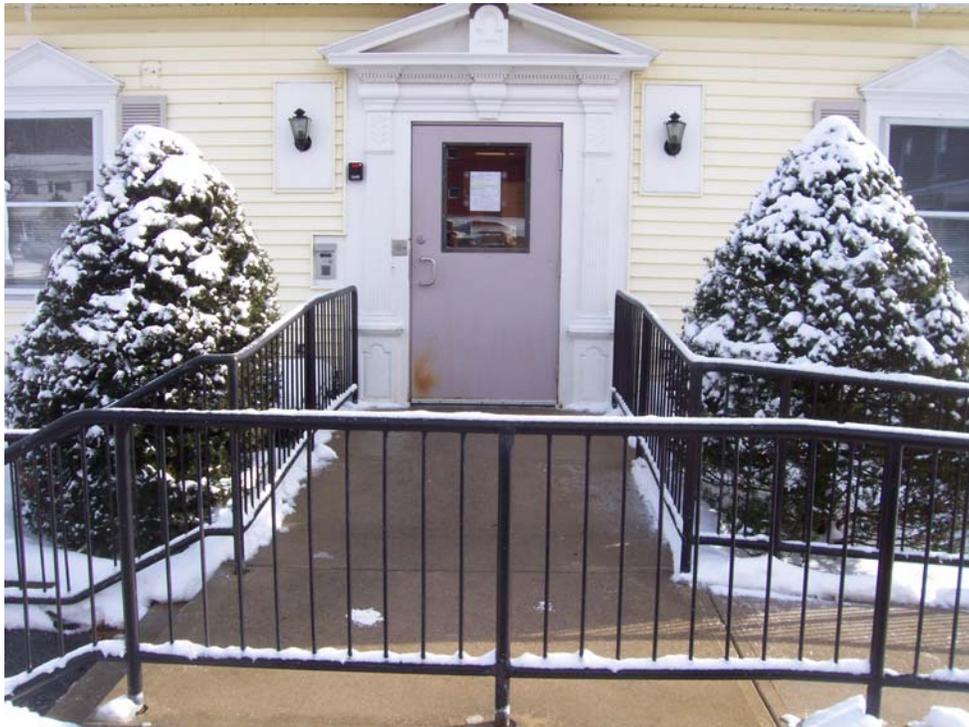
Town Offices Main Entry on the West Side

2. The small roof over the front door leaks, as evidenced by the water stains on the ceiling in the air lock. This may be a flashing problem, and should be addressed sooner than later.

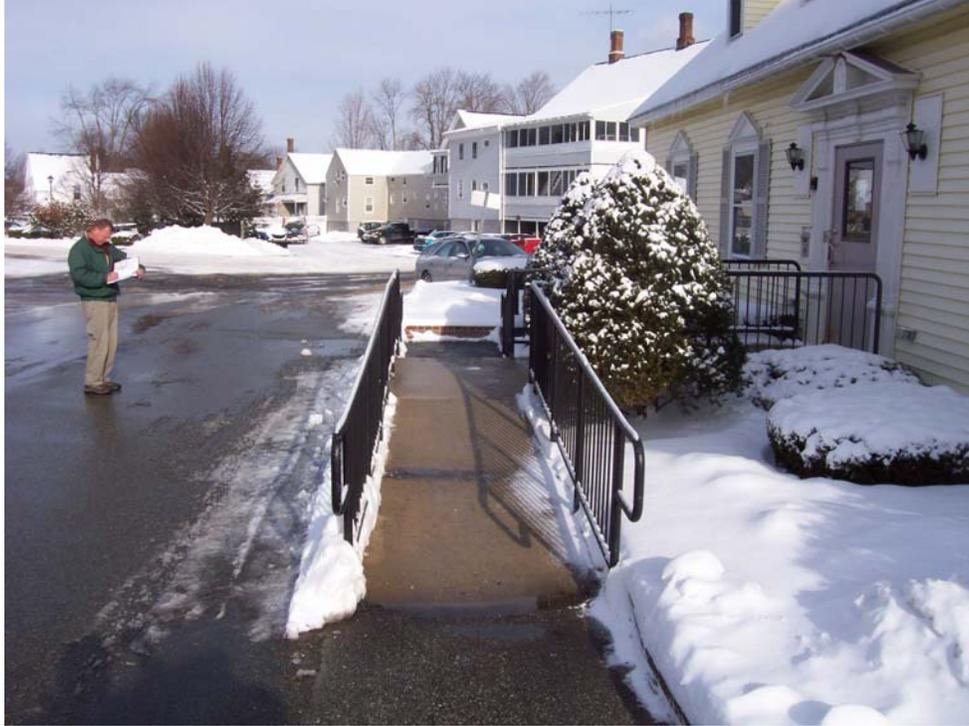
The main entrance into the building was altered in 1994 to meet ADA requirements. There is a ramp and stair set that leads to the front door with railing on each side. We measured the ramp width, clearances, and the clearance in front of the door and found that the present configuration does meet the minimum requirements of ADA. However, the front door into the building is not fitted with an automatic opener. The area in front of the door could be widened to allow better access for the general public.

Ramp at Main Entry to Town Office Building

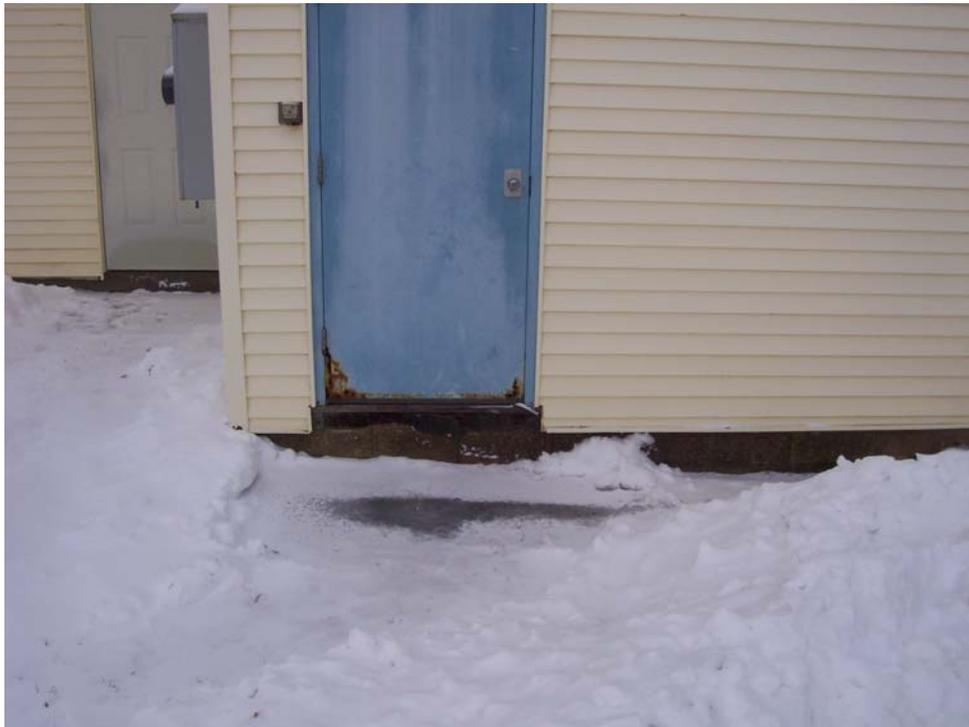
The exterior of the building is covered with vinyl siding. With the exception of several areas along the rear of the building, the siding is in good condition. The roof is a Gambrel-style roof covered with asphalt shingles. The shingles are in fair to good condition, and should not require replacement for another 8 to 10 years. Most of the windows are double-hung wood windows fitted with aluminum storm windows. The windows are in poor condition. Some are loose fitting and drafty, while others are tight and inoperable. Most of the building occupants have complained about the windows during the winter months as a source of cold air intrusion into the building. There is a large picture window at the second level along the rear or east side of the building. The seal has failed between the panes of glass, and the window should be replaced. The main door at the front of the building and the rear doors are metal clad. The metal has started to show signs of rust. On the main door, there are signs of rust bleeding through the paint. The door that accesses the rear storage area, however, is severely rusted along the bottom and is in need of replacement.

Rusted Door at the Rear of the Building

4. The building has a main door at the front and two doors at the rear. One of the rear doors provides an exit from the main conference room, while the second door provides access and egress from the storage/Electrical Room. All doors are steel clad doors with steel frames. All are showing signs of rust, but the door into the storage room is badly deteriorated along the bottom and is in need of replacement.

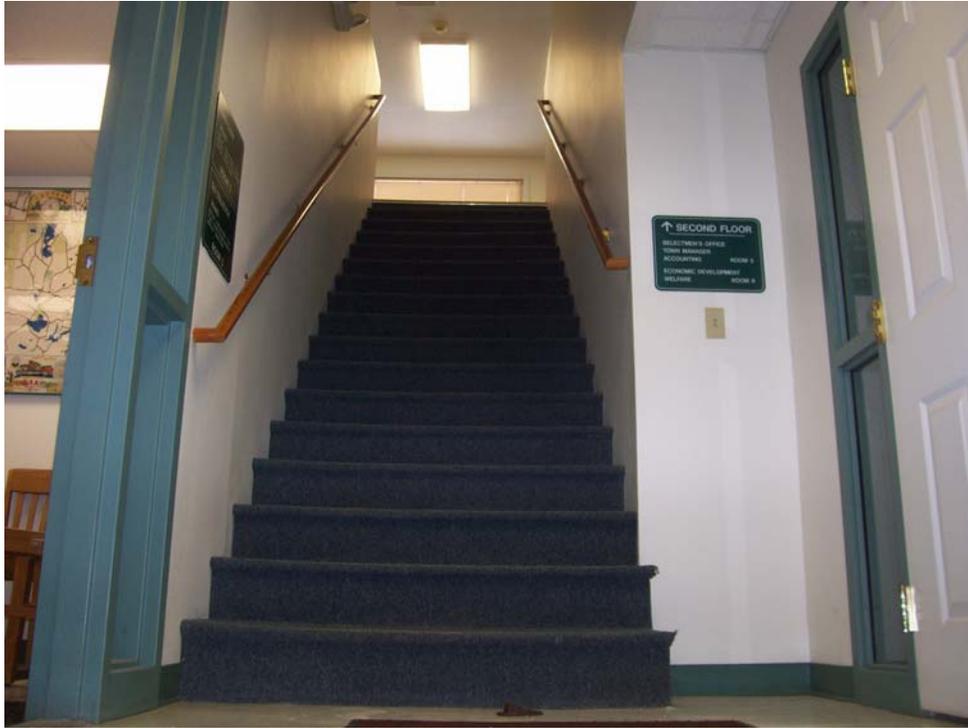
carpeted. The carpeting on the stairs is worn. However, all other carpeted areas are in good condition. Finishes throughout the building are in fair to good condition.

Main Stairway to the Second Floor

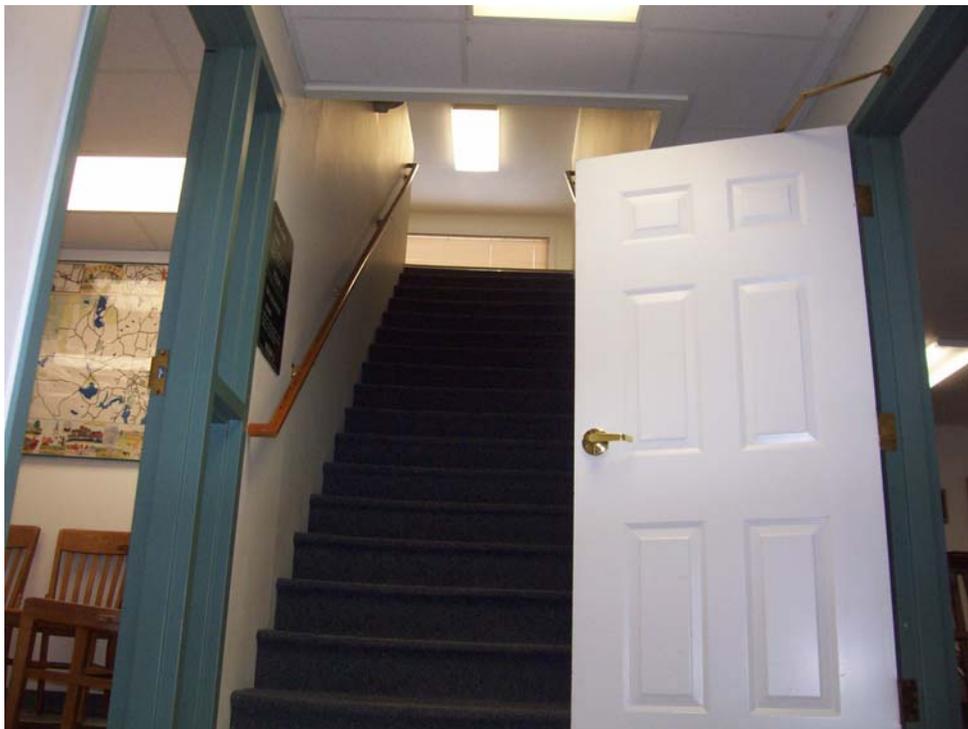
Conference Room Door Open into Main Stairway

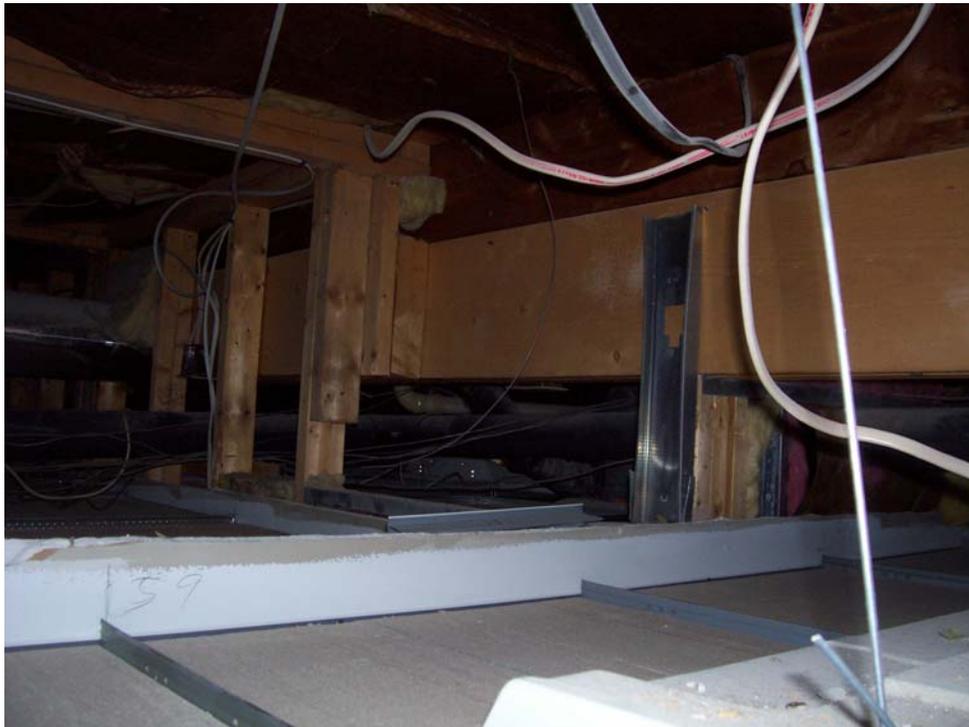
Structurally, the building is in fairly good condition, with the exception of the second floor on the north side of the building in the area of the upstairs meeting room. There is a pronounced sag in the floor near the middle of the building. It is our understanding that the floor was heavily loaded at one time with file cabinets that have since been relocated. However, the sag remains. We investigated the framing below, and found a main carrying beam fabricated from three (3) 2 x 8's in the area of concern. Based on the span, calculations show that the beam is considerably overstressed for normal office loads.

Second Floor Framing at Sagging Floor

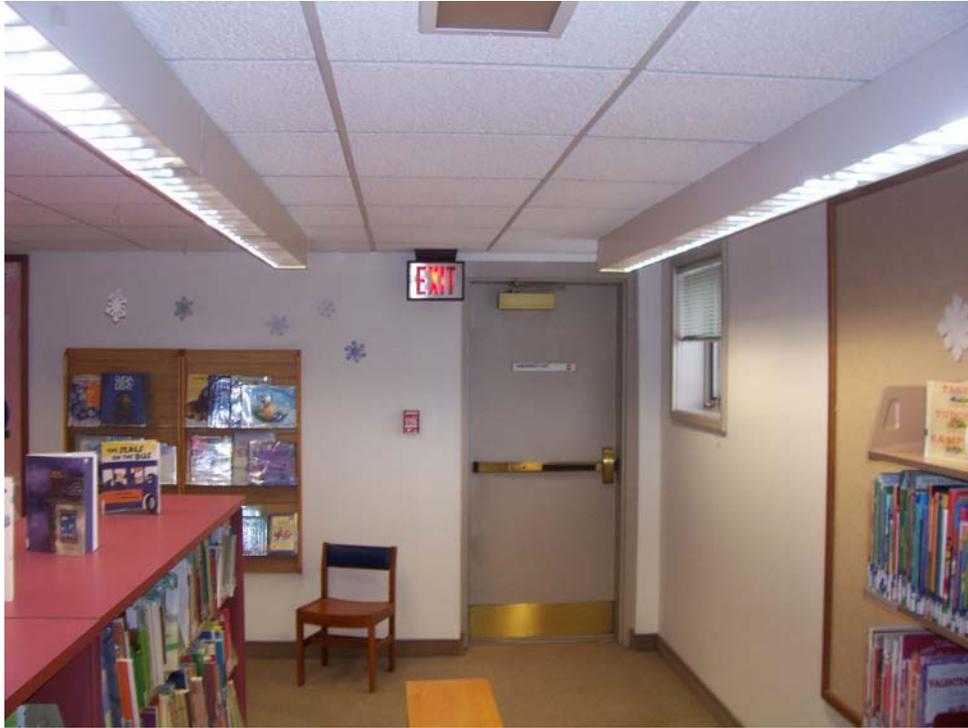
Damaged Drywall near Lower Level Entry Door
Library Addition

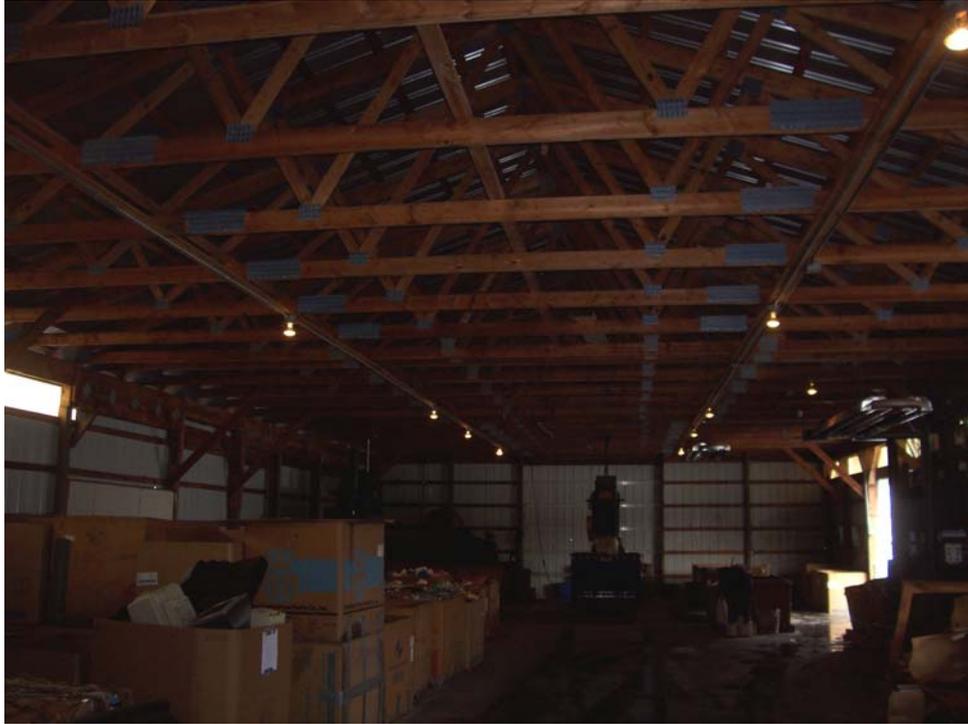
The construction consists of a 4-inch thick concrete slab-on-grade for the main floor with a frost wall and footing all around the perimeter. The walls are framed with 4" x 6" pressure-treated timber columns at about 8-feet on-center. The walls are vertical steel siding panels supported by horizontal girts at 24-inches on-center. The roof framing is a series of prefabricated wooden trusses that span 40-feet across the width of the building. The low slope, aluminum roofing panels are supported by 2 x 4 purlins that are fastened to the roof trusses at 24-inches on-center. Discussions with the recycling center staff revealed that there are a number of leaks in various sections of the roof. Apparently, the fasteners that hold the metal roofing in place have worked loose mainly due to repeated cycles of expansion and contraction. This is a sign that the roof may be nearing the end of its useful life and may need replacement in the next 3 to 5 years. There are some coatings on the market that are designed to waterproof and stop UV degradation and corrosion. For example, there is an acrylic, elastomeric, water-based, rubber-like coating system that remains flexible under hot and cold conditions. Such a coating could provide a temporary solution and prolong the roof replacement for several more years.

Recycling Center Wood Truss Roof Framing

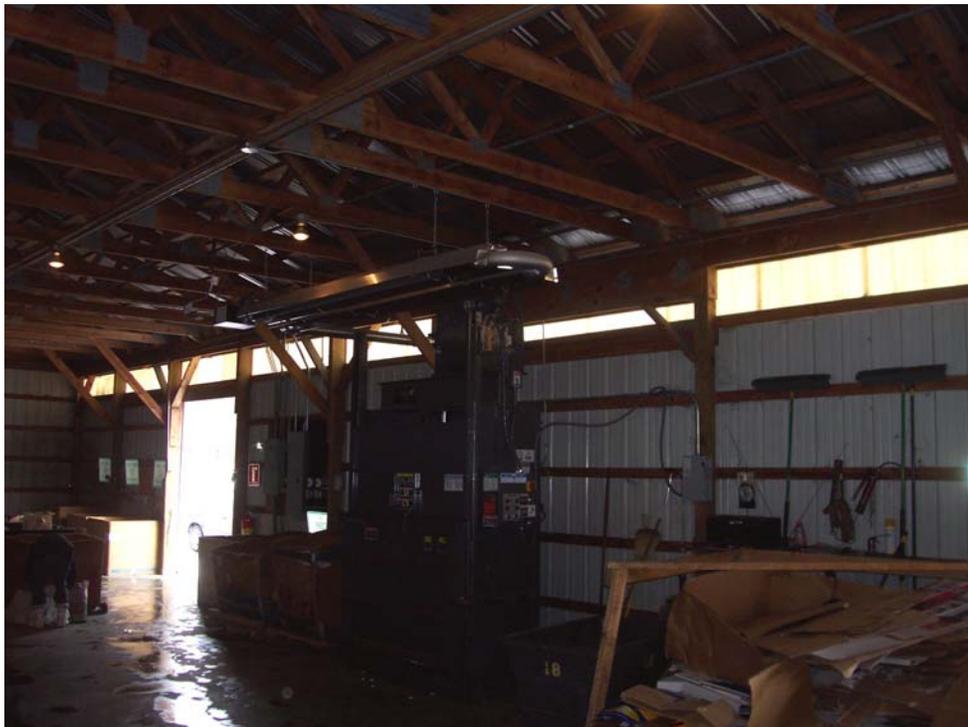
There is no insulation in the building, with the exception of the bathroom. The designated work areas used for processing materials are heated with overhead, propane-fired, direct heaters. The heaters are in very good conditions. There has been some discussion in the past with regard to insulating the roof of the building in an attempt to slow heat loss and thereby reduce energy costs. The roofing system was originally designed for a snow load of 40 pounds per square-foot. The caveat in adding insulation is that for a low slope roof, it could result in additional snow on the roof, which could overstress the existing structure. However, the roofing is aluminum, and generally most of the snow slides off the roof.

Recycling Center Typical Roof and Wall Framing

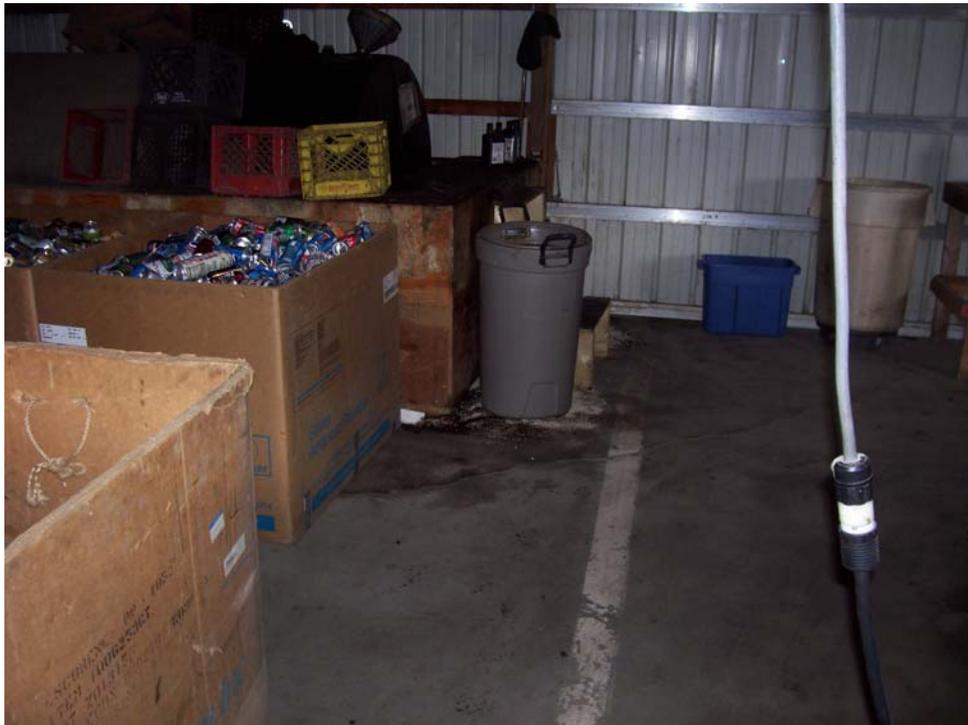
Within the building, located in the northwest corner, is a steel tank used for collecting old motor oil. The containment structure around the oil tank is constructed of wood walls, and the containment structure appears to be leaking oil out onto the floor. This should be remedied as soon as possible.

Storage Container for Used Motor Oil

1. Improve the containment around the used oil storage tank. The present containment is constructed of plywood and it leaks.
2. Investigate the feasibility of adding roof and wall insulation.
3. Apply a coating to the roof to prolong the life of the metal and seal the existing leaks. Budget for roof replacement in the next 5 to 7 years.
4. Consider connecting the Recycling Center to Town Sewage and add a line to bring Town Water to the site.
5. Add a second loading dock for handling recyclable product.
6. Replace the inefficient incandescent lamps with energy saving fluorescent fixtures.

ARCHITECTURAL			\$ Opinion of Cost			
COMPONENT	OBSERVATION	RECOMMENDATION	<i>Remaining Useful Life</i>	Short-Term	Mid-Term	Long-Term
Used Oil Containment	Present containment is plywood and appears to be leaking.	Improve containment around tank.	0 Years	\$2,500		
Metal Roof	Fasteners working loose, numerous leaks	Apply elastomeric coating to roof	1 year	\$5,000		
		Replace roof	5 to 7 years		\$32,000	
Building Insulation	There is a lack of building insulation.	Investigate the feasibility of adding roof and/or wall insulation both structurally and from an energy savings standpoint.	N/A	\$4,000		
Water and Sewage	Currently, there is no water or sewage at the site.	Consider installing a connection to Town sewage and a line for Town water.	5 years		\$100,000	
Loading Dock for Box Trailers	Currently there is a single loading dock for loading trailers with recyclables.	Consider the addition of adding a second loading dock.	2 to 3 years	\$30,000
