# **FACILITY ASSESSMENTS MUNICIPAL BUILDINGS PHASE I**

**JAFFREY, NEW HAMPSHIRE**

**SEPTEMBER 2008**

**THE H.L. TURNER GROUP Inc.**

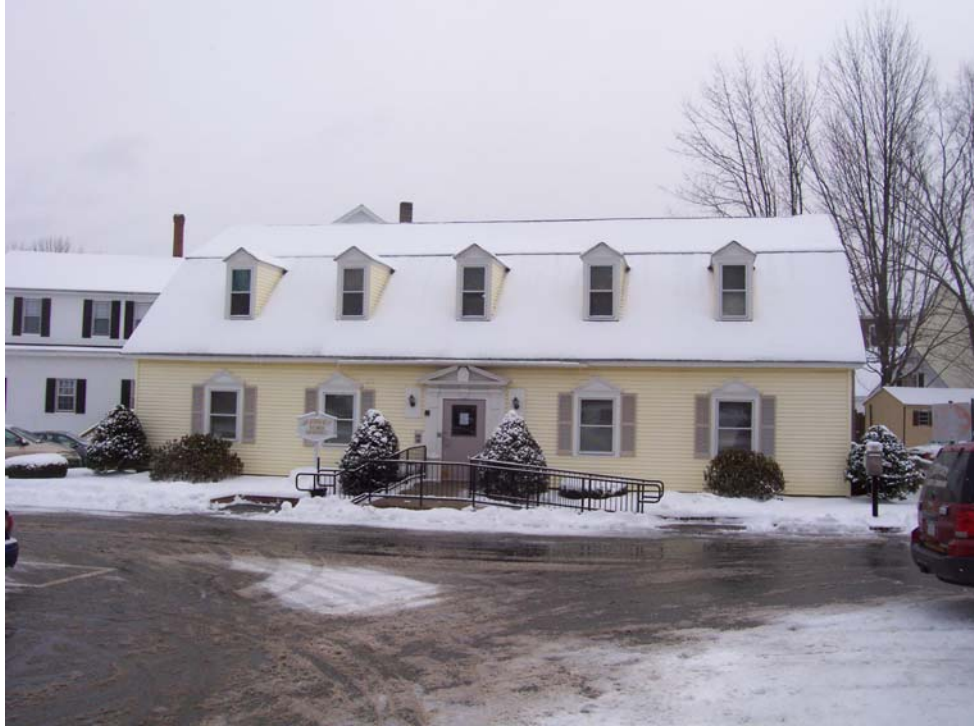
West Elevation – Town Office Building Main Entrance

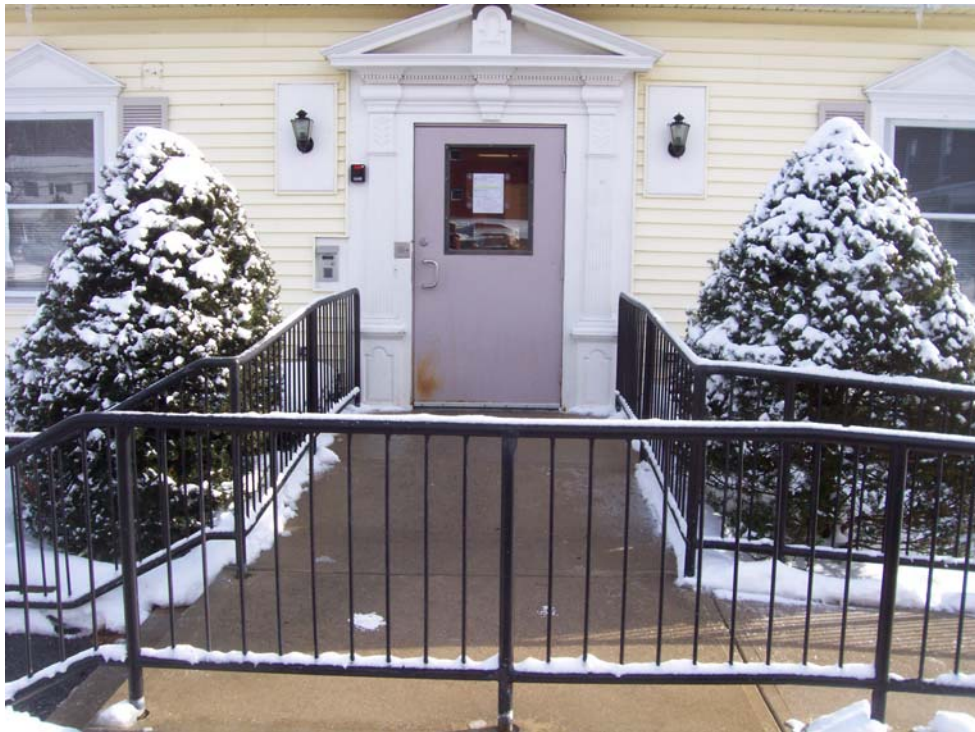
Town Offices Main Entry on the West Side

2. The small roof over the front door leaks, as evidenced by the water stains on the ceiling in the air lock. This may be a flashing problem, and should be addressed sooner than later.

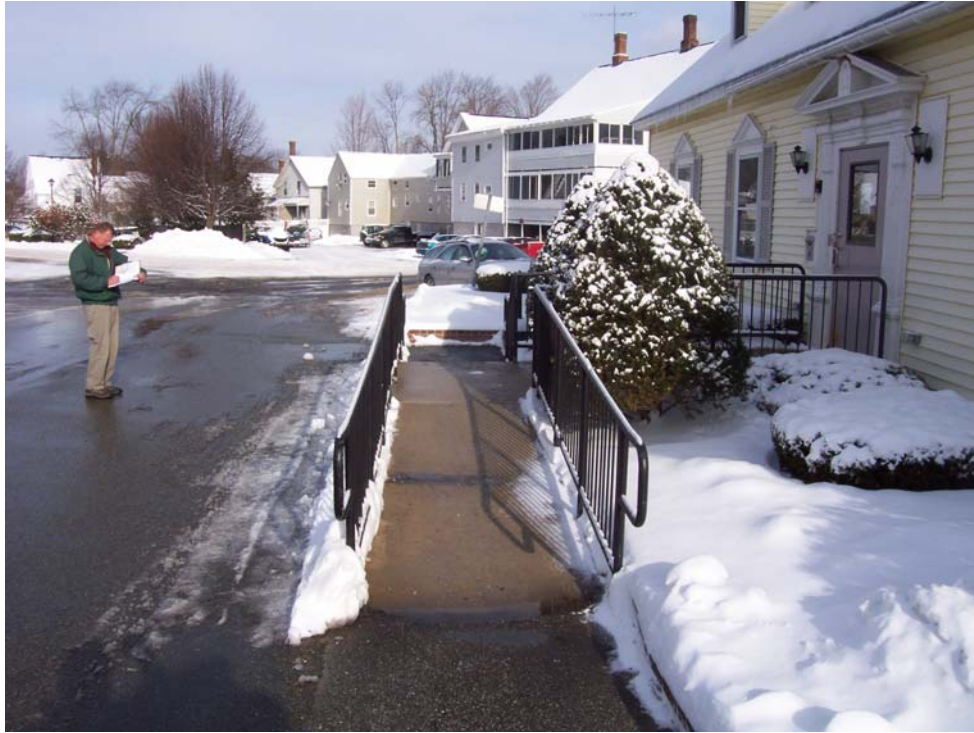
The main entrance into the building was altered in 1994 to meet ADA requirements. There is a ramp and stair set that leads to the front door with railing on each side. We measured the ramp width, clearances, and the clearance in front of the door and found that the present configuration does meet the minimum requirements of ADA. However, the front door into the building is not fitted with an automatic opener. The area in front of the door could be widened to allow better access for the general public.

Ramp at Main Entry to Town Office Building

7. Although the front entrance walkway and entry doors meet the minimal requirements of ADA, an automatic door opener is lacking. When the front door is replaced the automatic opener can be added at that time.

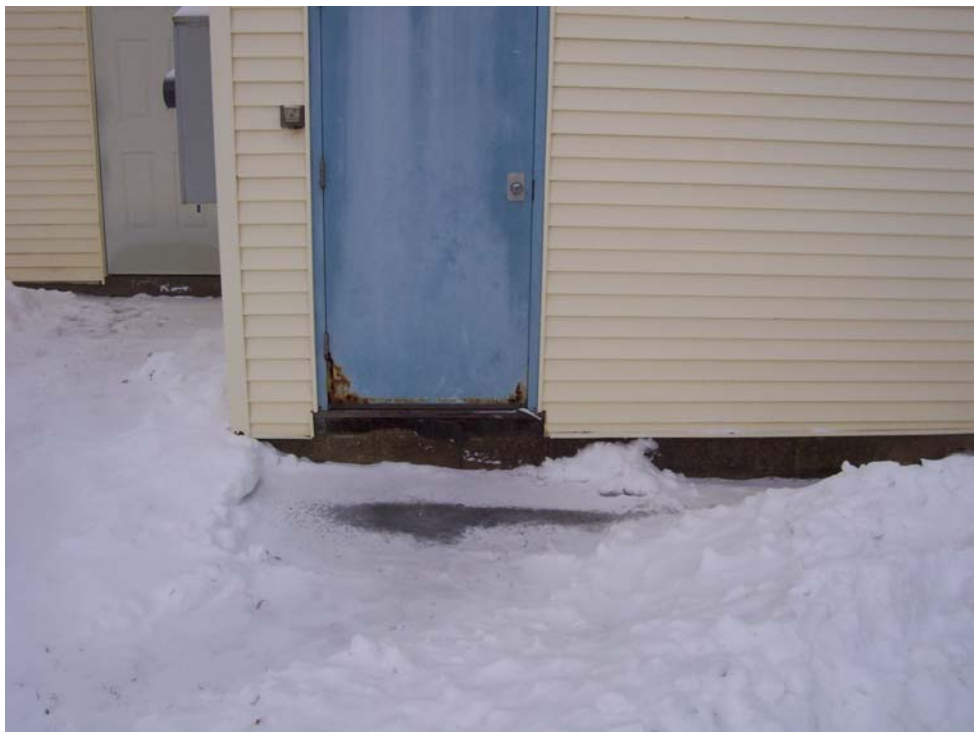
The exterior of the building is covered with vinyl siding. With the exception of several areas along the rear of the building, the siding is in good condition. The roof is a Gambrel-style roof covered with asphalt shingles. The shingles are in fair to good condition, and should not require replacement for another 8 to 10 years. Most of the windows are double-hung wood windows fitted with aluminum storm windows. The windows are in poor condition. Some are loose fitting and drafty, while others are tight and inoperable. Most of the building occupants have complained about the windows during the winter months as a source of cold air intrusion into the building. There is a large picture window at the second level along the rear or east side of the building. The seal has failed between the panes of glass, and the window should be replaced. The main door at the front of the building and the rear doors are metal clad. The metal has started to show signs of rust. On the main door, there are signs of rust bleeding through the paint. The door that accesses the rear storage area, however, is severely rusted along the bottom and is in need of replacement.

Rusted Door at the Rear of the Building

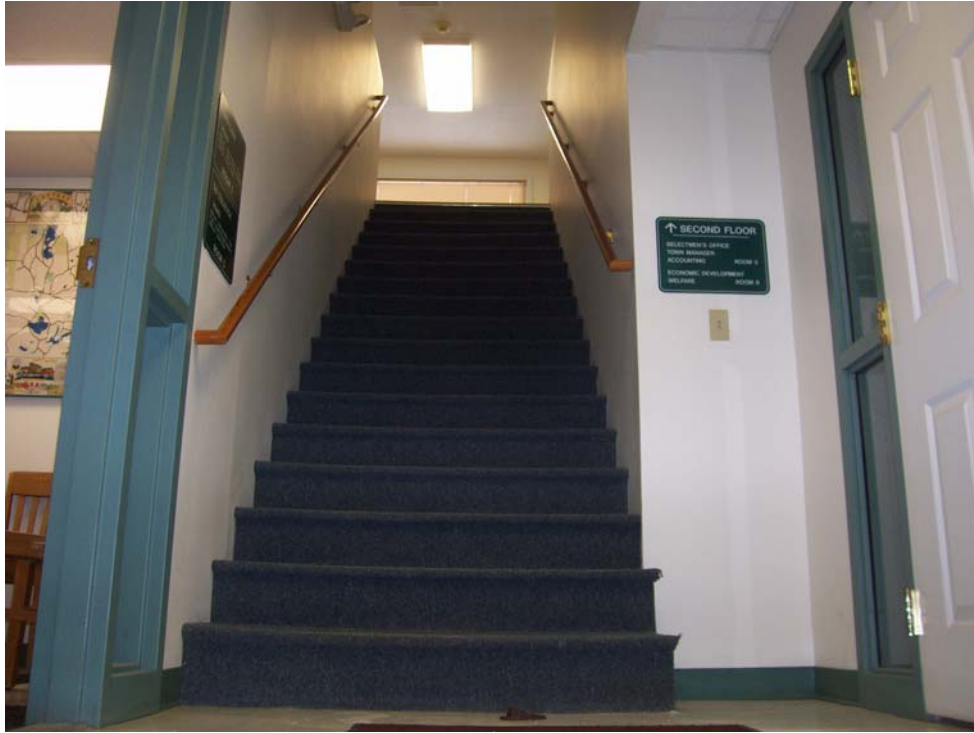
carpeted. The carpeting on the stairs is worn. However, all other carpeted areas are in good condition. Finishes throughout the building are in fair to good condition.

Main Stairway to the Second Floor

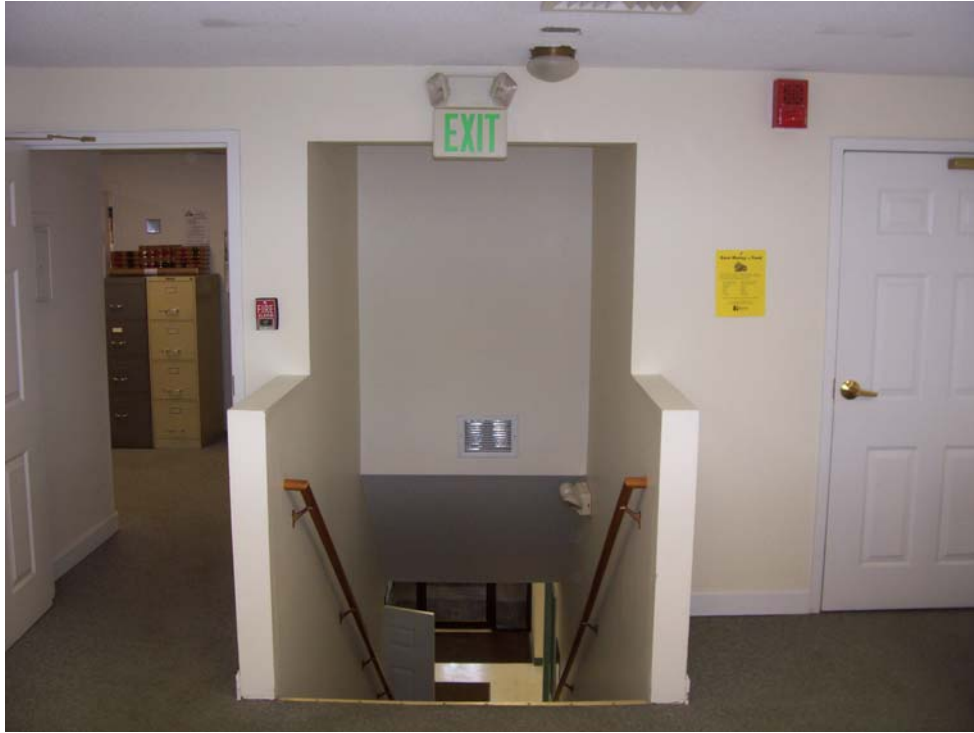
Main Stairway at the Second Floor

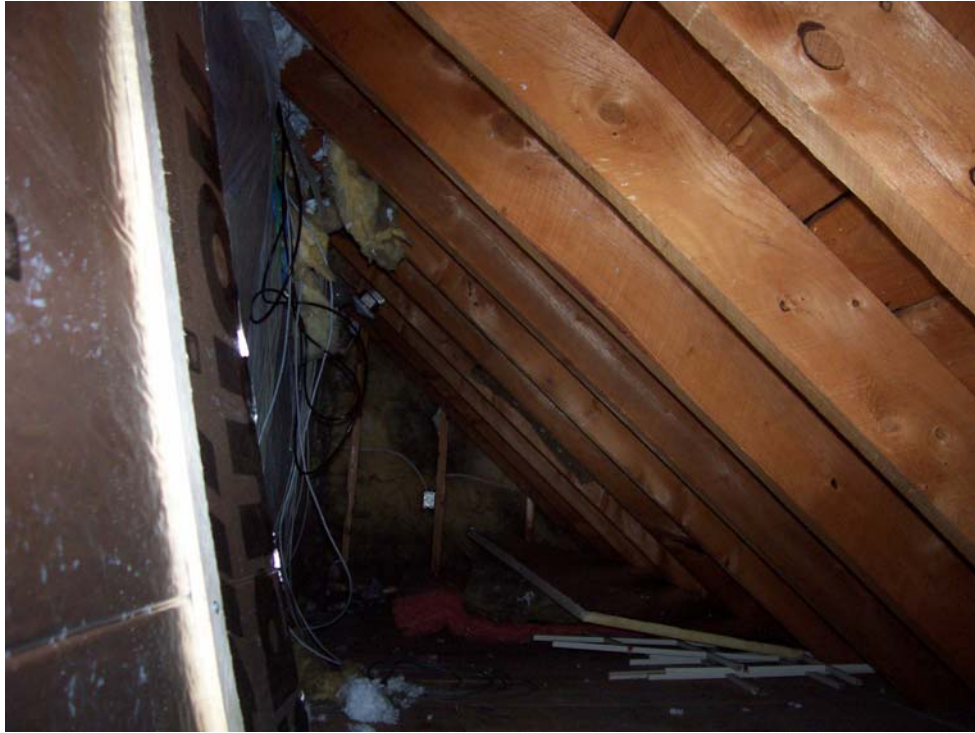
Roof Framing at the Crawl Space

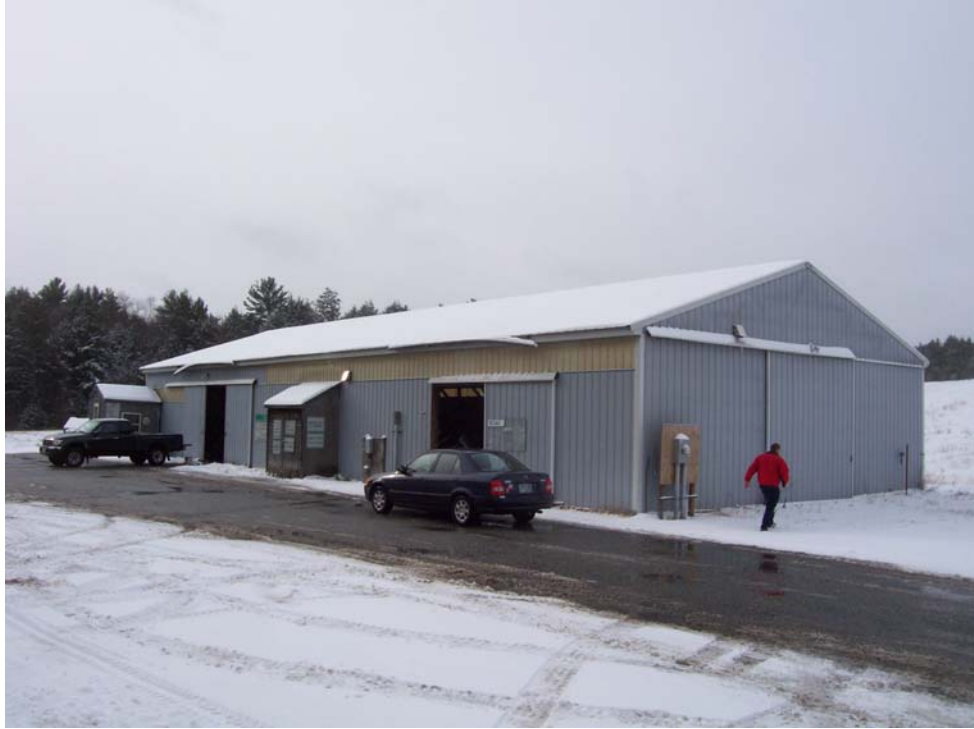
East Elevation – Front of Recycling Center
