FACILITY ASSESSMENTS MUNICIPAL BUILDINGS PHASE II

JAFFREY, NEW HAMPSHIRE

JANUARY 2009

THE H.L. TURNER GROUP Inc.

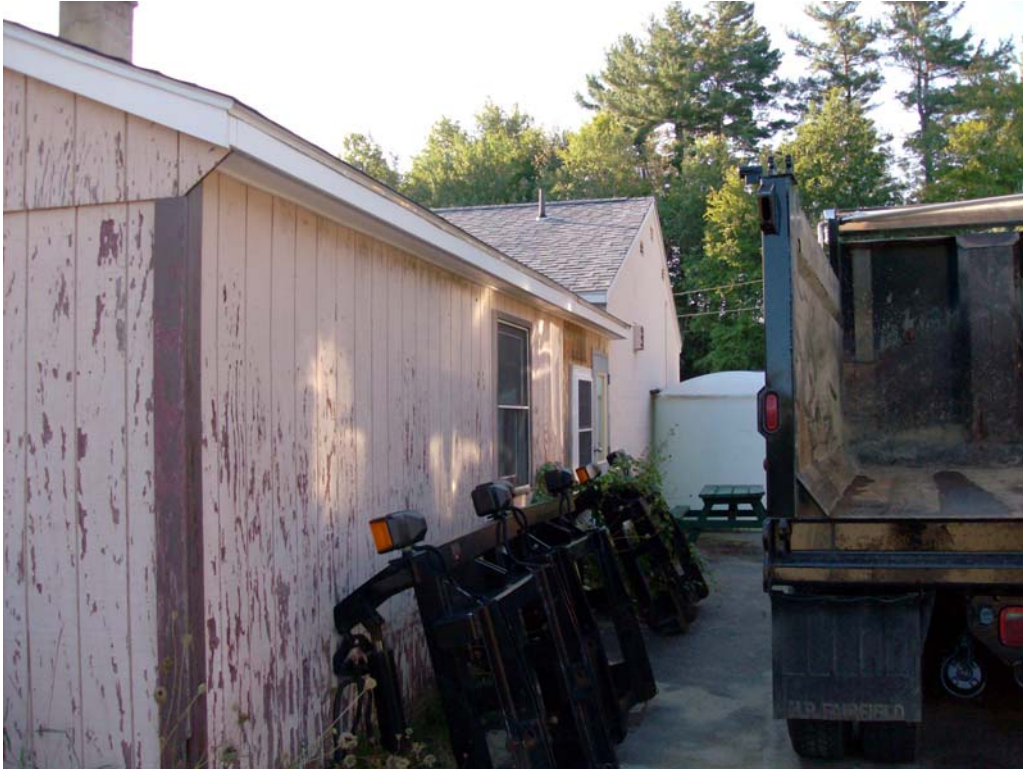
The wood-framed portion of the administration wing houses the office of the DPW Director. It also serves as a small conference room. The siding on this section of the building is T-111 wood panels. The paint is flaking and peeling, and the siding is badly in need of scraping and a new coat of paint. Some of the trim boards around the Director's office are rotted and need replacement. The trim boards on the rest of the building are in very good condition as they have been replaced with PVC composite trim boards. The shingle roof over the Administrative section was recently replaced in 2005 and is in very good condition. The shingle roof over the garage portion is showing signs of wear and is in fair condition. It should be scheduled for replacement in the next 5 to 6 years. Also, we were informed that the roof flashing at the interface between the administration portion of the building and the garage area needs to be repaired or replaced. A driving rain can result in significant leakage that finds its way through the ceiling into the secretary's office.

West Side of Administration Wing with T-111 Siding

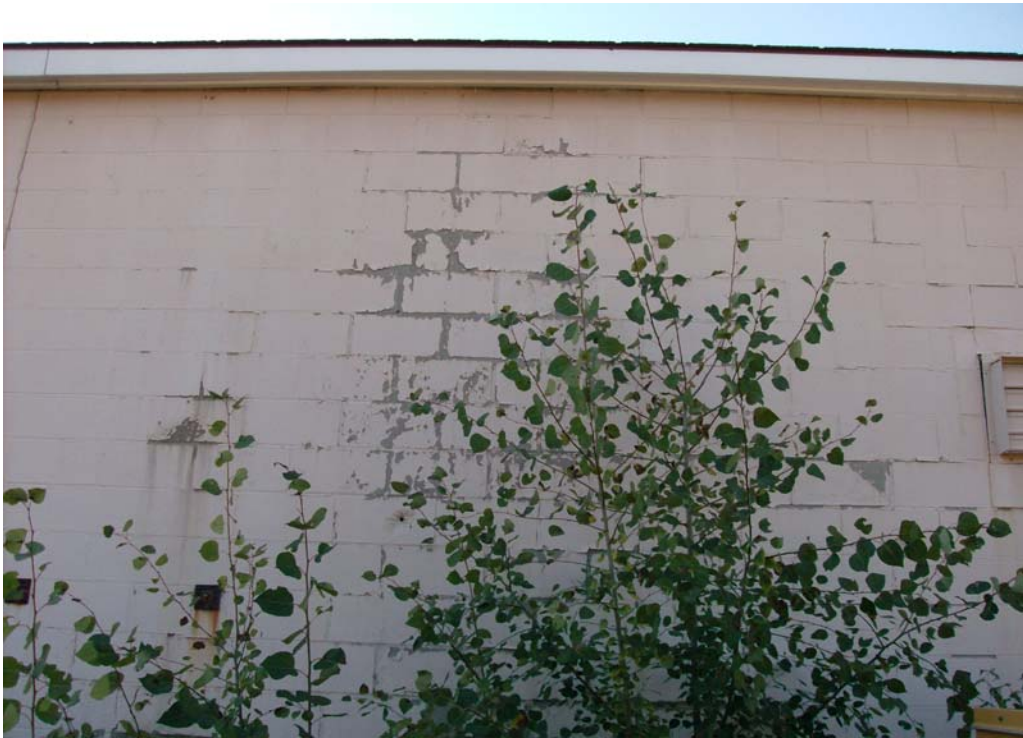
The CMU walls, particularly along the north wall or rear of the building, have some cracking at the mortar joints, and there are large areas where the paint is peeling and flaking off the wall. The lack of a frost wall makes the building very susceptible to movement from frost heaves, which may explain some of the cracks in the masonry walls. Along the lower courses of block, moss has started to grow, indicating a persistence of moisture and an inability of the block to dry out. Despite these issues, most of the block is in generally good condition.

Rear Wall of DPW Garage (Facing North)

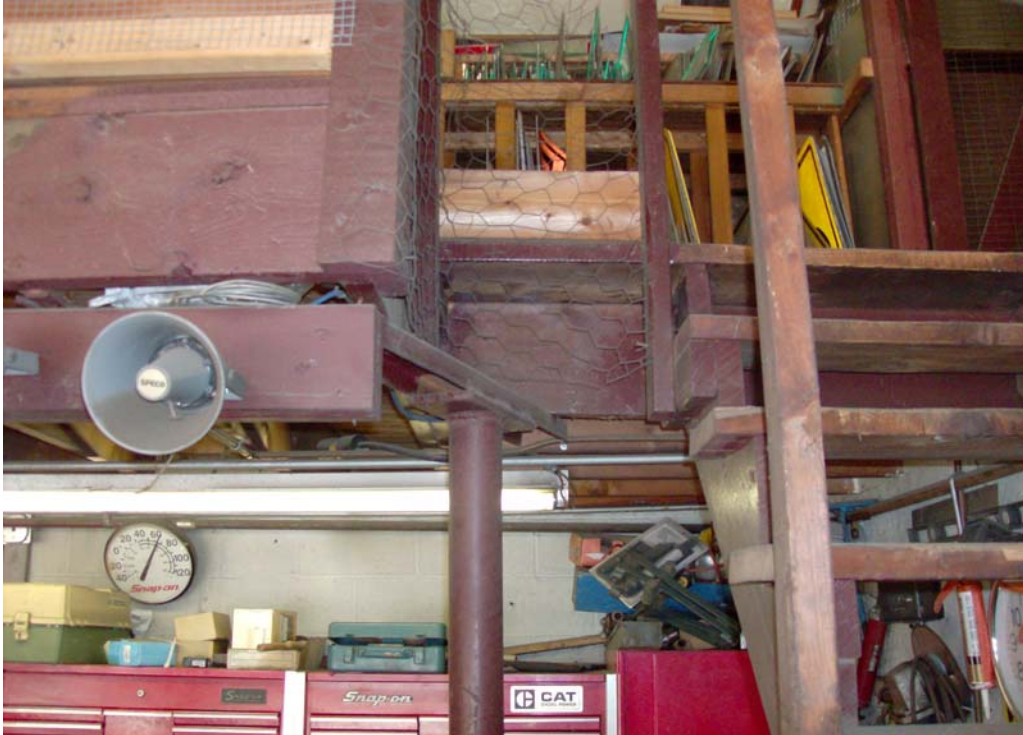
There is a wood-framed mezzanine in the garage along the north wall. It runs nearly the full length of the equipment bays. The framing is somewhat questionable in that the main beam supporting the floor joists is a pair of 2 x 8's that span over 8-feet between columns. Also, the post supporting the eastern-most corner of the mezzanine is not aligned below the support beam and relies on a cantilevered piece of channel off the post to support the mezzanine beam. It is recommended that calculations be performed to determine the safe live load capacity for the mezzanine. Eventually a sign should be posted with the load limit.

Unconventional Support for Outside Corner of Mezzanine

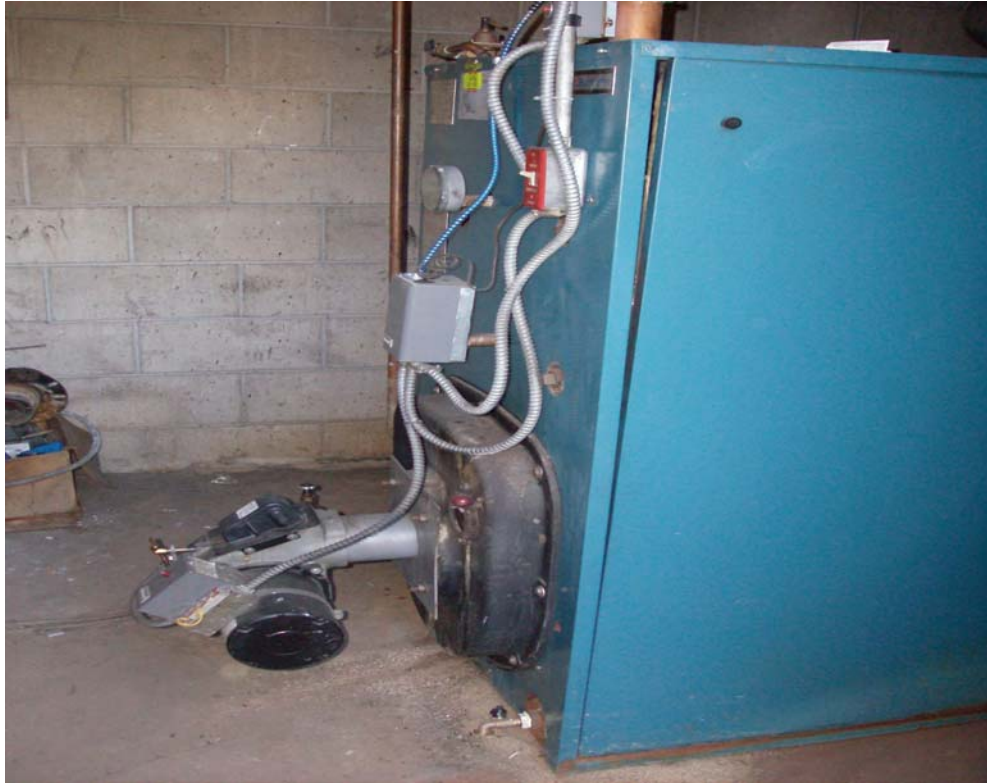
The break room across the hall needs a new floor. The existing plywood floor is worn out. We were informed that the existing concrete floor under the plywood was damaged during a fire back in 1967. Apparently, the room was originally used to store chemicals and the chemicals got onto the floor prior to the fire. Several attempts have been made to restore the floor with little success. Some feel the only alternative is to jackhammer out the floor and replace it. The available crew space does not provide adequate space for meetings and training, or for those personnel who work long hours during snowstorms or emergencies.

Oil-Fired Hot Water Boiler

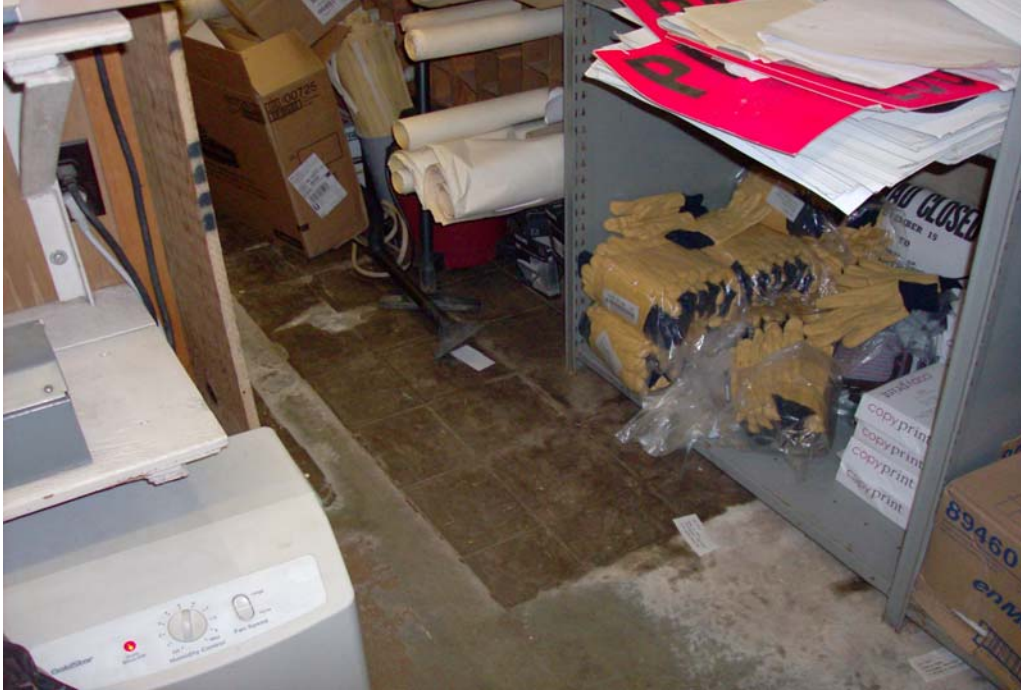
Storage Room – Note Old Asbestos Floor Tiles

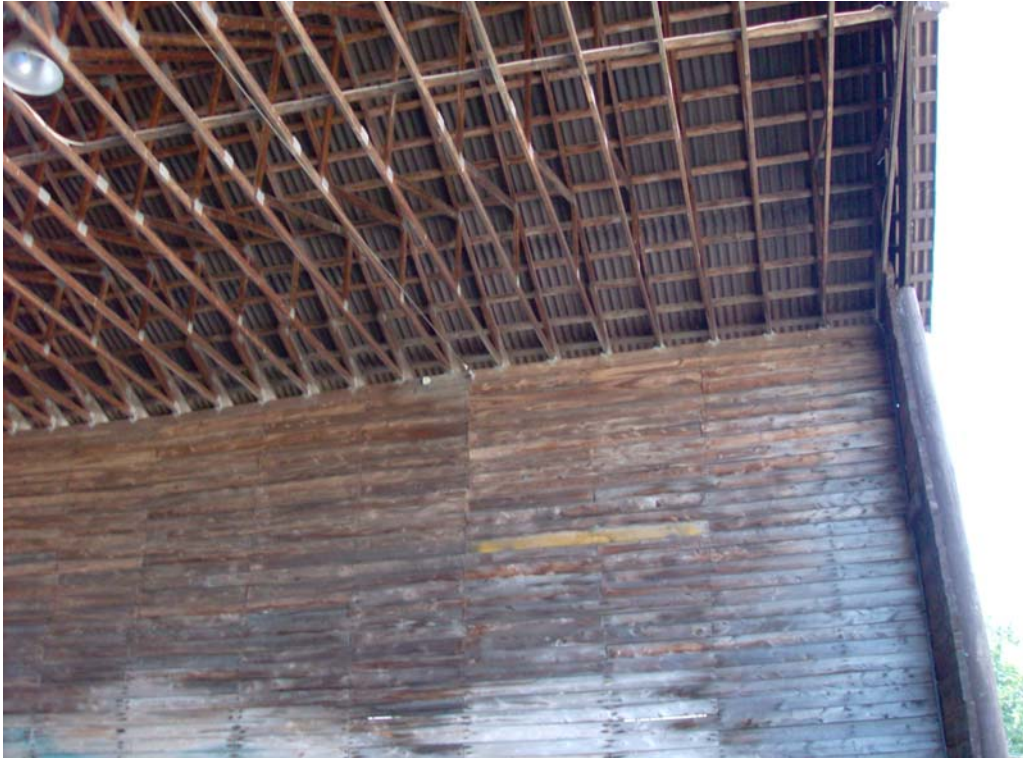
The sand and salt storage shed was constructed in 1994. Other than some large gaps in the siding on the back or southerly wall, the building is in generally good condition, and is functional for its intended purpose. The roof is a series of wood trusses spaced at 24-inches on-center. We did notice some bracing installed, but it appears the diagonal pieces of bracing were omitted.

Roof Trusses and Wood Covered Walls in Salt Storage Shed

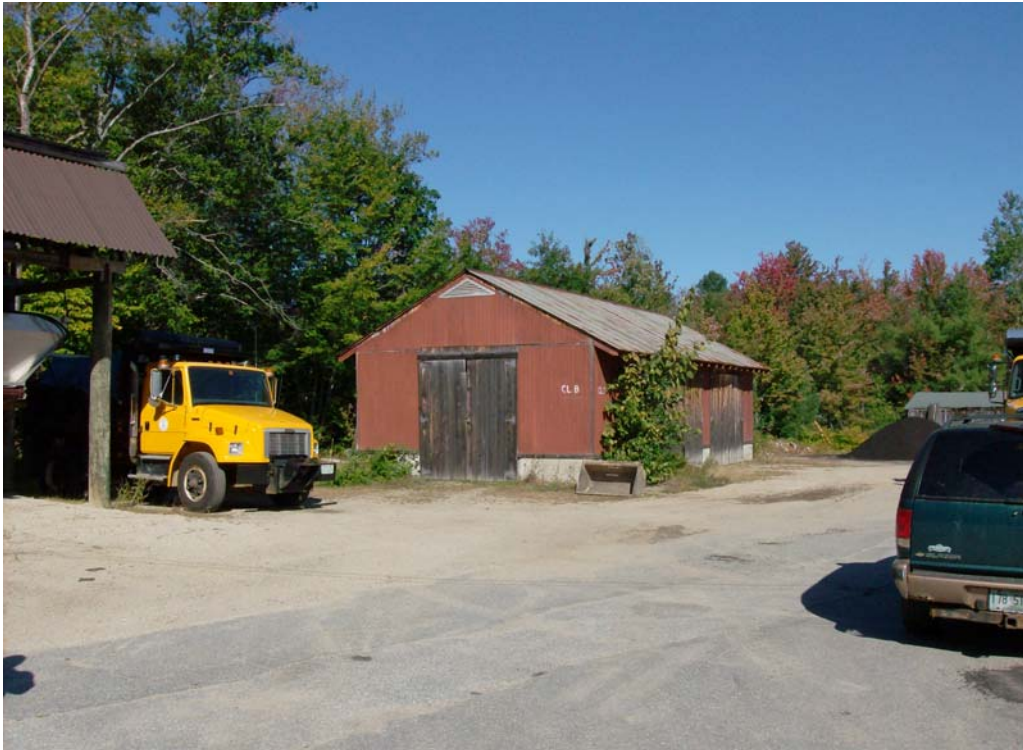
a concrete slab-on-grade. The CMU foundation wall is cracked at a few locations and there is very pronounced cracking in the walls at two of the three doorjambes. Further north is a wood-framed building that appears to be structurally unstable as evidenced by the pronounced lean of the walls. It is not known if this structure is currently being used for storage, but judging by its appearance, it is recommended that it be abandoned or demolished.

Wood Framed Equipment Storage Shed

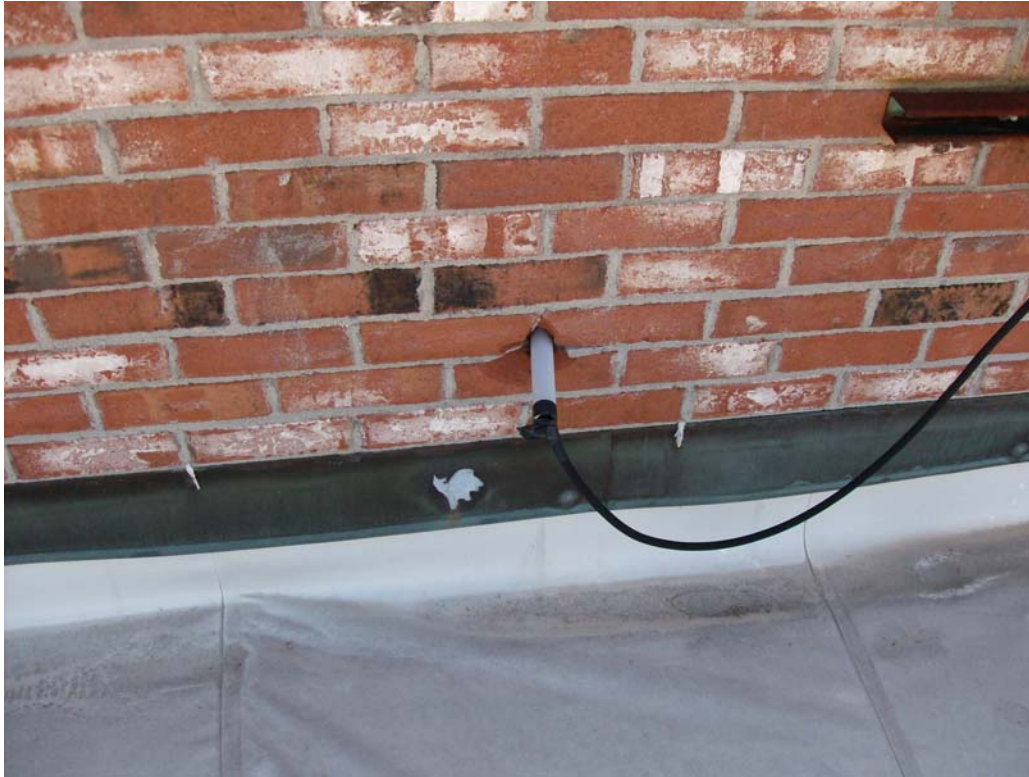
Wall Penetration for Antenna Cable at Roof Parapet

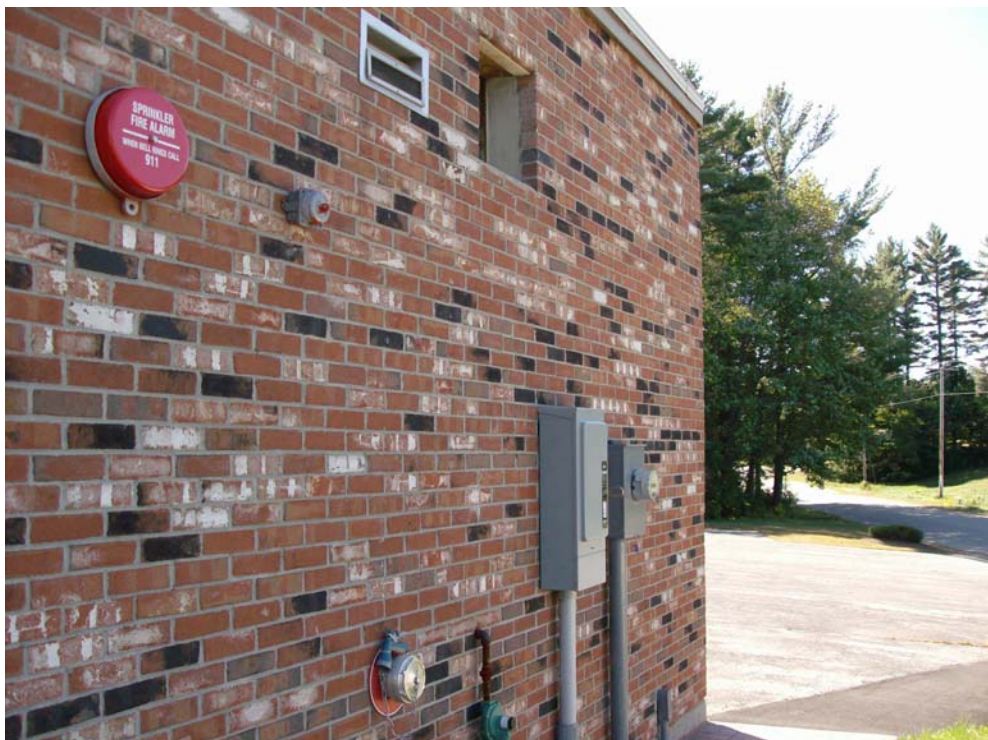
Southwest Corner of Building – Note Uncovered Wall Opening

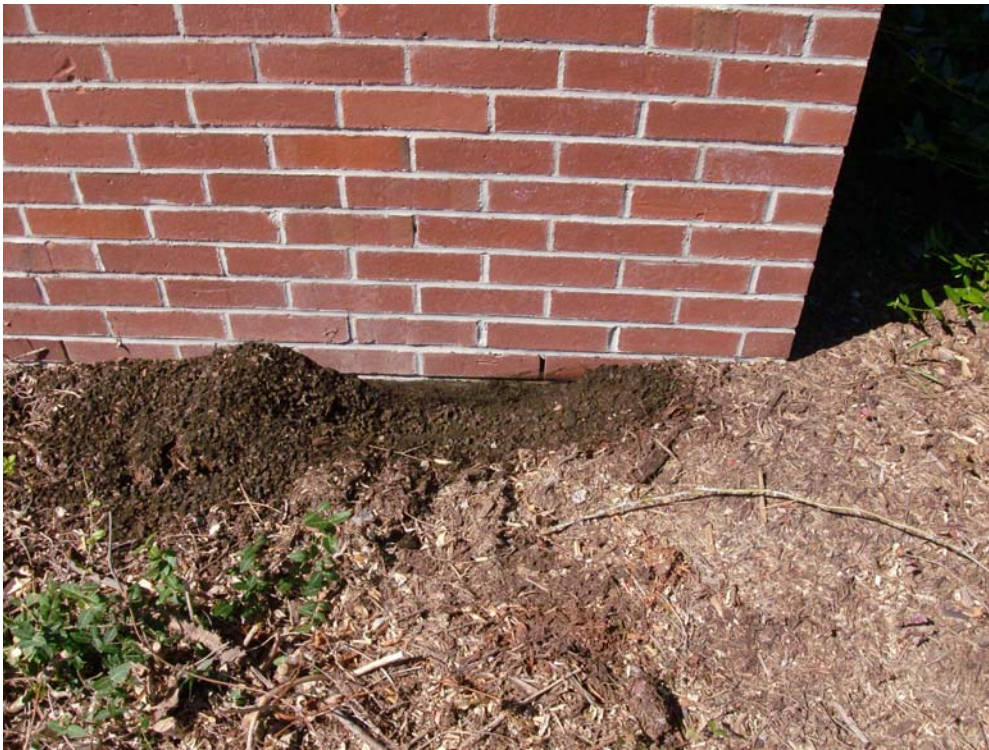
Soil and Mulch Blocking Mortar Joint Weeps

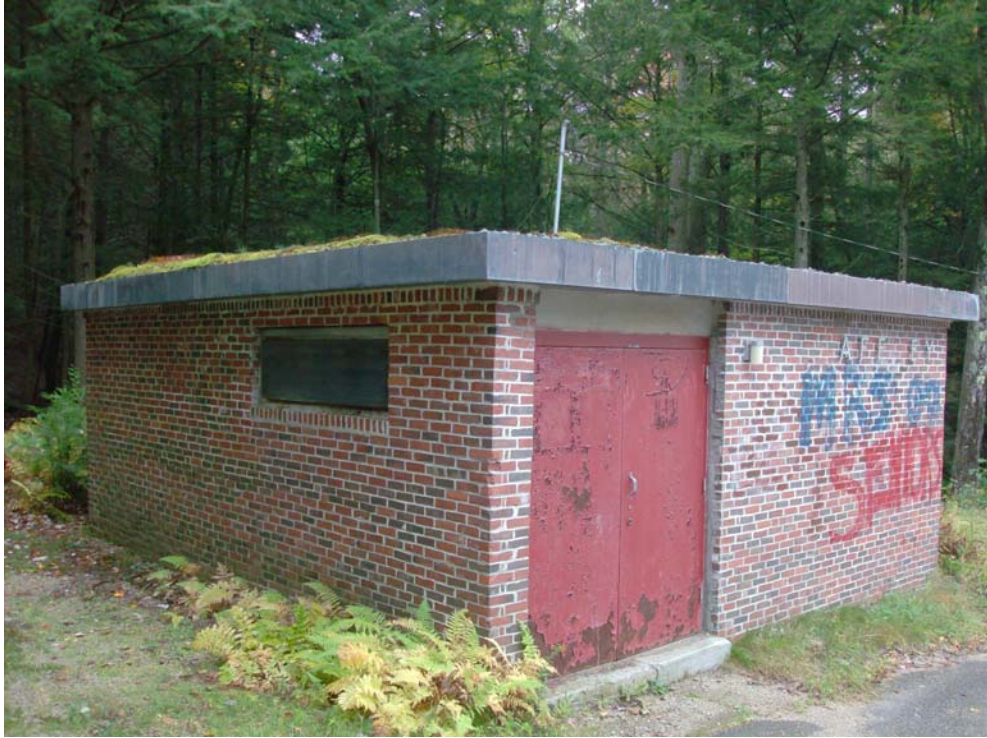
The Squantum Road Station no longer functions as a pumping station. It is currently used for storage. The building is constructed of CMU with a brick façade. Much of the building's façade has been covered with graffiti. The roof is a flat, ballasted-type membrane roof. Most of the roof is covered by a well established growth of moss. We suspect the membrane roof is far beyond its useful life and is in need of replacement.

Former Pump Station on Squantum Road

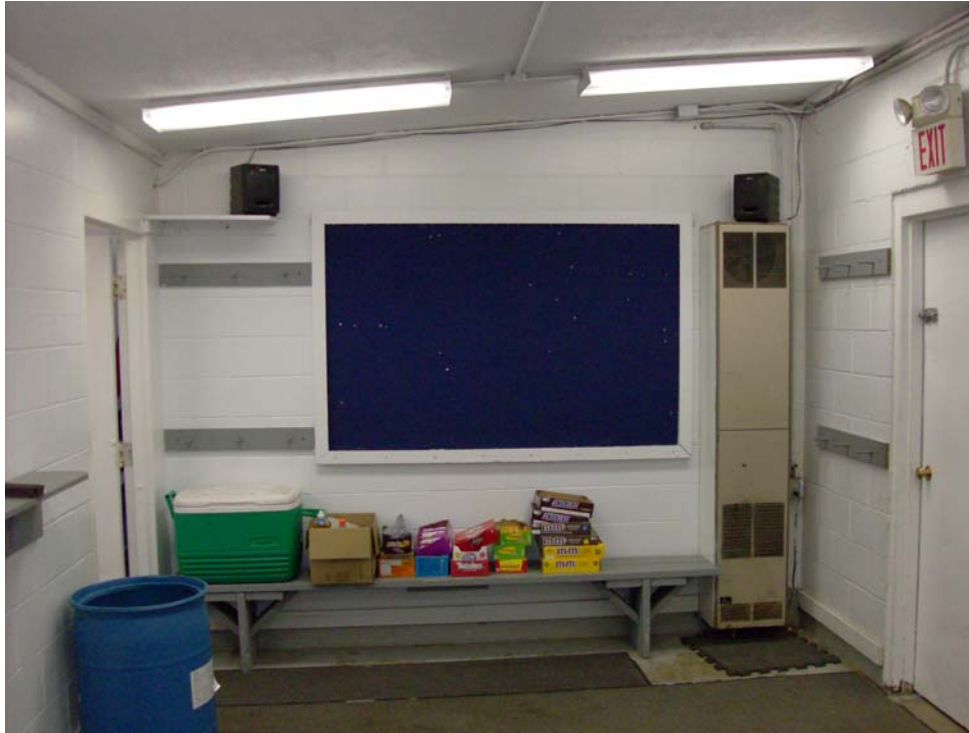
Youth Center – Area Outside Concession Window – Note Gas Wall Heater

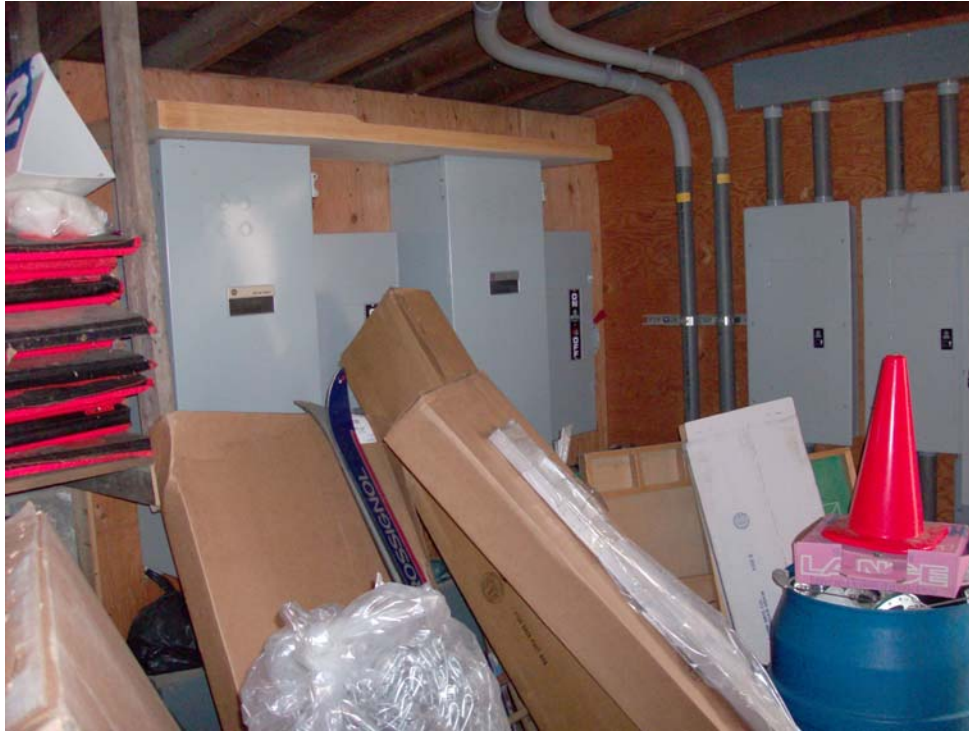
Electrical Panels in the “Dungeon” – Note Boxes and Debris Blocking Panel Access

ARCHITECTURAL/HVAC AND ELECTRICAL			\$ Opinion of Cost			
COMPONENT	OBSERVATION	RECOMMENDATION	<i>Remaining Useful Life</i>	Short-Term	Mid-Term	Long-Term
Storage Building	Large cracks in masonry walls allowing water intrusion and further damage.	Repoint cracks.	0 to 1 year	\$600		
Storage Building	Miscellaneous boxes and recreation equipment piled in front of electrical panels.	Clean out area in front of electrical panels. Maintain at least 36-inches of clear space.	N/A	-----		
			Sub-Total	\$25,525	\$13,500	-----

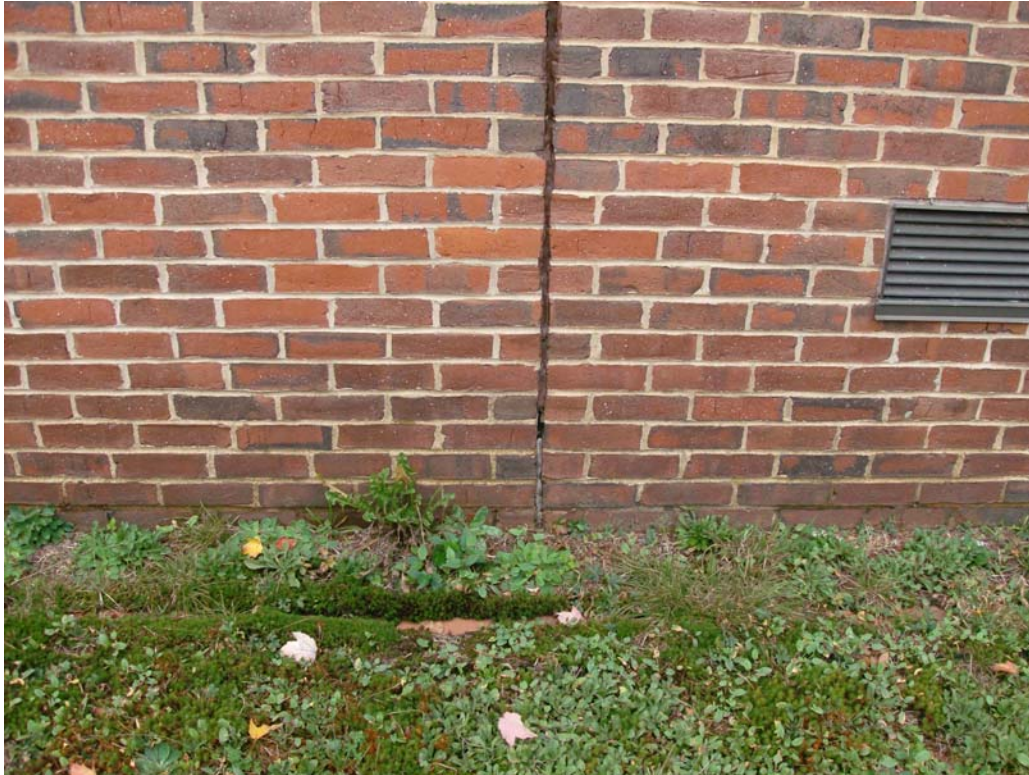
Typical Brick Control Joint

1. The boiler is near the end of its useful life. It should be replaced with a high efficiency unit within the next two to three years. We understand that the Town is now in the process of obtaining prices for a new boiler.
2. Install strobes throughout the building, including in the bathrooms.
3. Add grab bars in the toilet stalls to comply with ADA guidelines.
4. There are some vertical control joints in the brick façade where there are gaps in the existing sealant. These areas should be re-caulked.
5. Insulate all piping in the attic space subject to freezing.

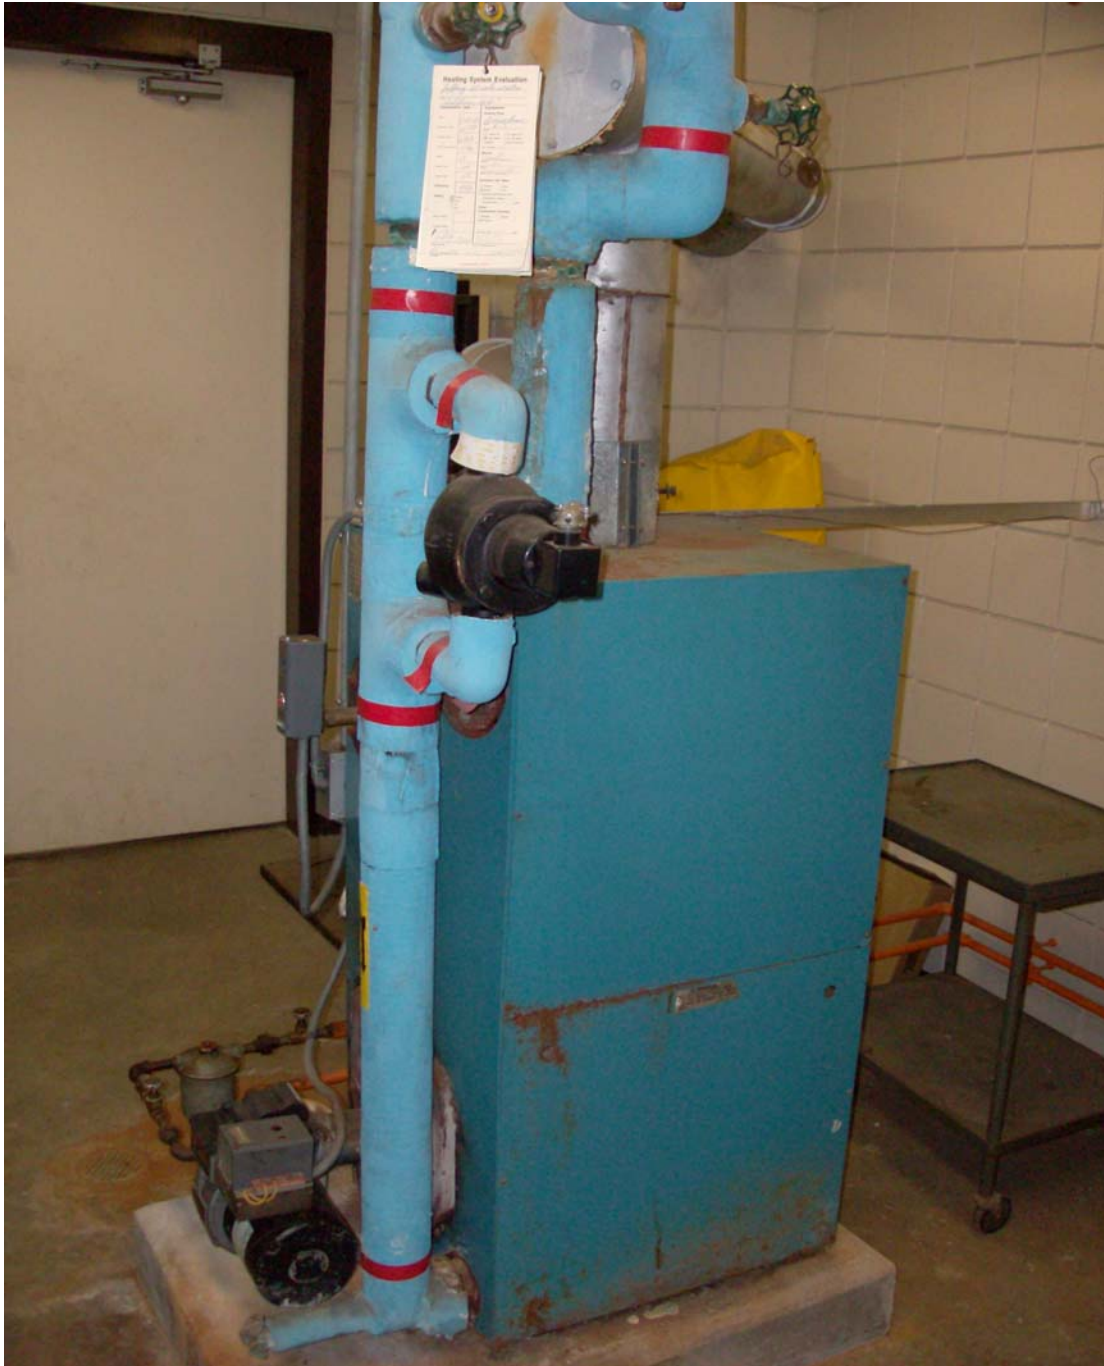
Oil-Fired Boiler for Forced Hot Water Heat

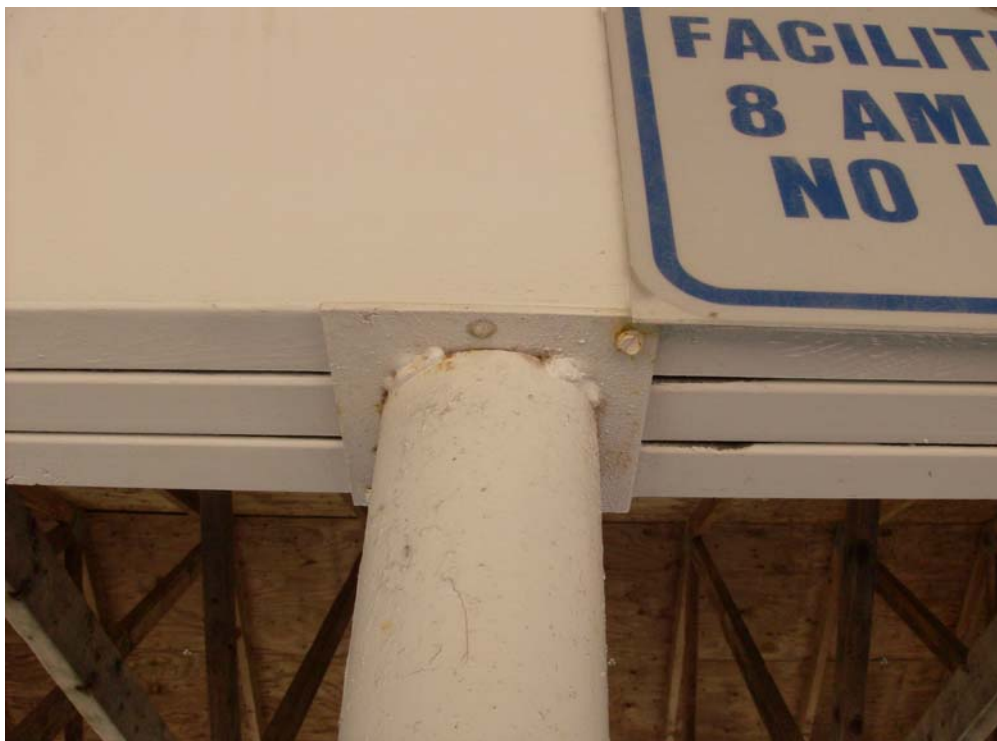
Beam to Column Connection – Roof Over Picnic Area

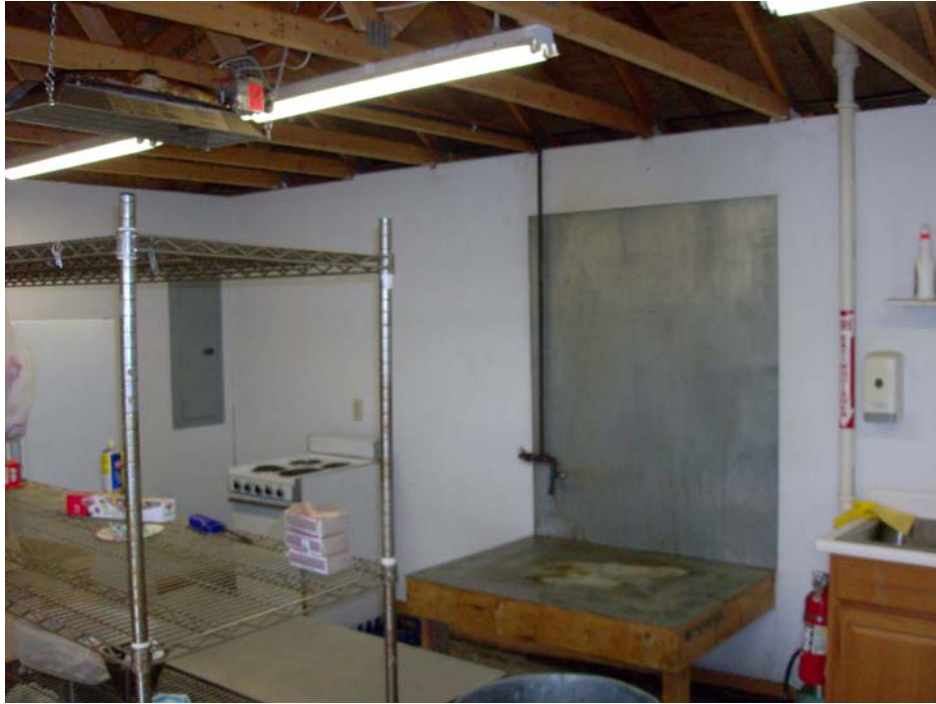
Table for Gas Griddle – Note No Overhead Hood

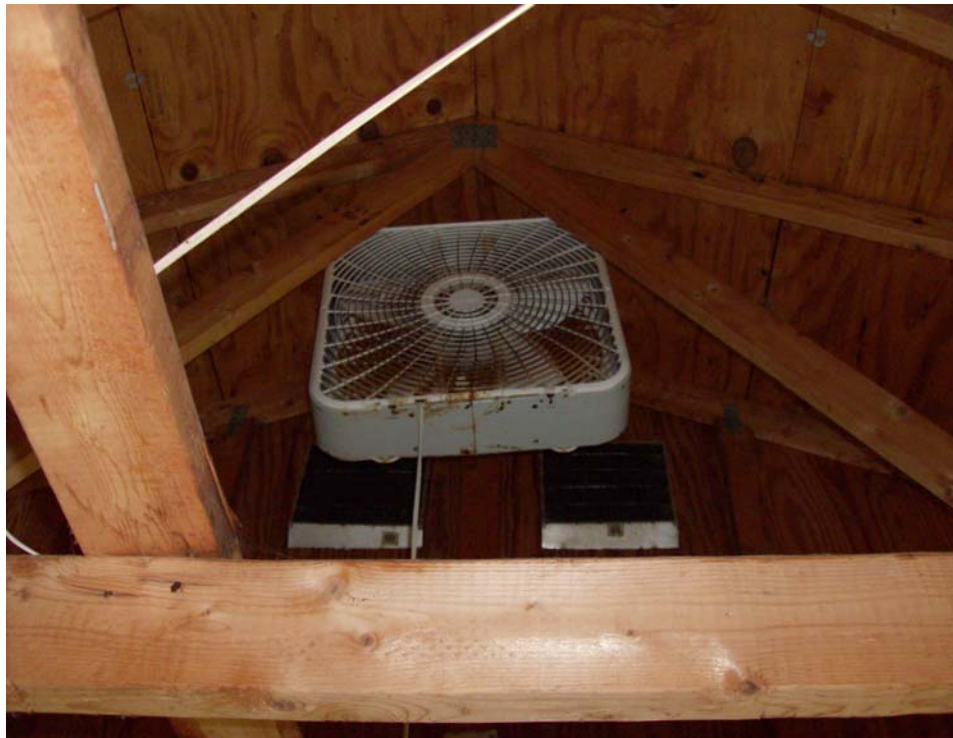
Box Fan Used to Vent Cooking Fumes and Smoke

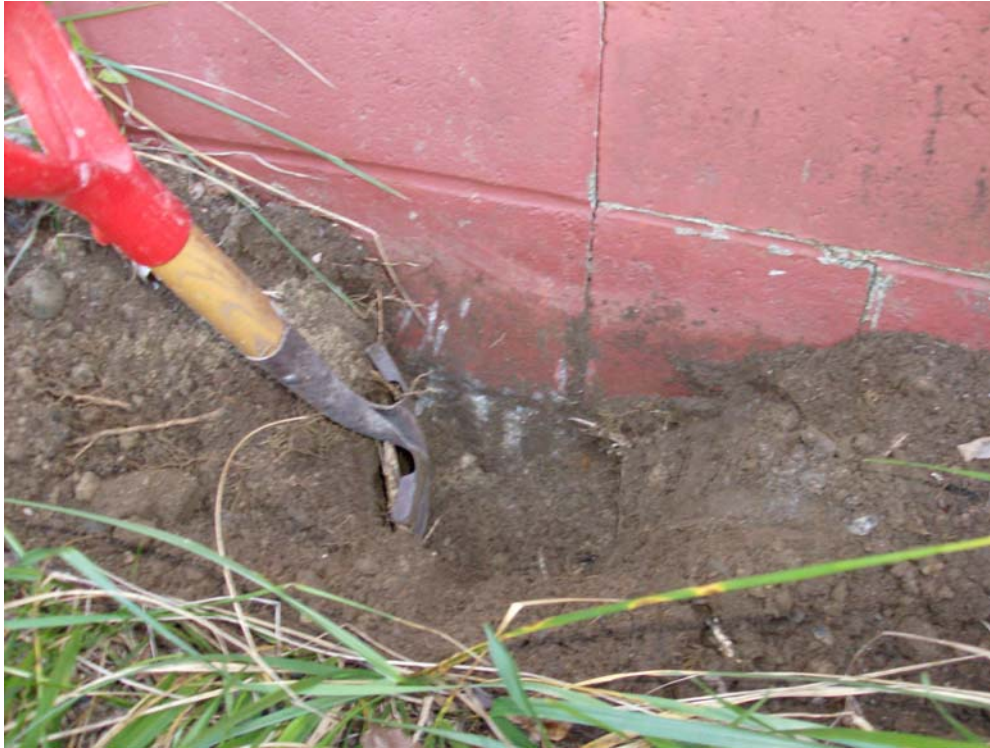
Existing Grade Covering Lower Block Course and Weep Holes

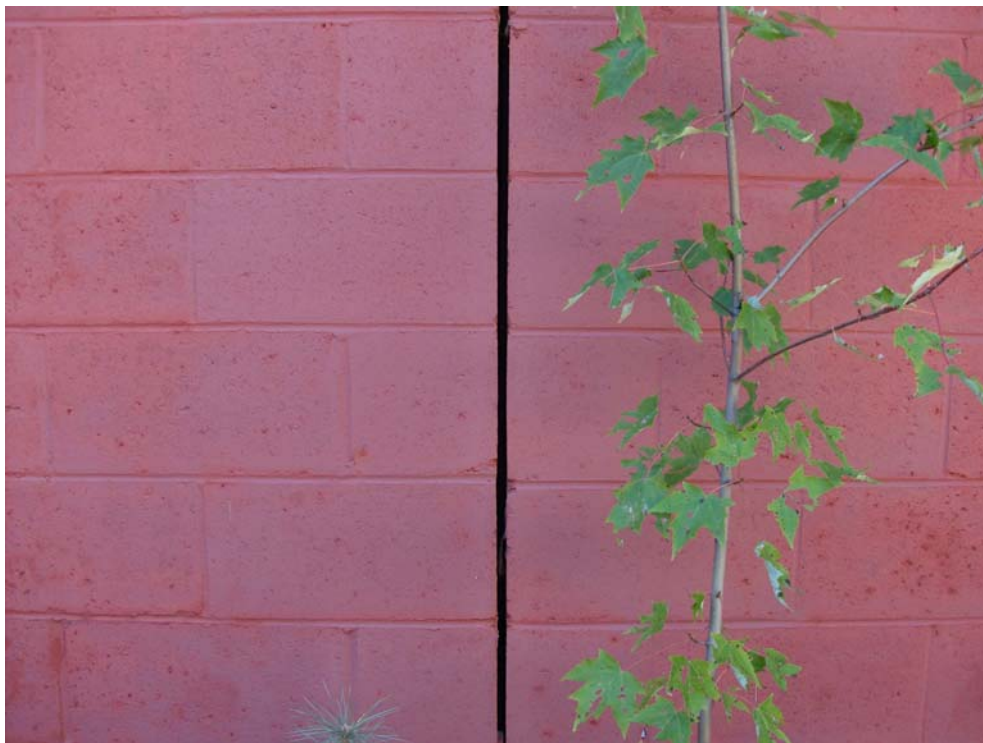
CMU Control Joint in Need of Caulking
