**FACILITY ASSESSMENTS
MUNICIPAL BUILDINGS
PHASE II**

JAFFREY, NEW HAMPSHIRE

JANUARY 2009

THE H.L. TURNER GROUP Inc.

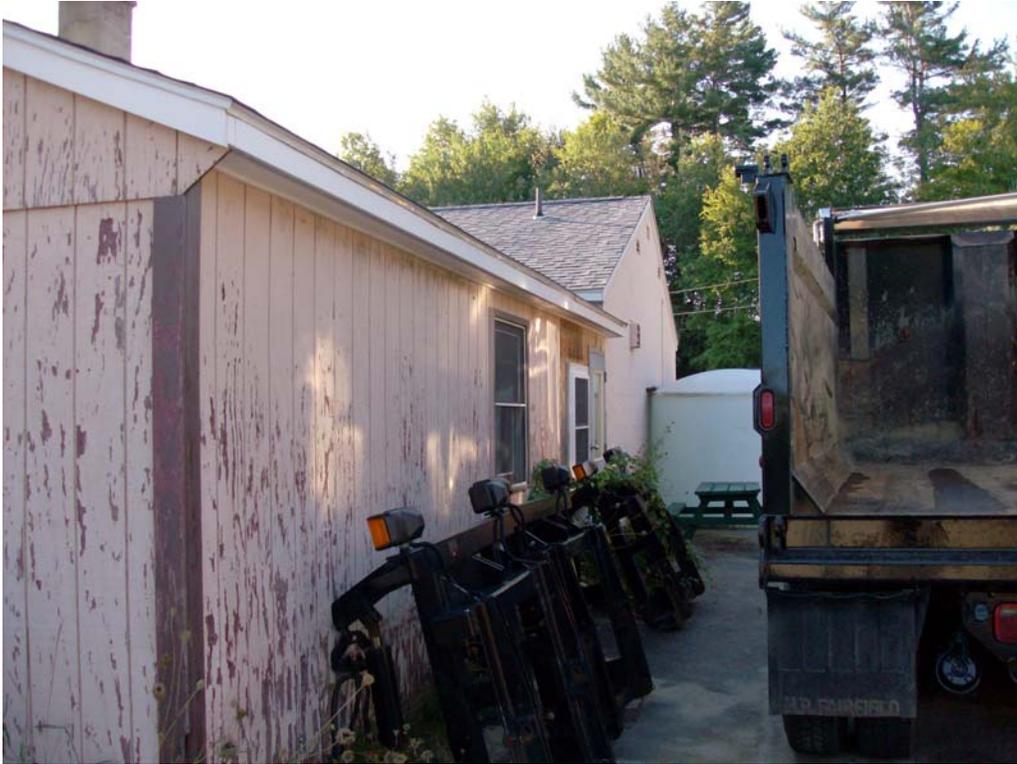
The wood-framed portion of the administration wing houses the office of the DPW Director. It also serves as a small conference room. The siding on this section of the building is T-111 wood panels. The paint is flaking and peeling, and the siding is badly in need of scraping and a new coat of paint. Some of the trim boards around the Director's office are rotted and need replacement. The trim boards on the rest of the building are in very good condition as they have been replaced with PVC composite trim boards. The shingle roof over the Administrative section was recently replaced in 2005 and is in very good condition. The shingle roof over the garage portion is showing signs of wear and is in fair condition. It should be scheduled for replacement in the next 5 to 6 years. Also, we were informed that the roof flashing at the interface between the administration portion of the building and the garage area needs to be repaired or replaced. A driving rain can result in significant leakage that finds its way through the ceiling into the secretary's office.

West Side of Administration Wing with T-111 Siding

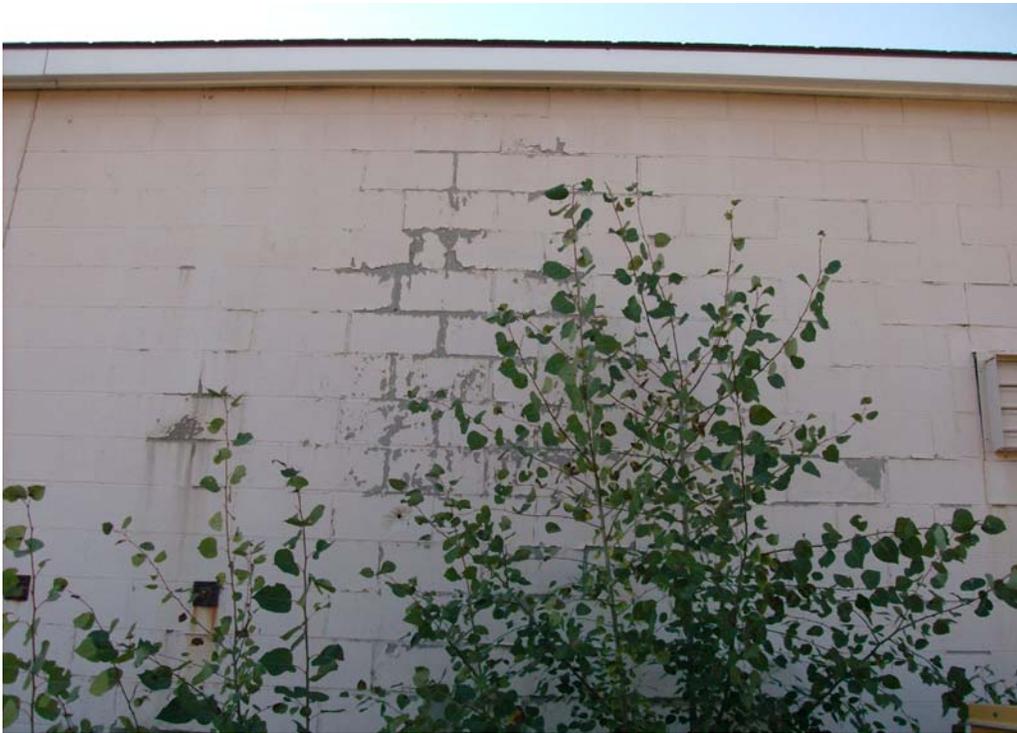
The CMU walls, particularly along the north wall or rear of the building, have some cracking at the mortar joints, and there are large areas where the paint is peeling and flaking off the wall. The lack of a frost wall makes the building very susceptible to movement from frost heaves, which may explain some of the cracks in the masonry walls. Along the lower courses of block, moss has started to grow, indicating a persistence of moisture and an inability of the block to dry out. Despite these issues, most of the block is in generally good condition.

Rear Wall of DPW Garage (Facing North)

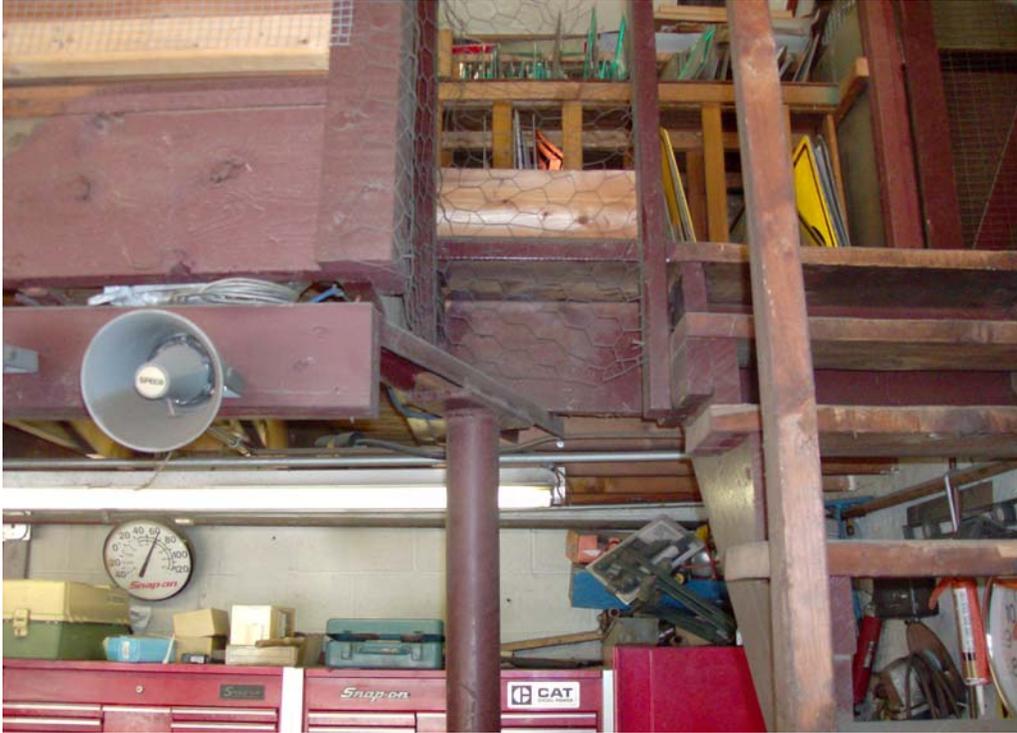
There is a wood-framed mezzanine in the garage along the north wall. It runs nearly the full length of the equipment bays. The framing is somewhat questionable in that the main beam supporting the floor joists is a pair of 2 x 8's that span over 8-feet between columns. Also, the post supporting the eastern-most corner of the mezzanine is not aligned below the support beam and relies on a cantilevered piece of channel off the post to support the mezzanine beam. It is recommended that calculations be performed to determine the safe live load capacity for the mezzanine. Eventually a sign should be posted with the load limit.

Unconventional Support for Outside Corner of Mezzanine

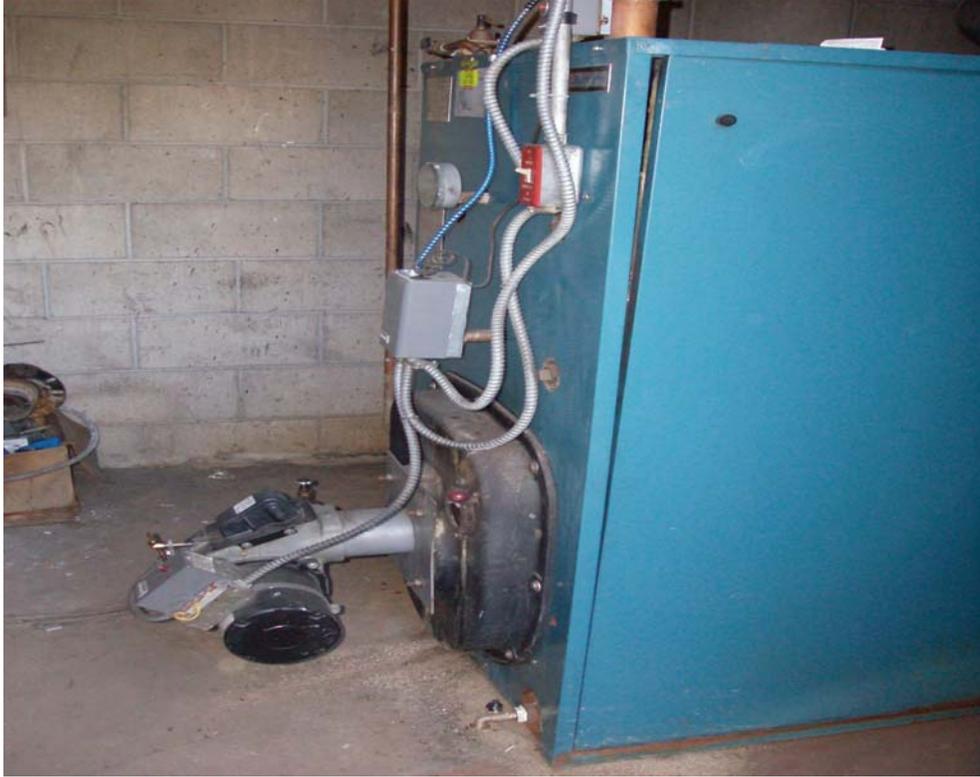
Oil-Fired Hot Water Boiler

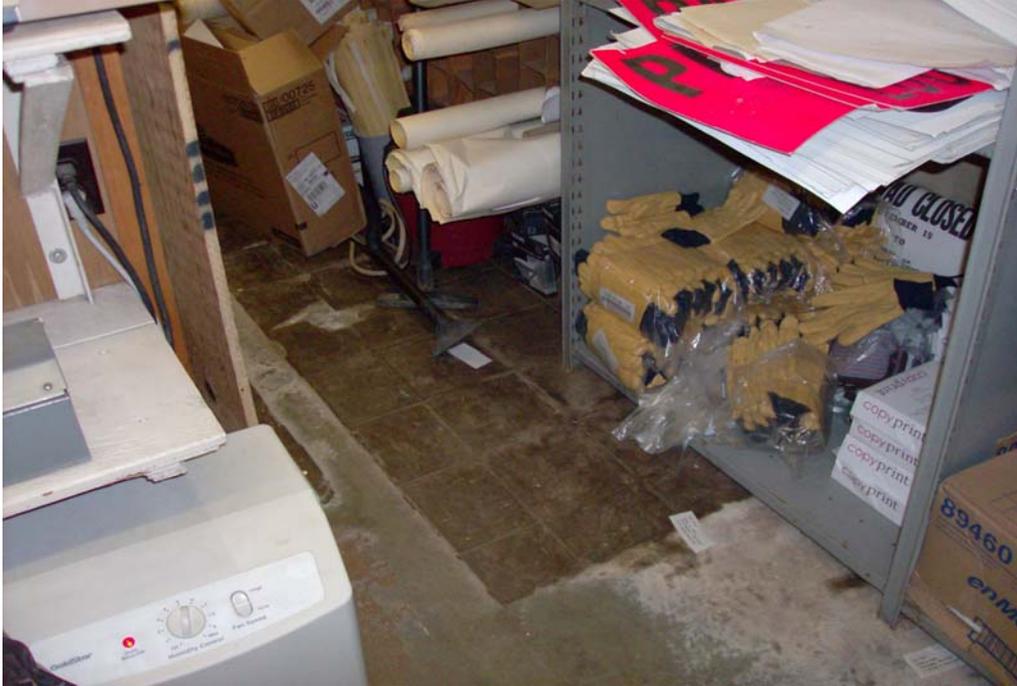
Storage Room – Note Old Asbestos Floor Tiles

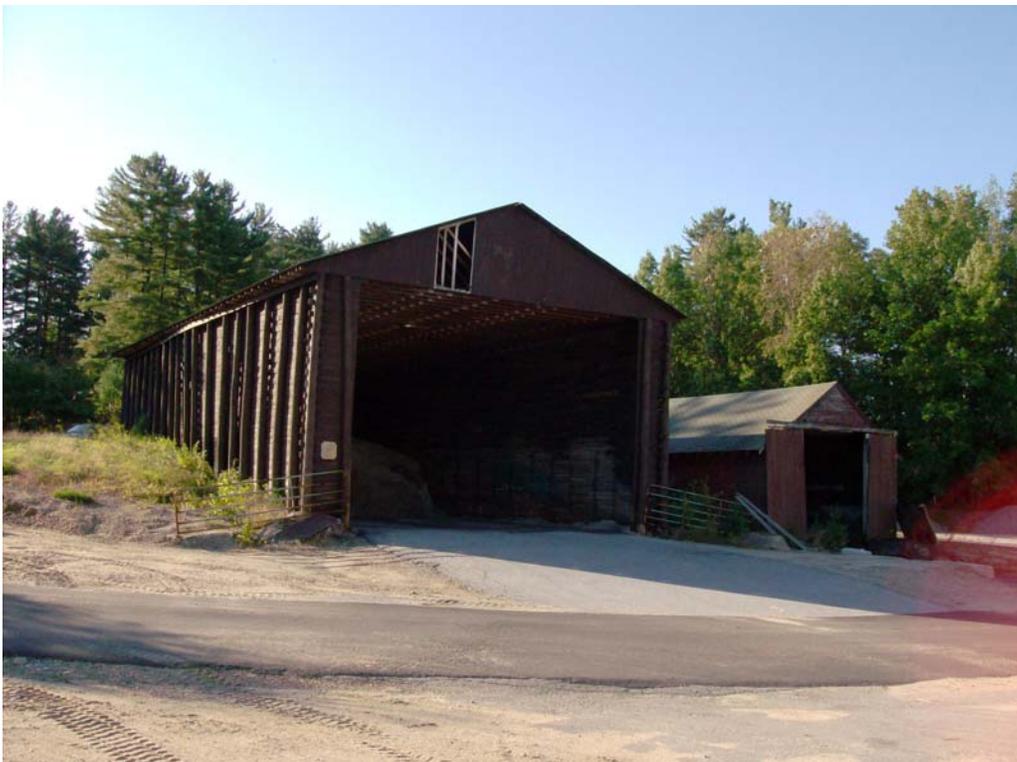
The sand and salt storage shed was constructed in 1994. Other than some large gaps in the siding on the back or southerly wall, the building is in generally good condition, and is functional for its intended purpose. The roof is a series of wood trusses spaced at 24-inches on-center. We did notice some bracing installed, but it appears the diagonal pieces of bracing were omitted.

Salt Storage Shed (left) and Storage Shed for Large Front End Loader

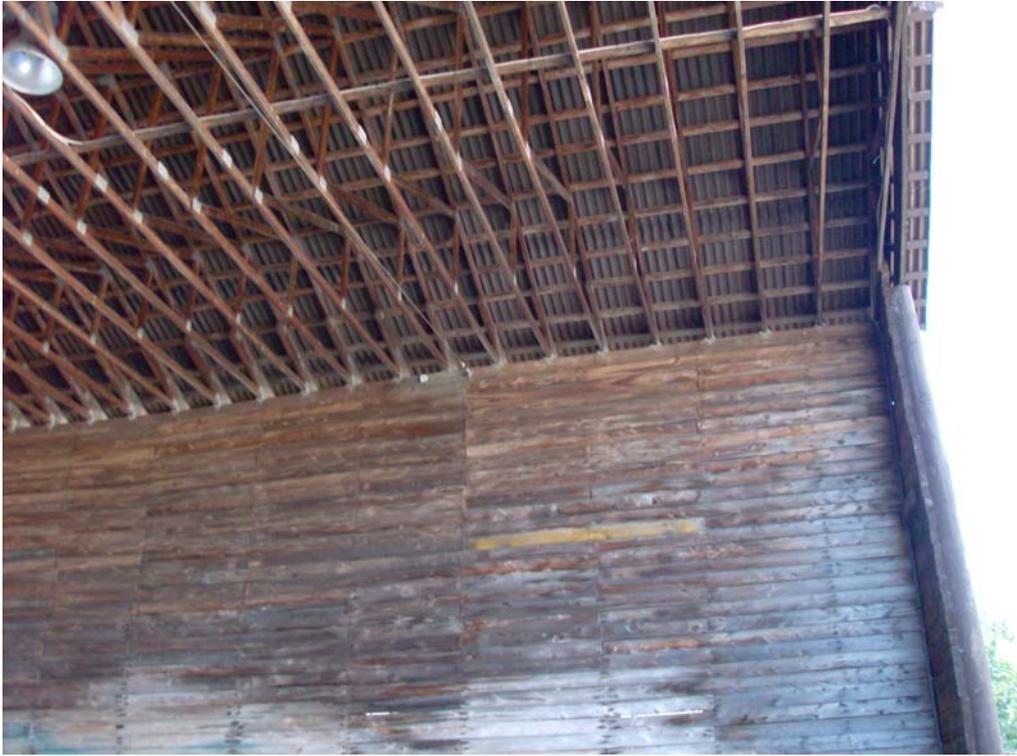
Roof Trusses and Wood Covered Walls in Salt Storage Shed

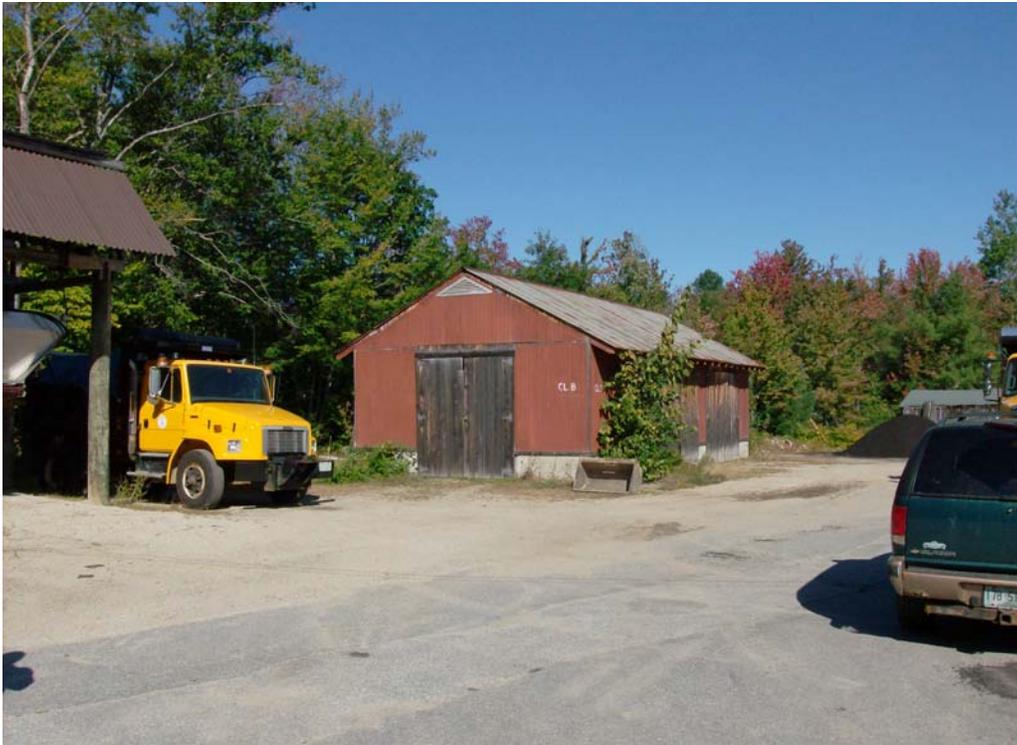
a concrete slab-on-grade. The CMU foundation wall is cracked at a few locations and there is very pronounced cracking in the walls at two of the three doorjambes. Further north is a wood-framed building that appears to be structurally unstable as evidenced by the pronounced lean of the walls. It is not known if this structure is currently being used for storage, but judging by its appearance, it is recommended that it be abandoned or demolished.

Wood Framed Equipment Storage Shed

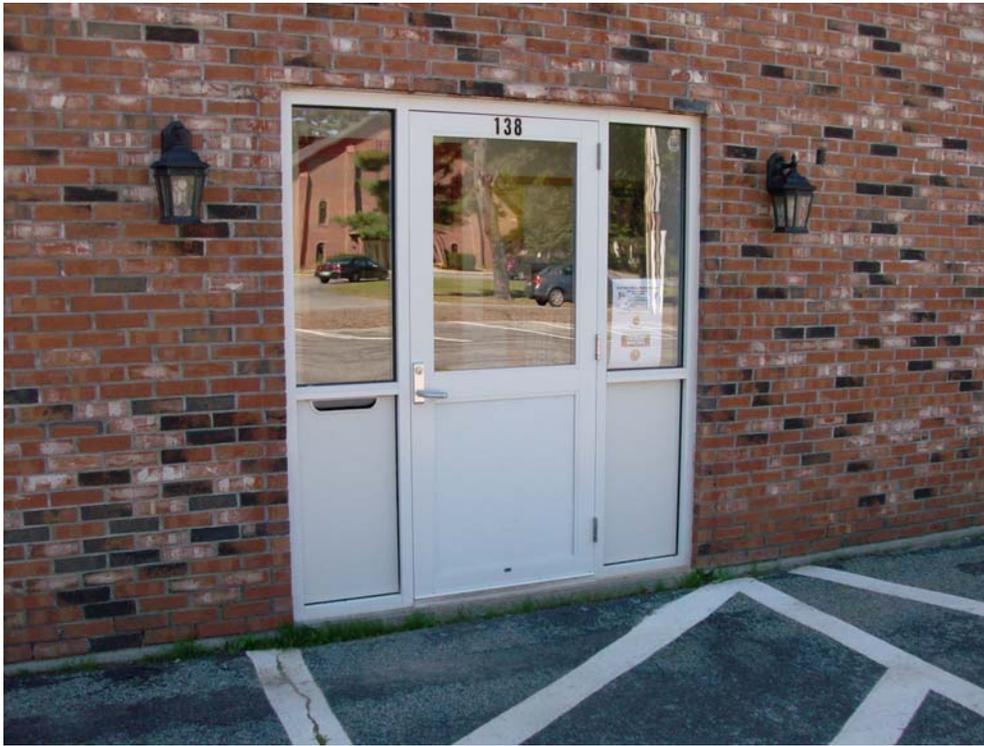
Main Entrance into Fire Station – Note Step

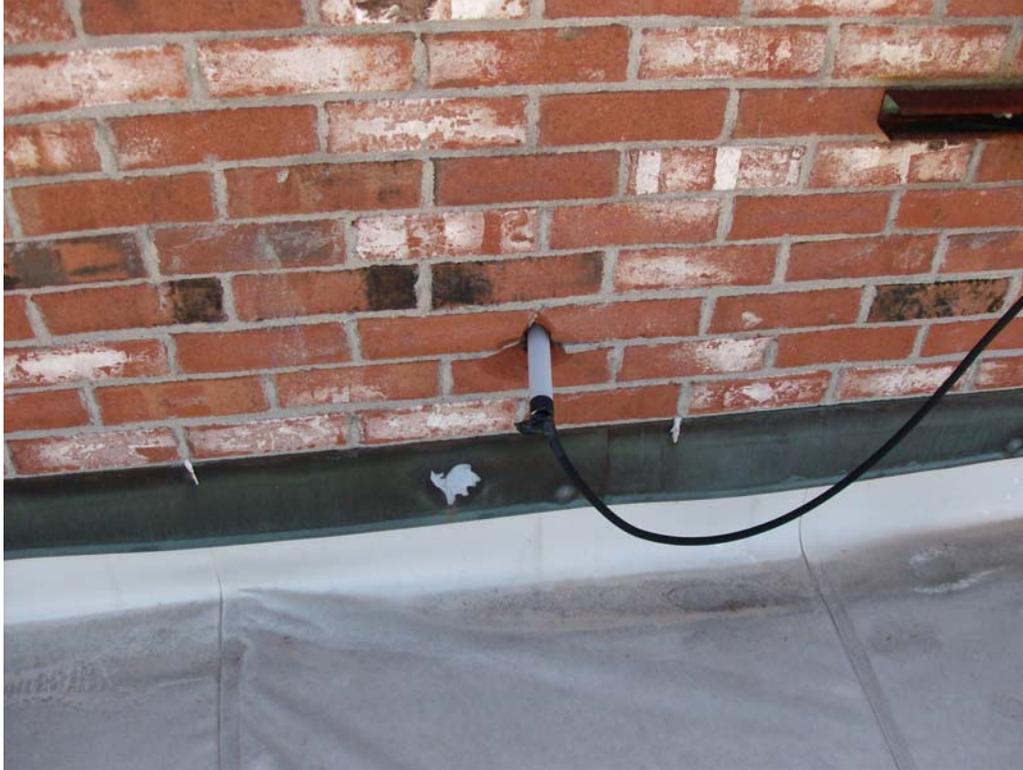
Wall Penetration for Antenna Cable at Roof Parapet

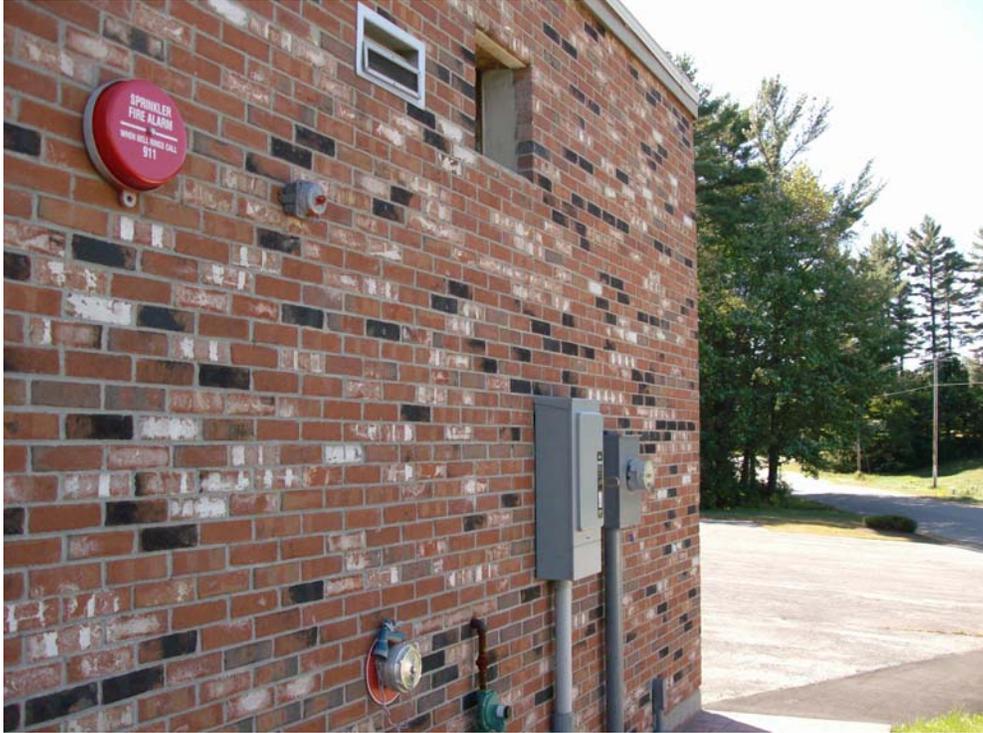
Southwest Corner of Building – Note Uncovered Wall Opening

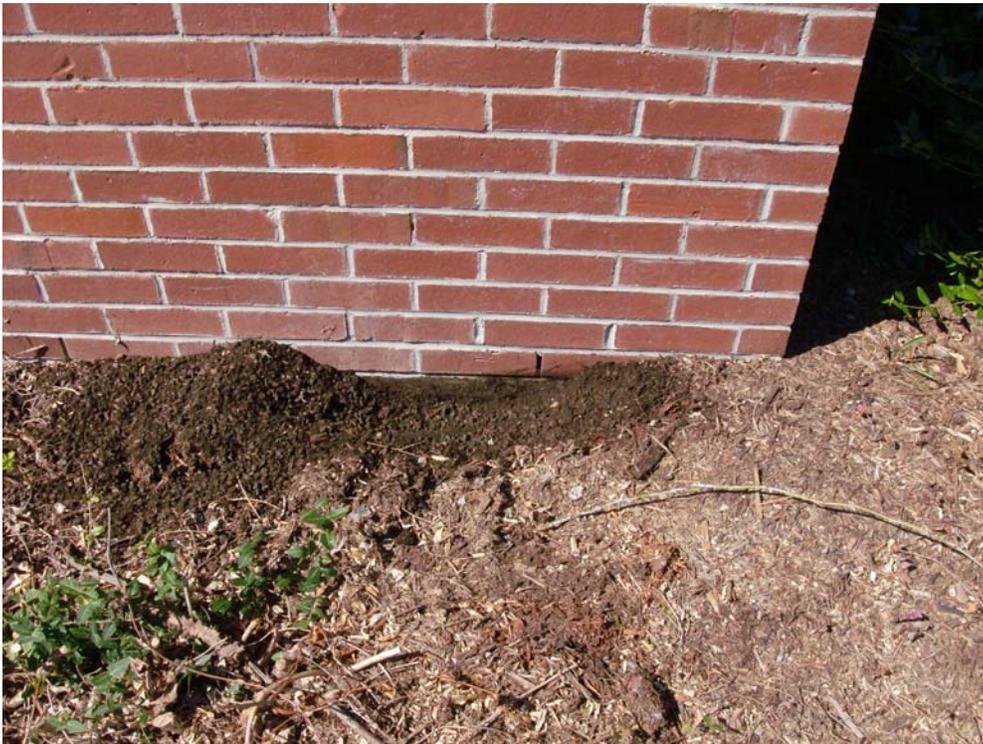
Soil and Mulch Blocking Mortar Joint Weeps

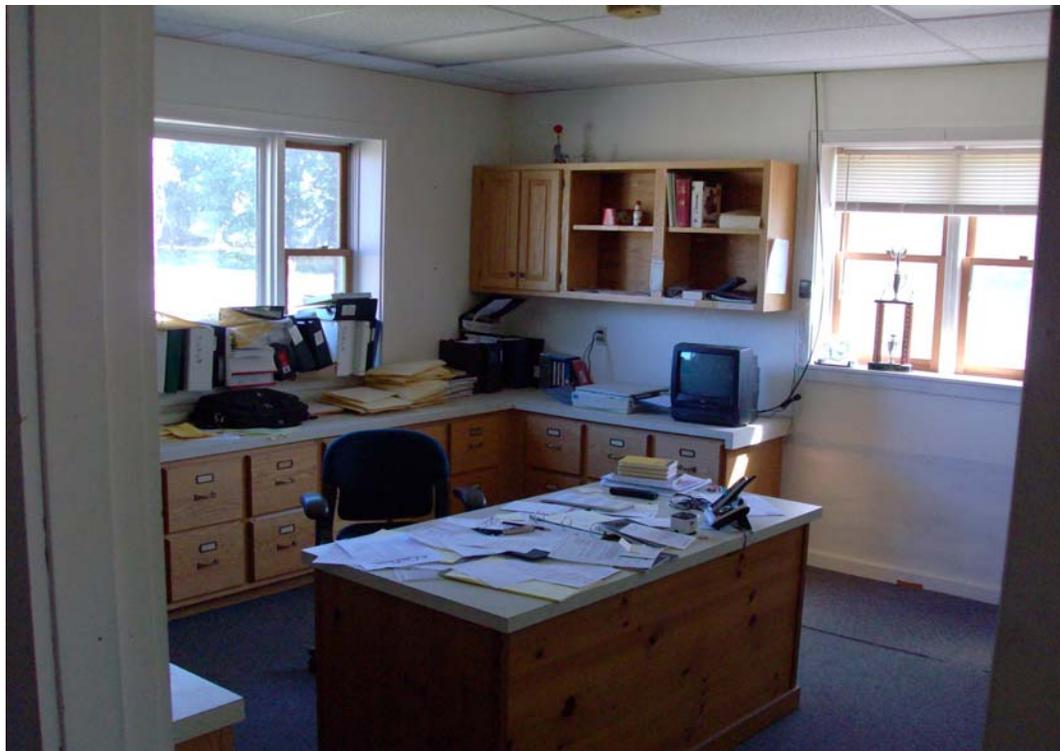
Office at Northeast Corner

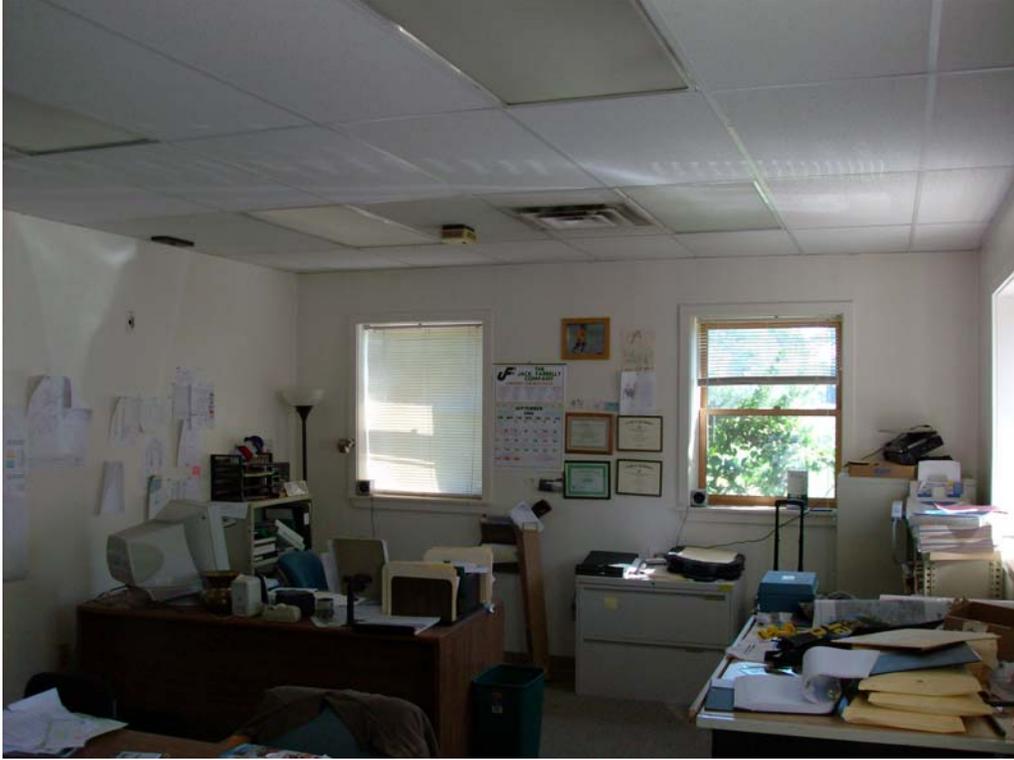
Office at Southeast Corner

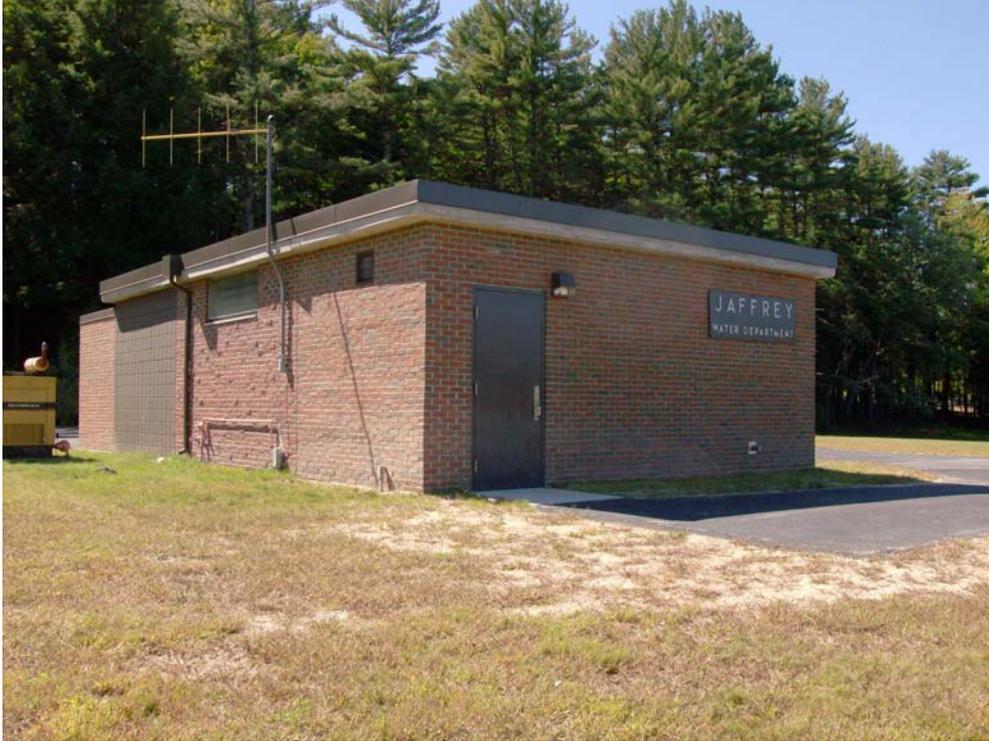
The Turnpike Road Station is constructed of concrete masonry block (CMU) with a brick façade. The building has a flat roof that is covered with a ballasted membrane roof system. There is a band of metal trim at the edge of the roof along the perimeter of the building. In general, the building is in very good condition. A separate, stand-alone, gas-fired generator is on-site for emergency use in the event of a power failure.

Pump Station off Turnpike Road

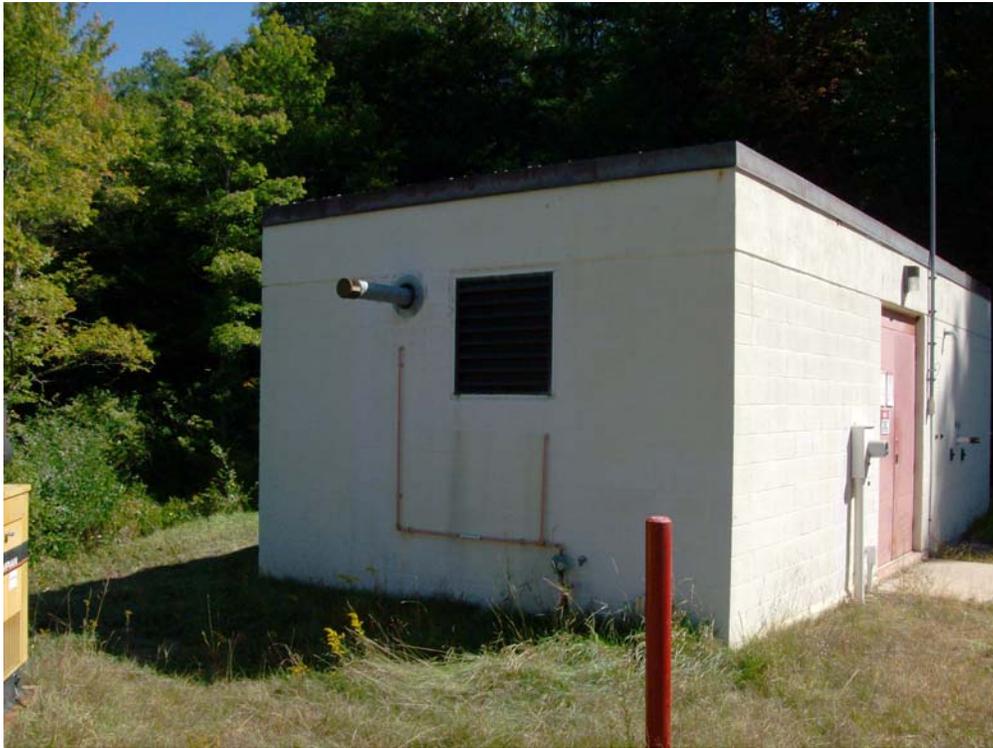
The station off Woodbound Road is constructed of concrete masonry block. The building has a flat roof covered with a ballasted membrane roof. From the outside, the building appears to be in good condition. A separate stand-alone, gas-fired generator is on-site for emergency use in the event of a power failure.

Pump Station off Woodbound Road

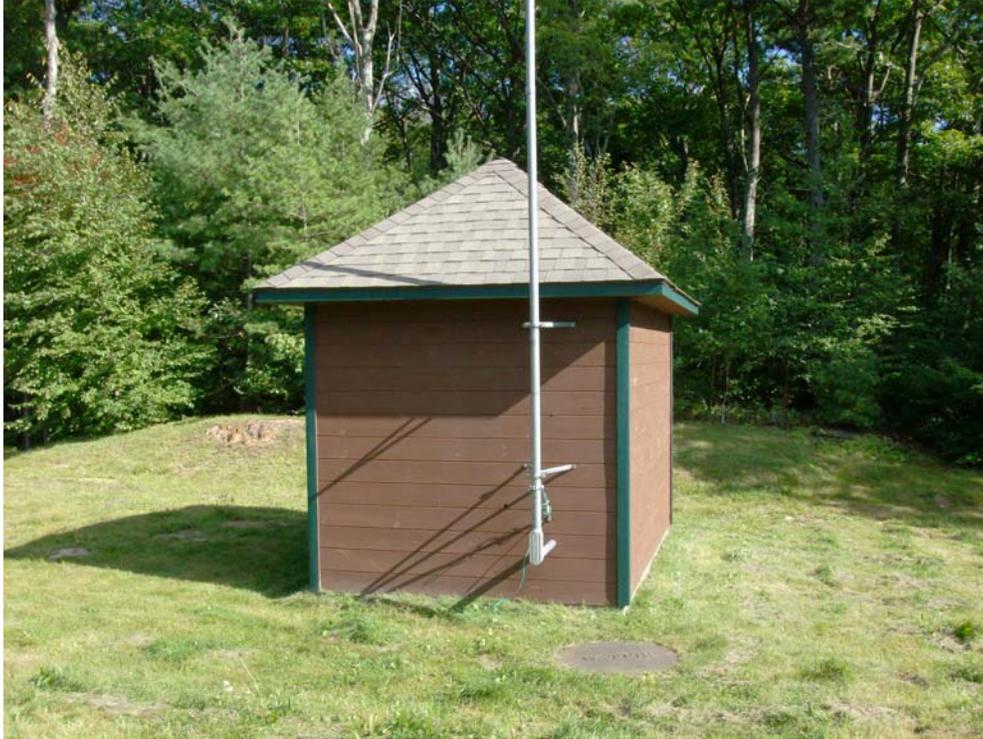
The underground reservoir and well pumphouse off Poole Road are actually located in Monadnock State Park. The well pumphouse is a wood-framed building sided with horizontal tongue and groove V-groove pine. The hip-style roof is covered with standard 3-tab asphalt shingles. The building is in very good condition.

Reservoir and Well Pumphouse in Monadnock State Park

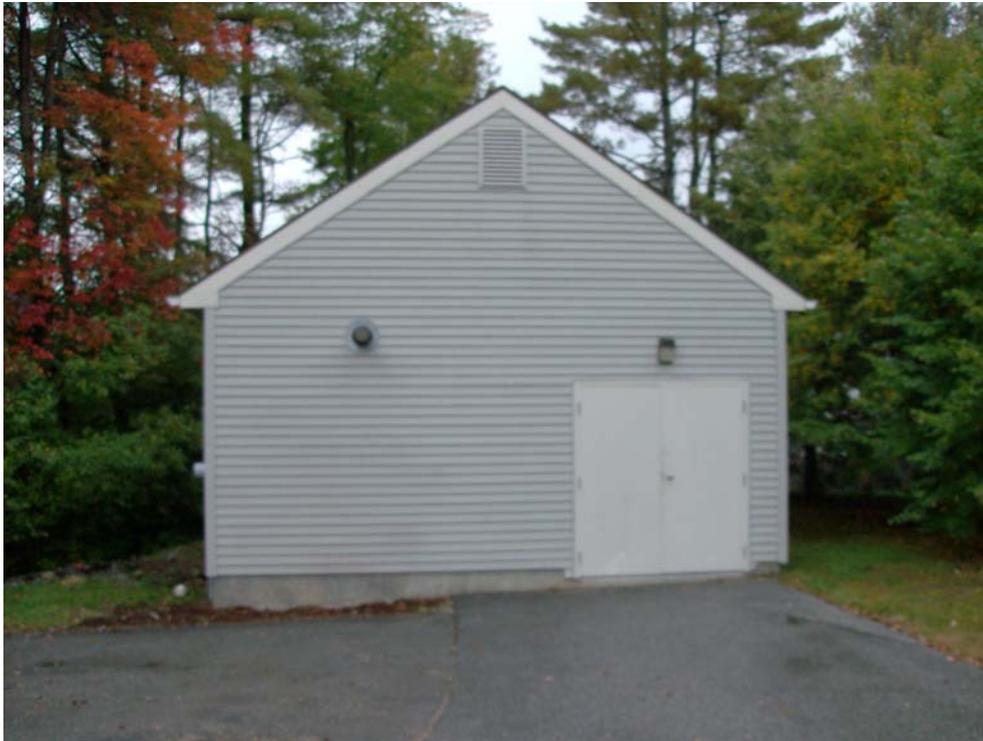
The Mountain Road Pump Station is a wood-framed structure covered with vinyl siding. The gable-style roof is covered with standard 3-tab asphalt shingles. In general, the building is in very good condition. A separate stand-alone, gas-fired generator is on-site for emergency use in the event of a power failure.

Pump Station on Mountain Road

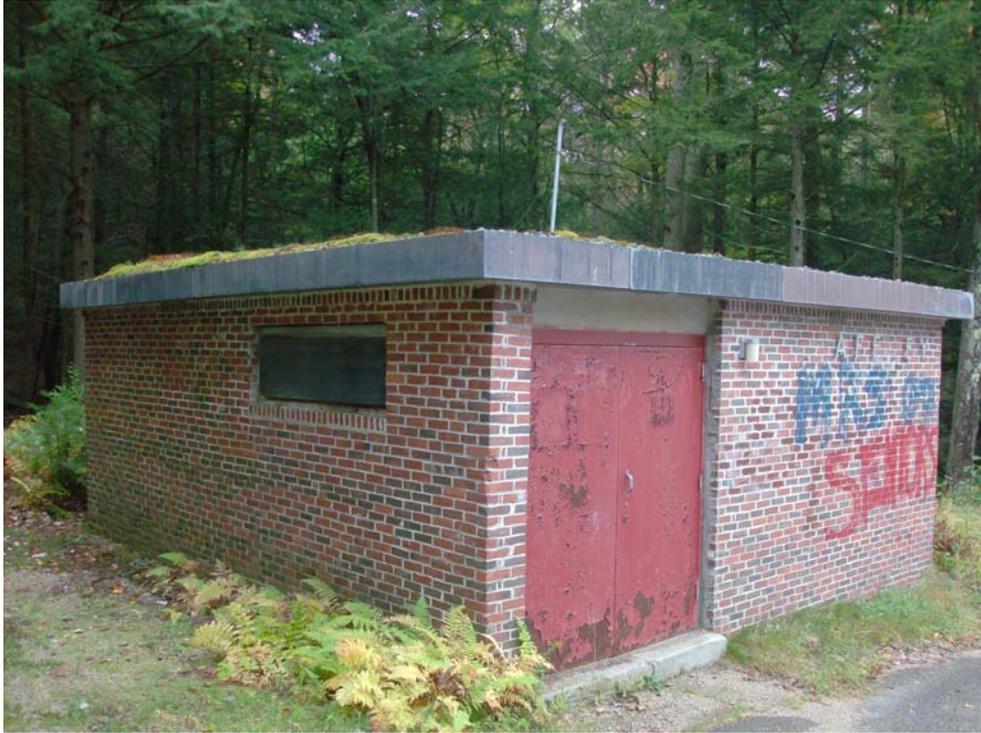
The Squantum Road Station no longer functions as a pumping station. It is currently used for storage. The building is constructed of CMU with a brick façade. Much of the building's façade has been covered with graffiti. The roof is a flat, ballasted-type membrane roof. Most of the roof is covered by a well established growth of moss. We suspect the membrane roof is far beyond its useful life and is in need of replacement.

Former Pump Station on Squantum Road

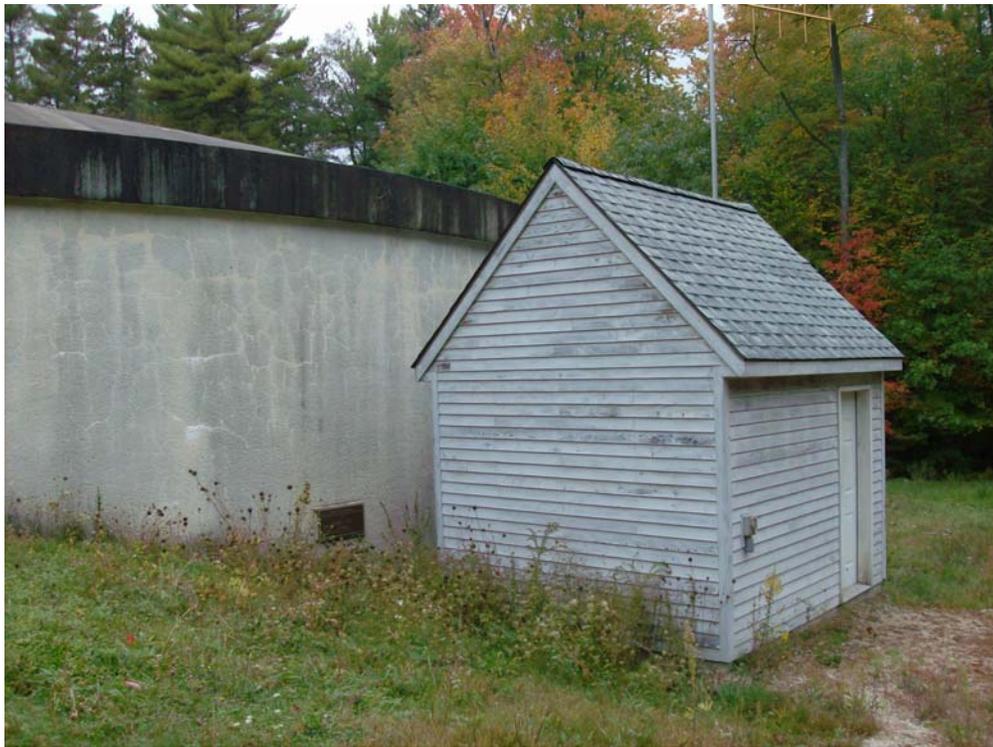
The Bullet Pond Reservoir and well pumphouse is located on a dirt road off Squantum Road over the Town line in Rindge. The reservoir is an above-ground shotcrete structure constructed by the Natgun Corporation in 1994. It is an 80-foot diameter covered tank which holds 750,000 gallons of water. The well pumphouse is a wood-framed structure. The siding is wood clapboards, and the roof is covered with standard 3-tab asphalt shingles. Other than needing a fresh coat of paint, the pumphouse structure is in good condition. The shotcrete cladding of the reservoir is in good condition with no signs of cracking or spalling. There is no generator on-site, but in the event of an emergency, the pumphouse building does have an exterior receptacle for plugging in a portable generator if needed.

Bullet Pond Reservoir and Wellhouse

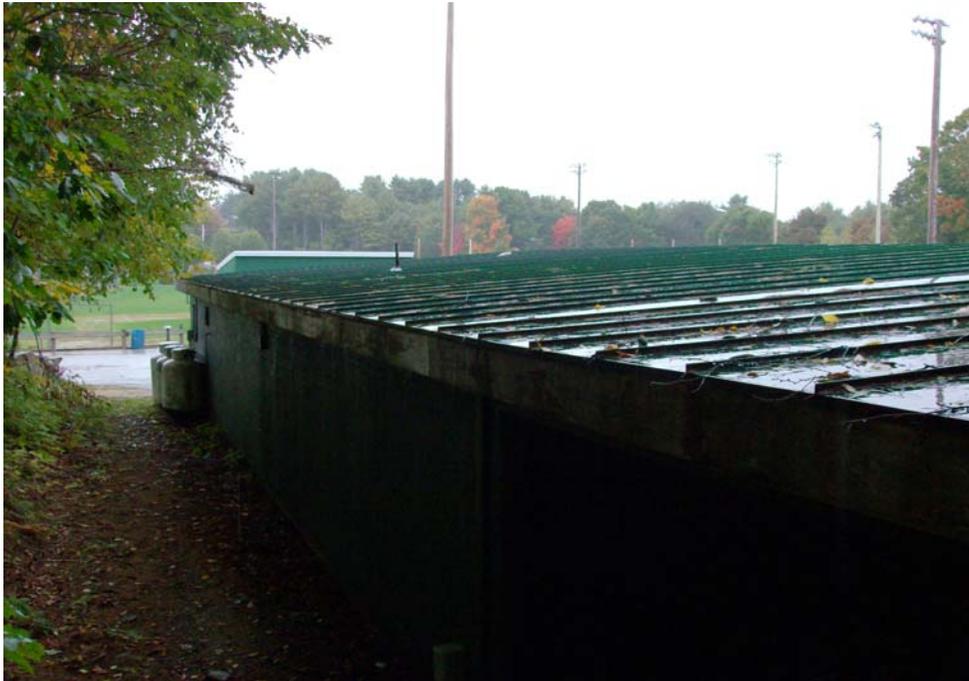
New Standing Seam Metal Roof on Youth Center

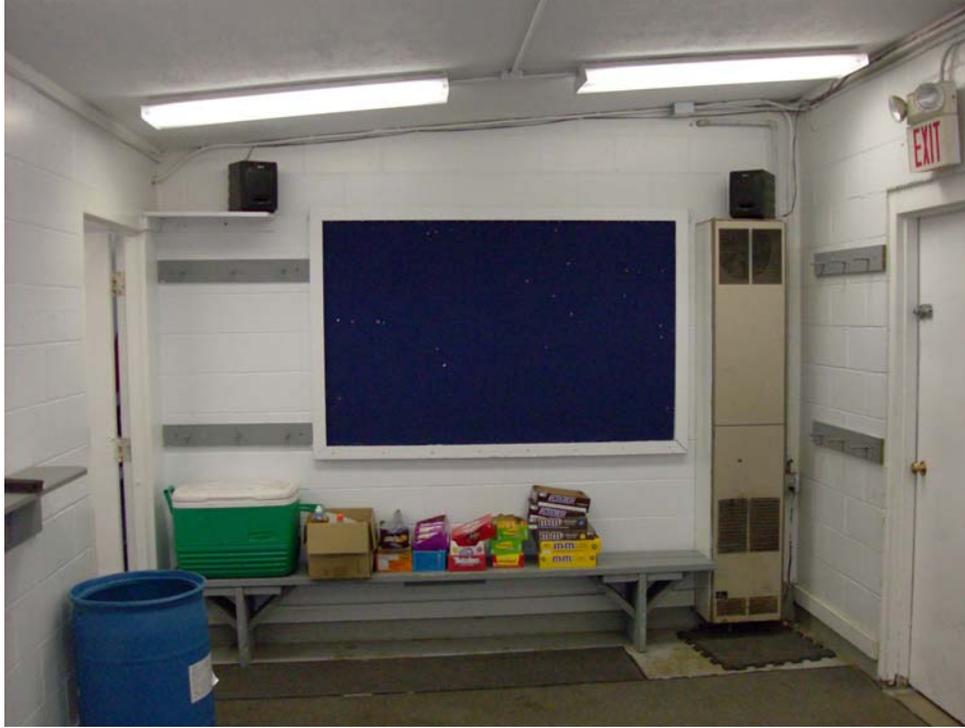
Youth Center – Area Outside Concession Window – Note Gas Wall Heater

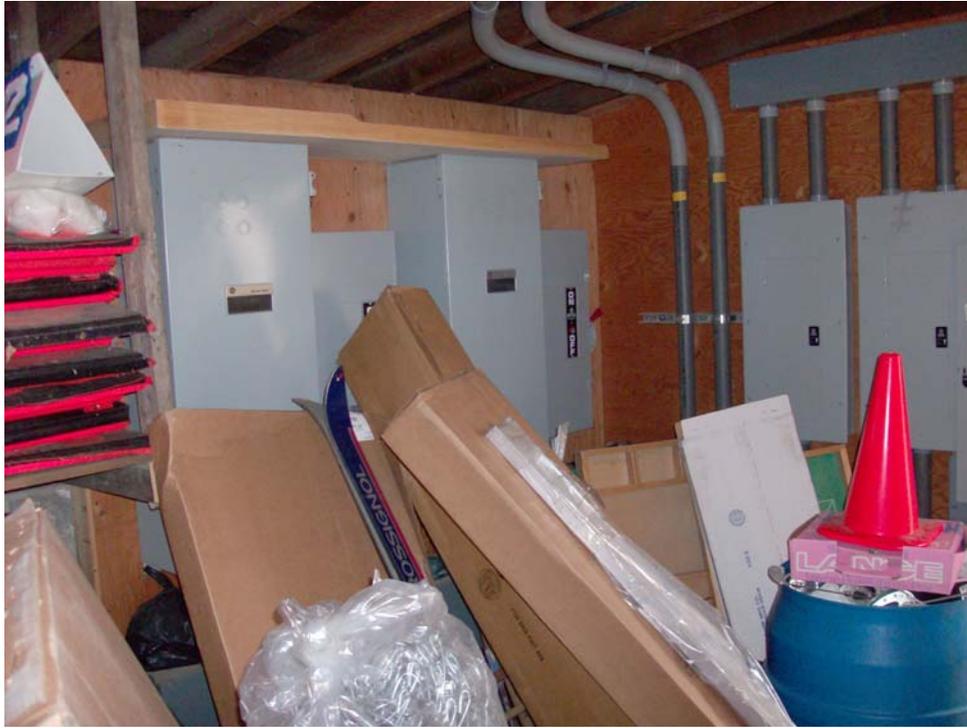
Electrical Panels in the “Dungeon” – Note Boxes and Debris Blocking Panel Access

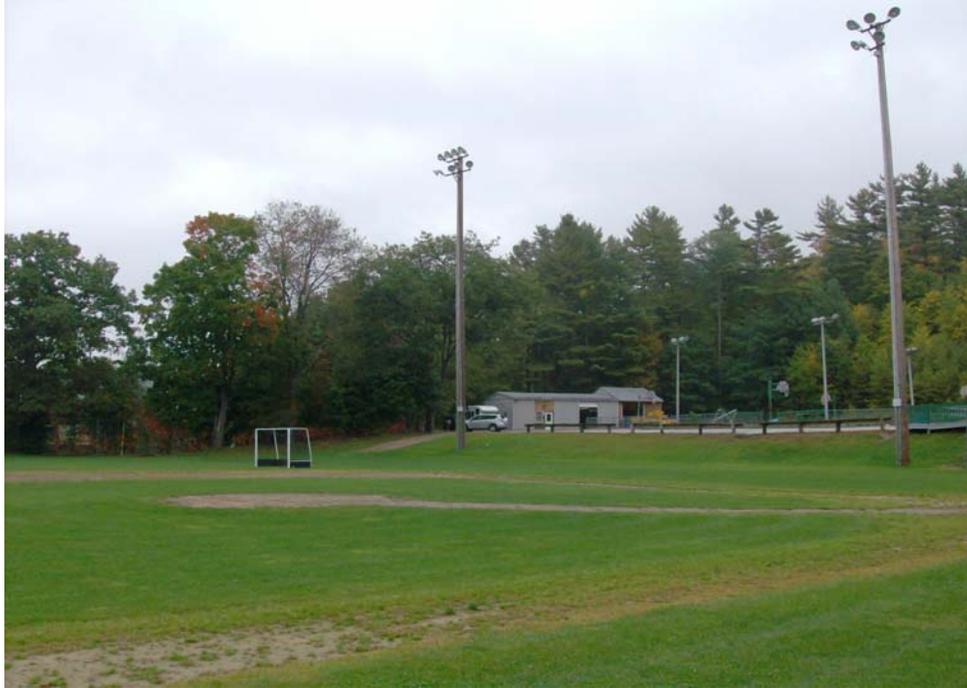
Overview of Field Looking Towards Parks and Recreation Office

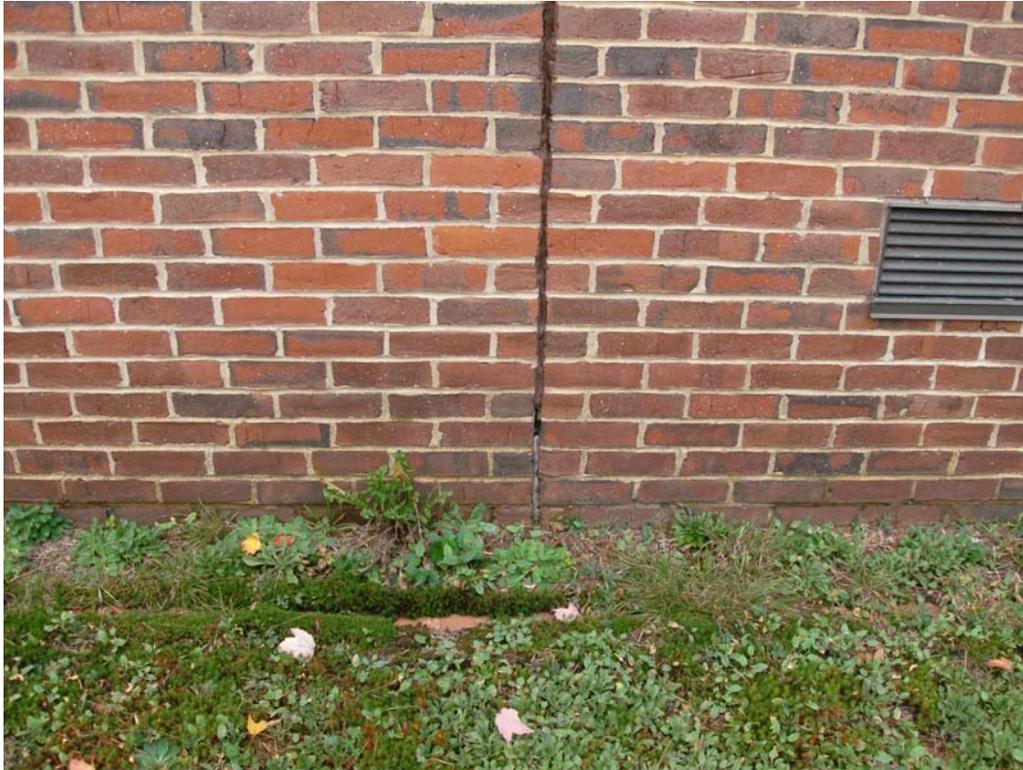
Typical Brick Control Joint

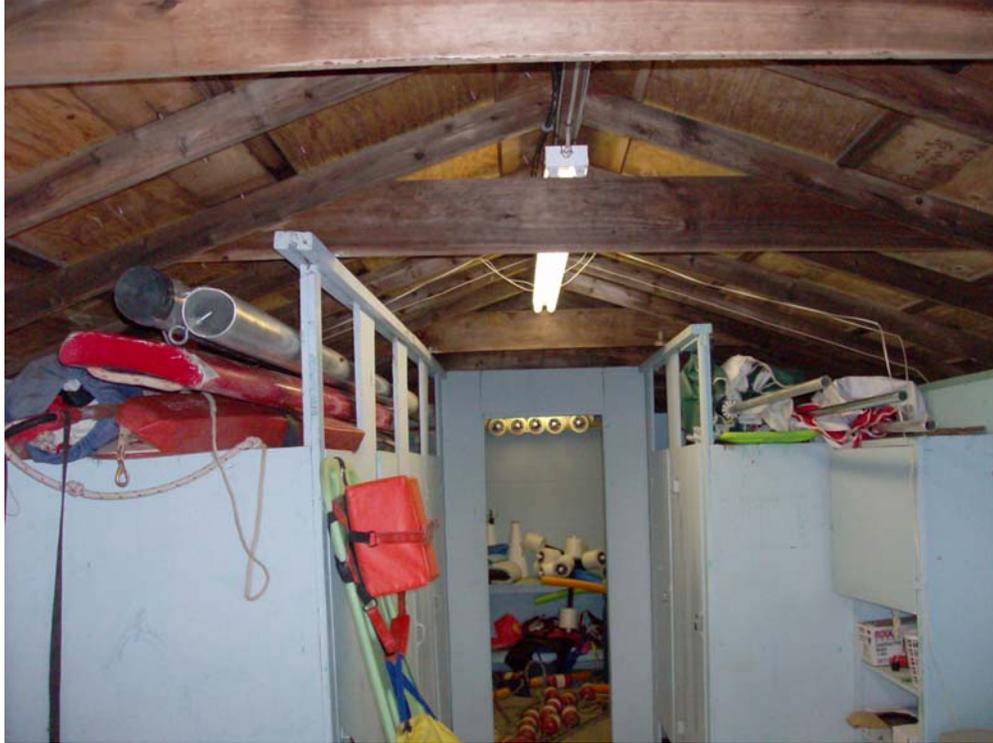
Changing Rooms – Currently Being Used for Winter Storage

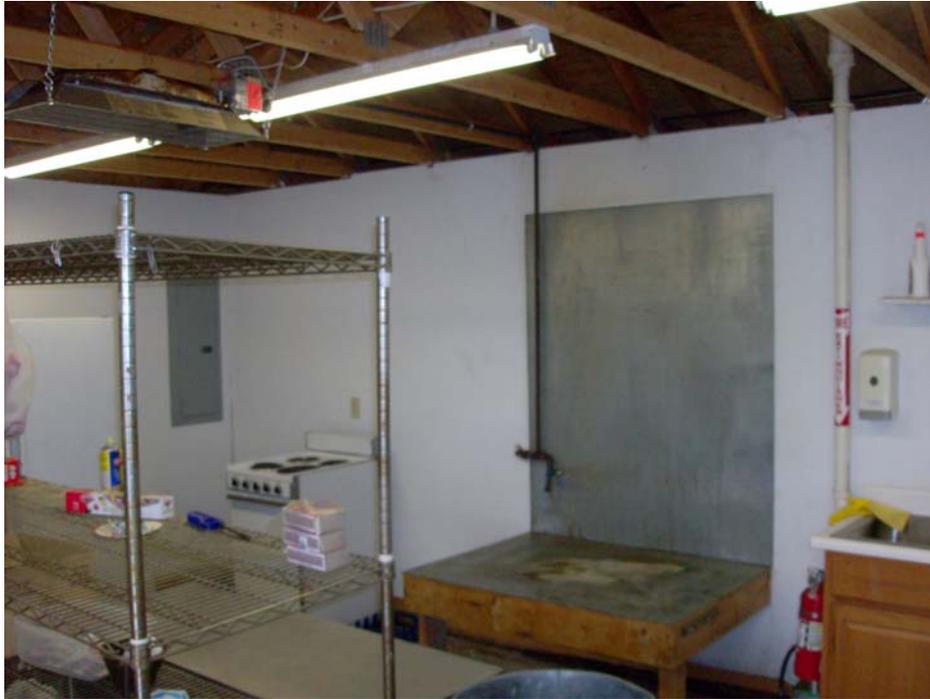
Table for Gas Griddle – Note No Overhead Hood

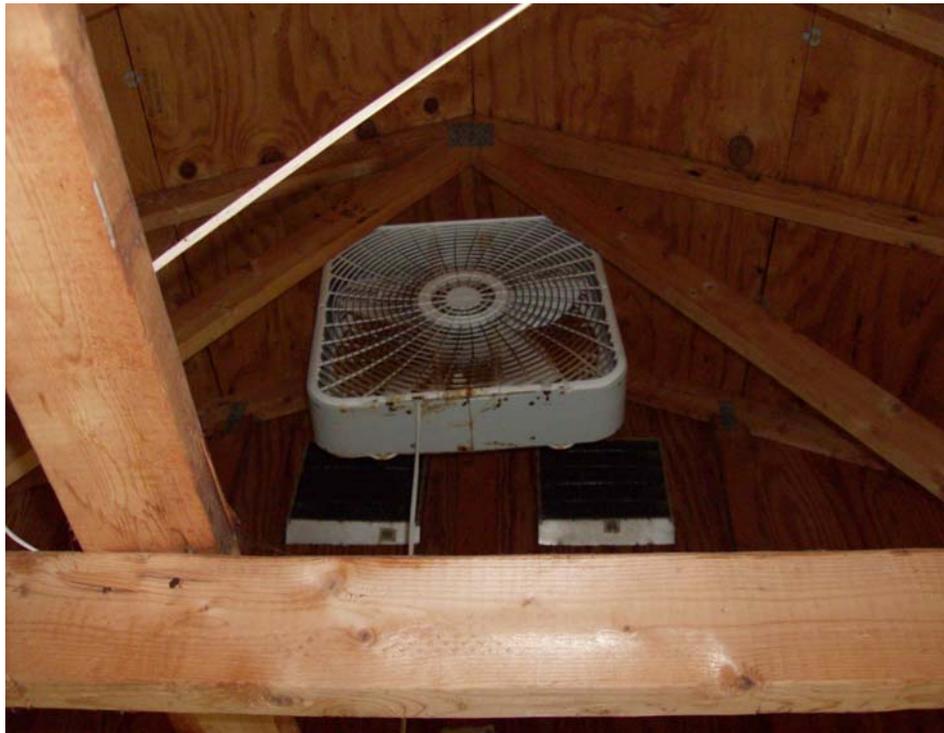
Box Fan Used to Vent Cooking Fumes and Smoke
