**FACILITY ASSESSMENTS
MUNICIPAL BUILDINGS
PHASE II**

JAFFREY, NEW HAMPSHIRE

JANUARY 2009

THE H.L. TURNER GROUP Inc.

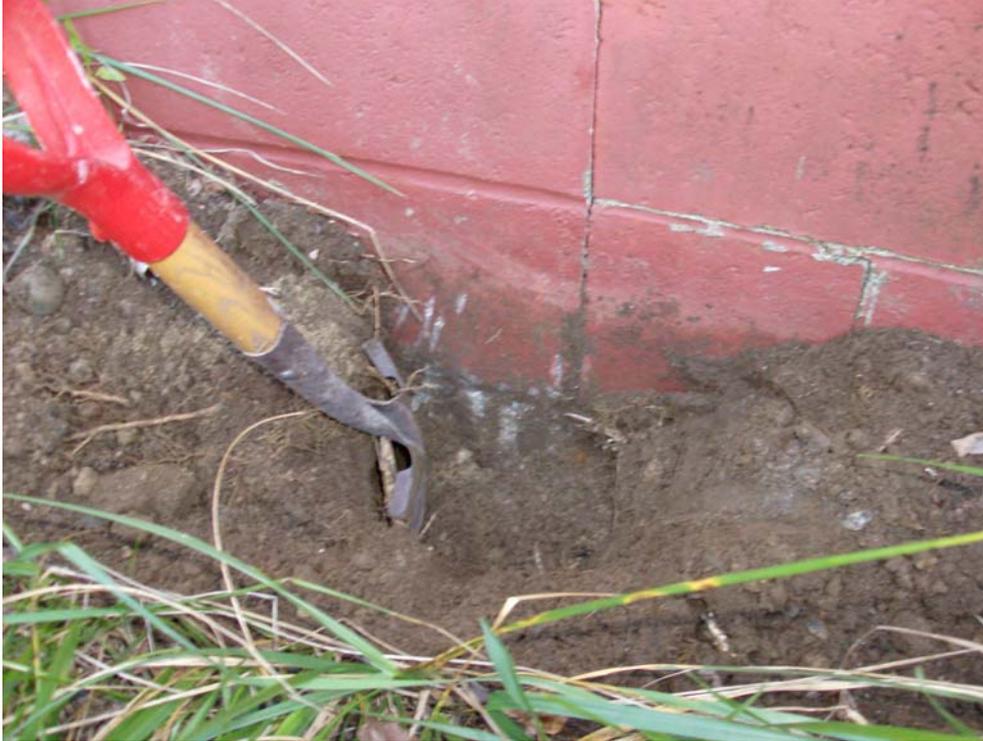
Existing Grade Covering Lower Block Course and Weep Holes
